When is Reservoir Cleaning not just Cleaning? - following the evidence trail

Jillian Busch - Data Based Solutions Pty Ltd

Dave Barry - Aqualift Potable Diving Pty Ltd

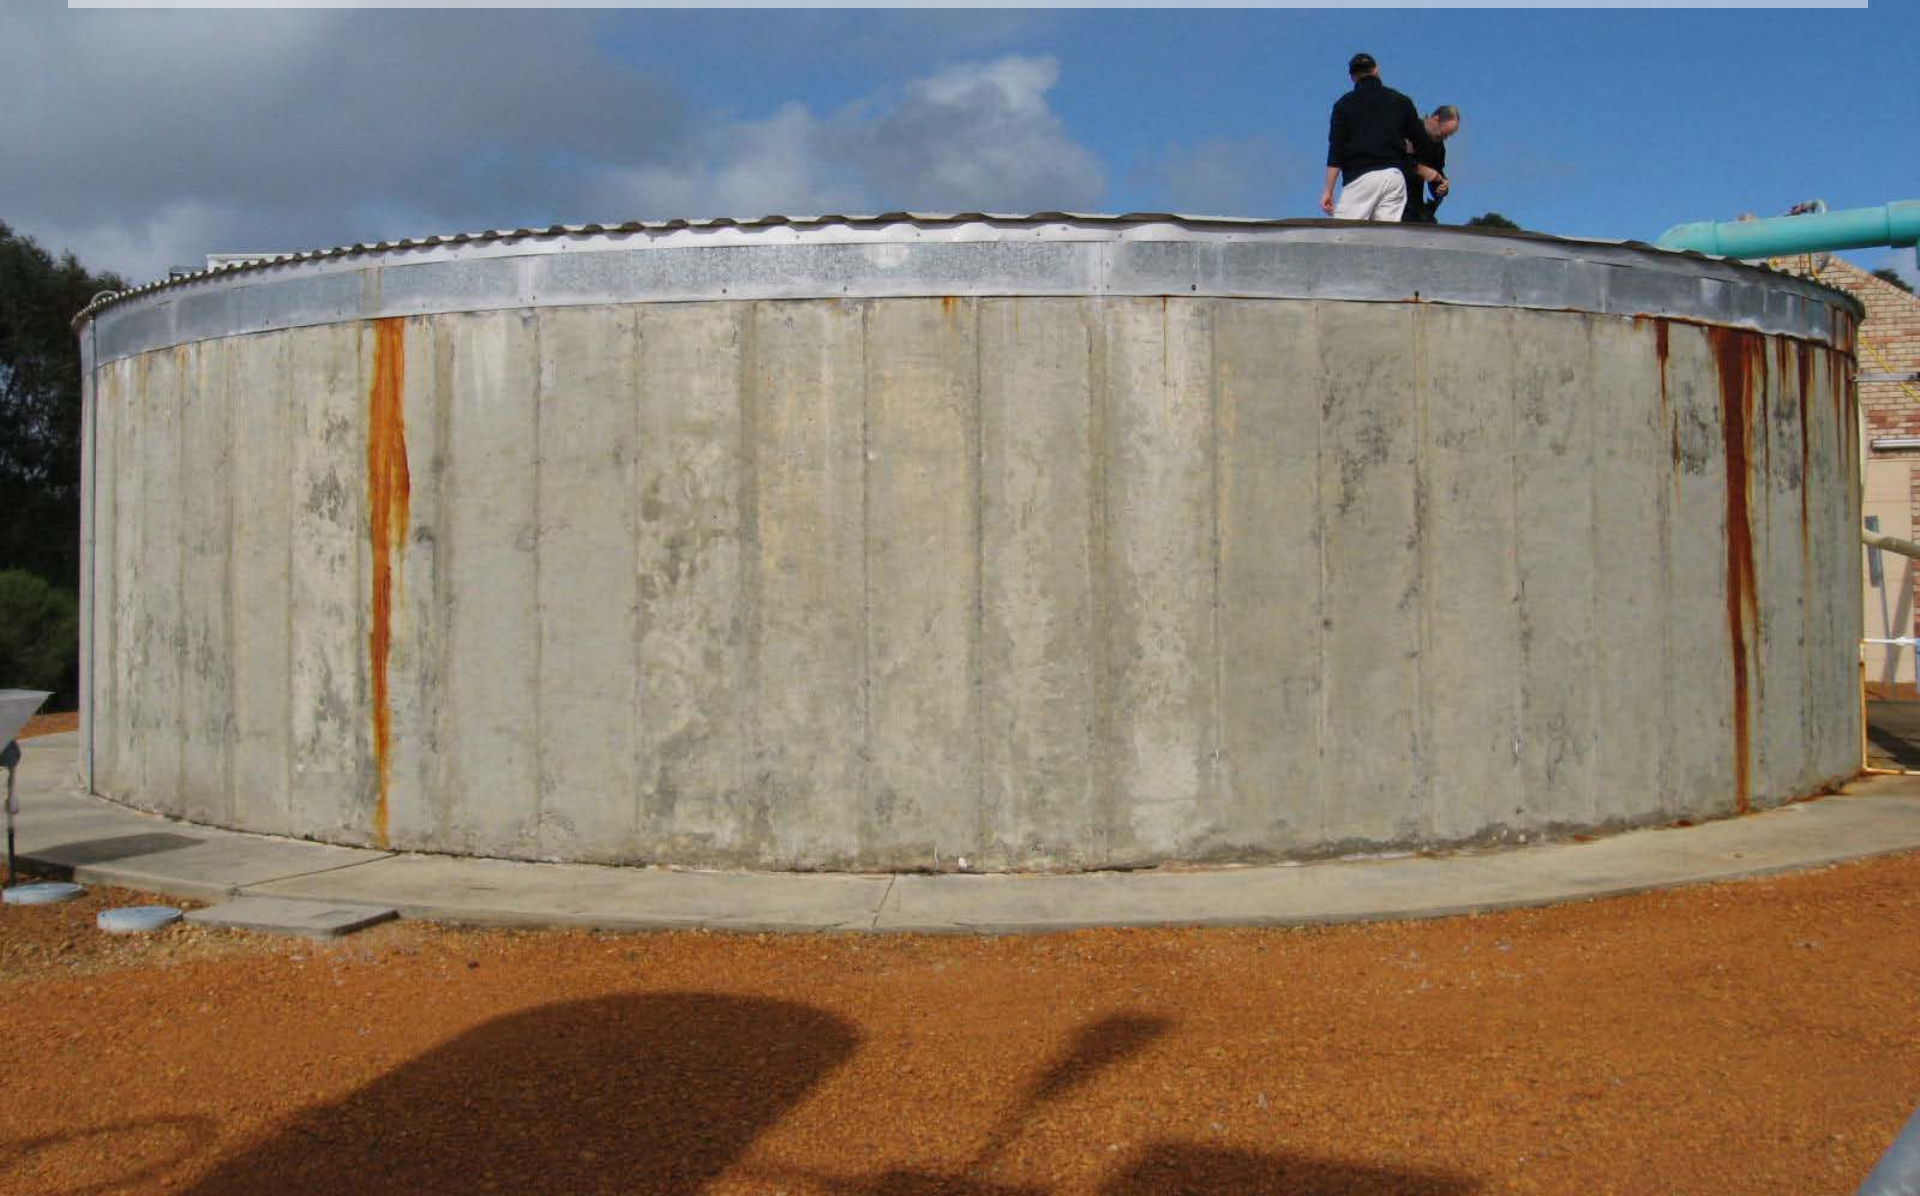
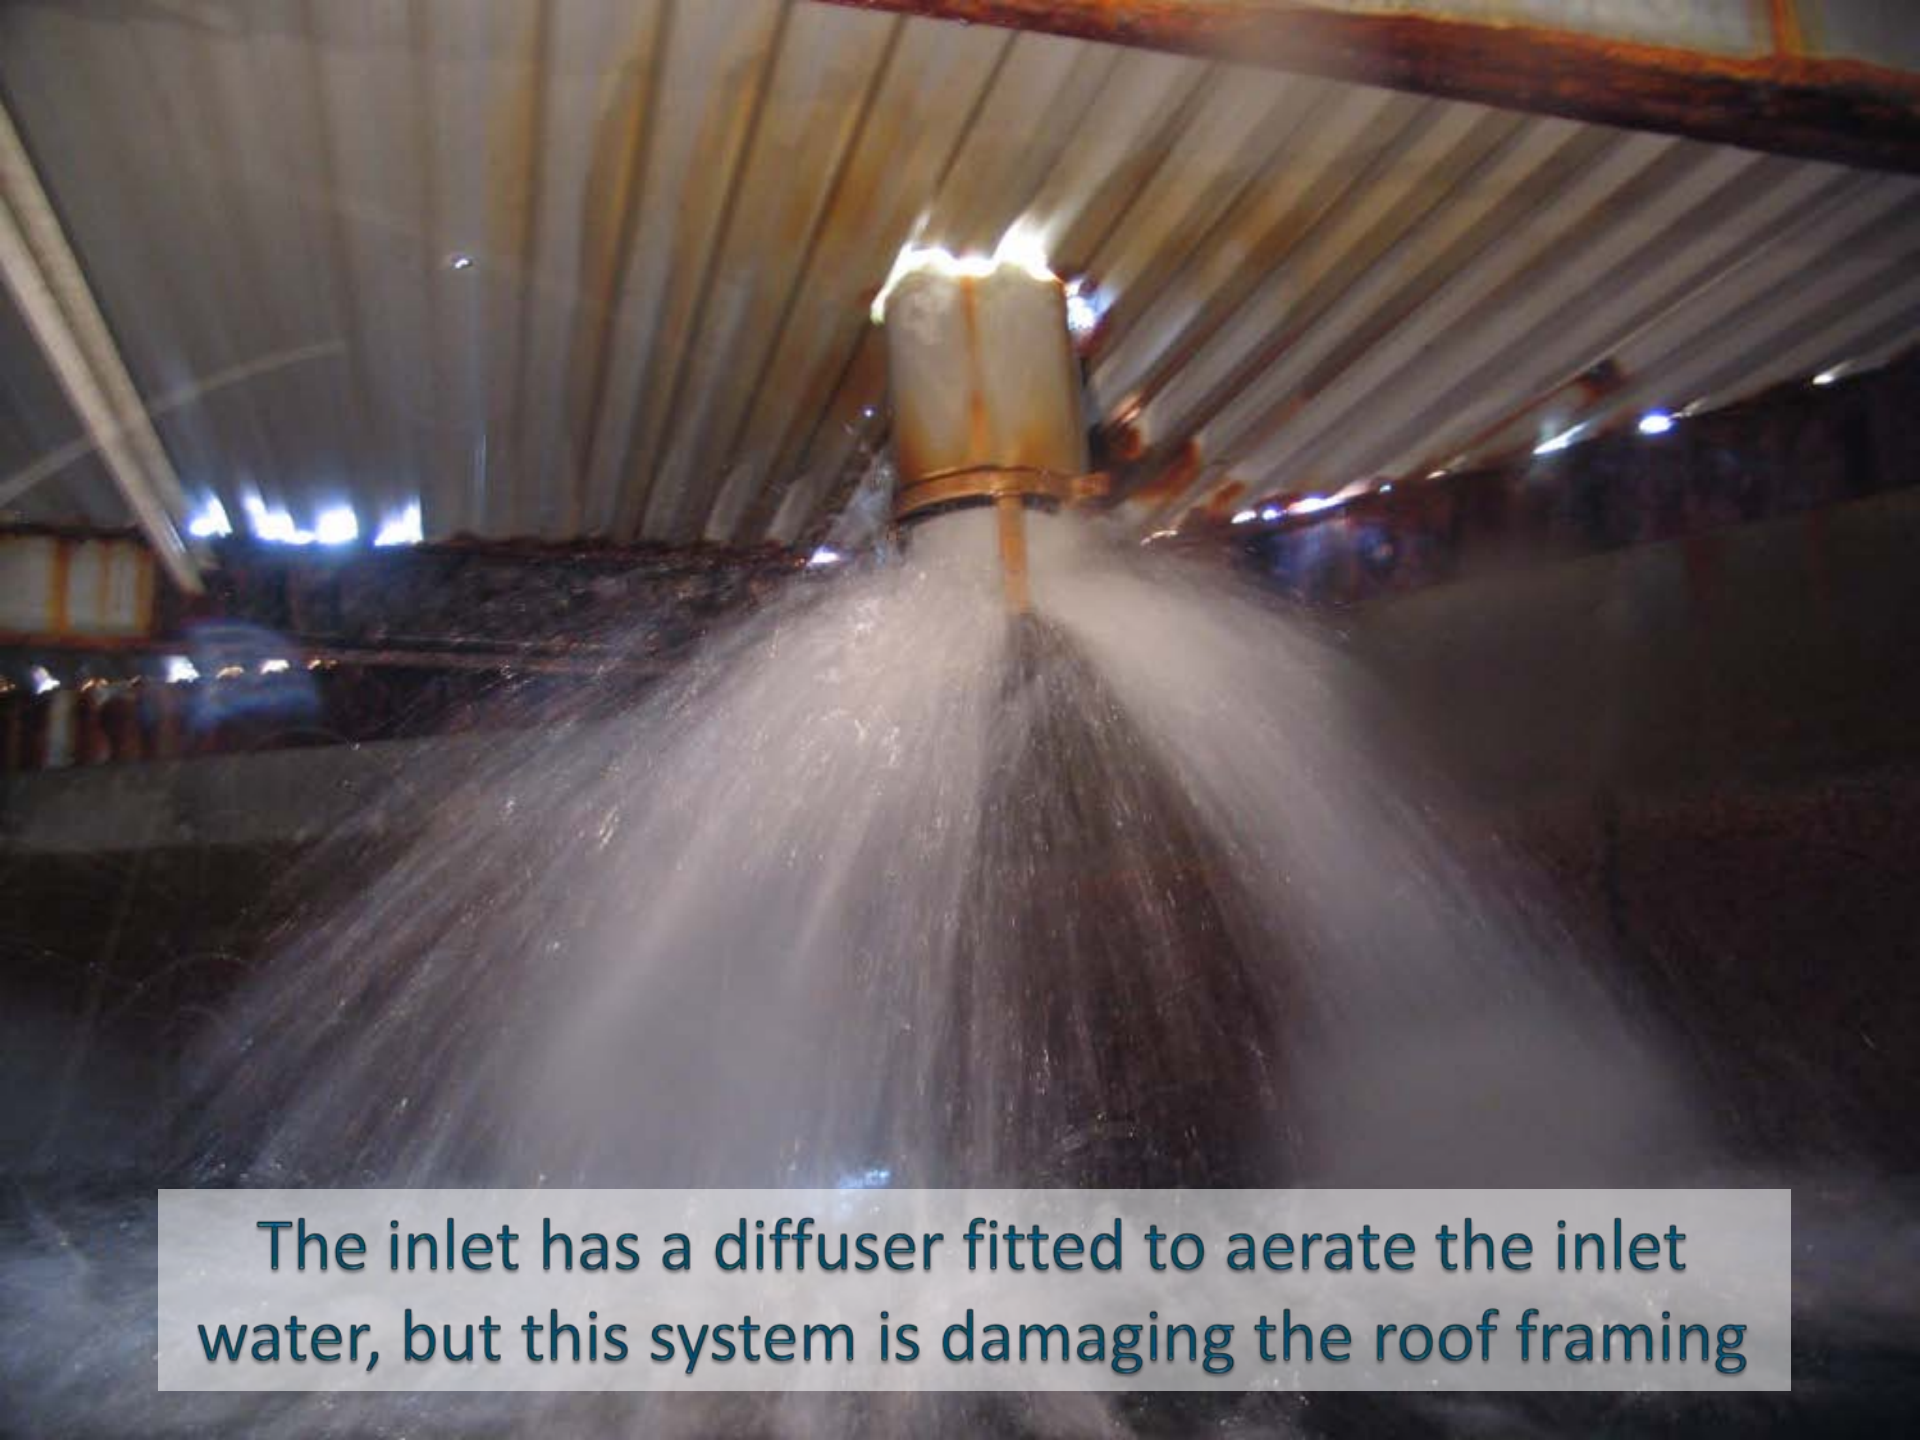
Corrosion bleeding down the upper walls – caused by bore water from a ‘top fill’ inlet spraying onto the roof framing

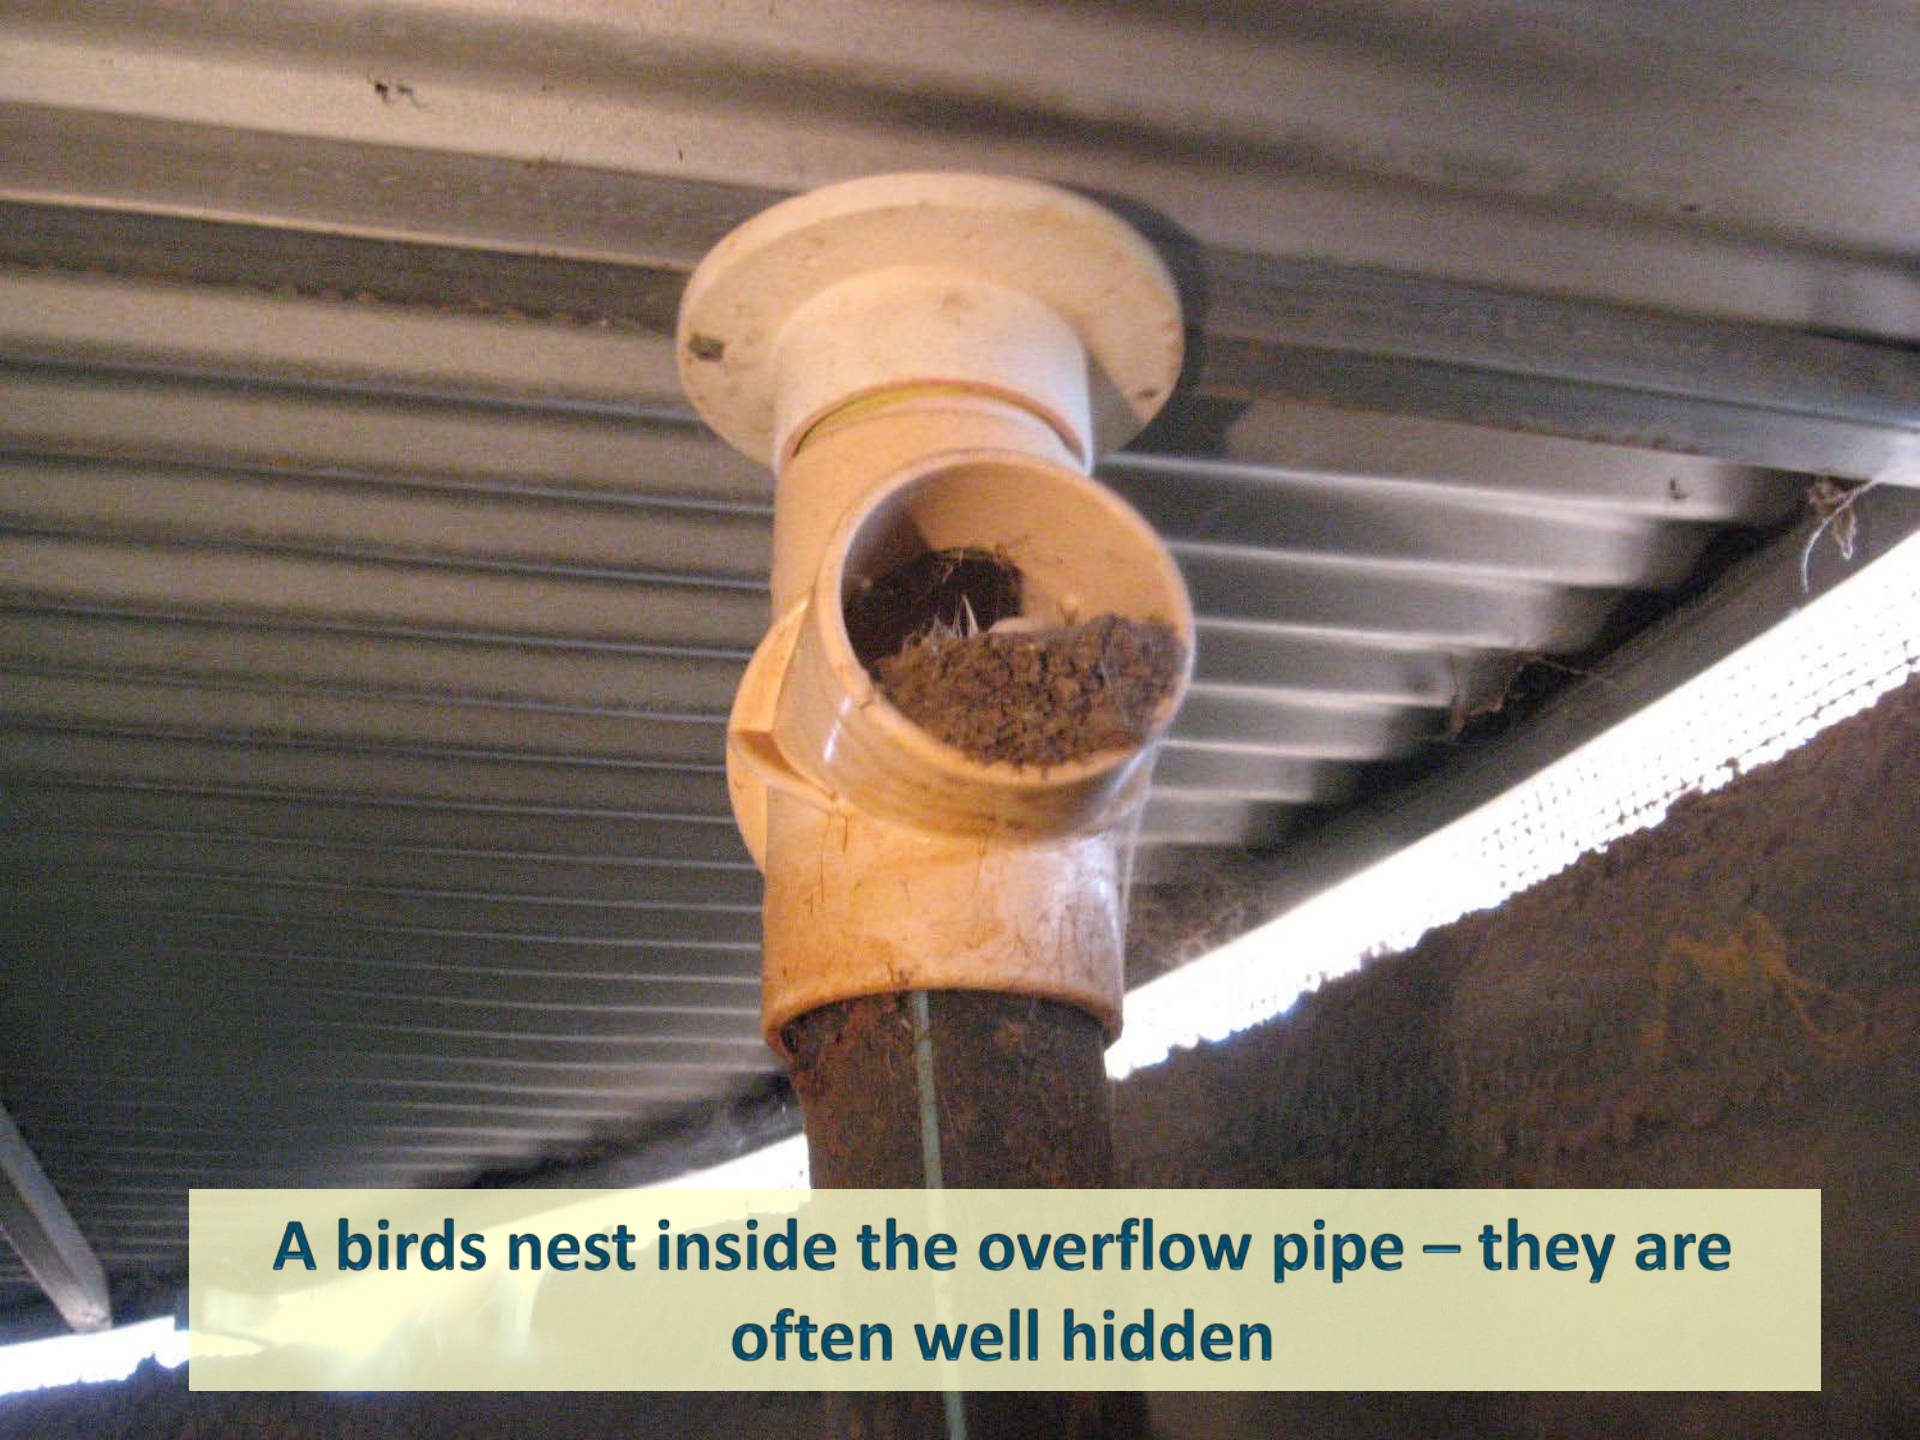
A birds nest in the rafters indicates an entry point close by

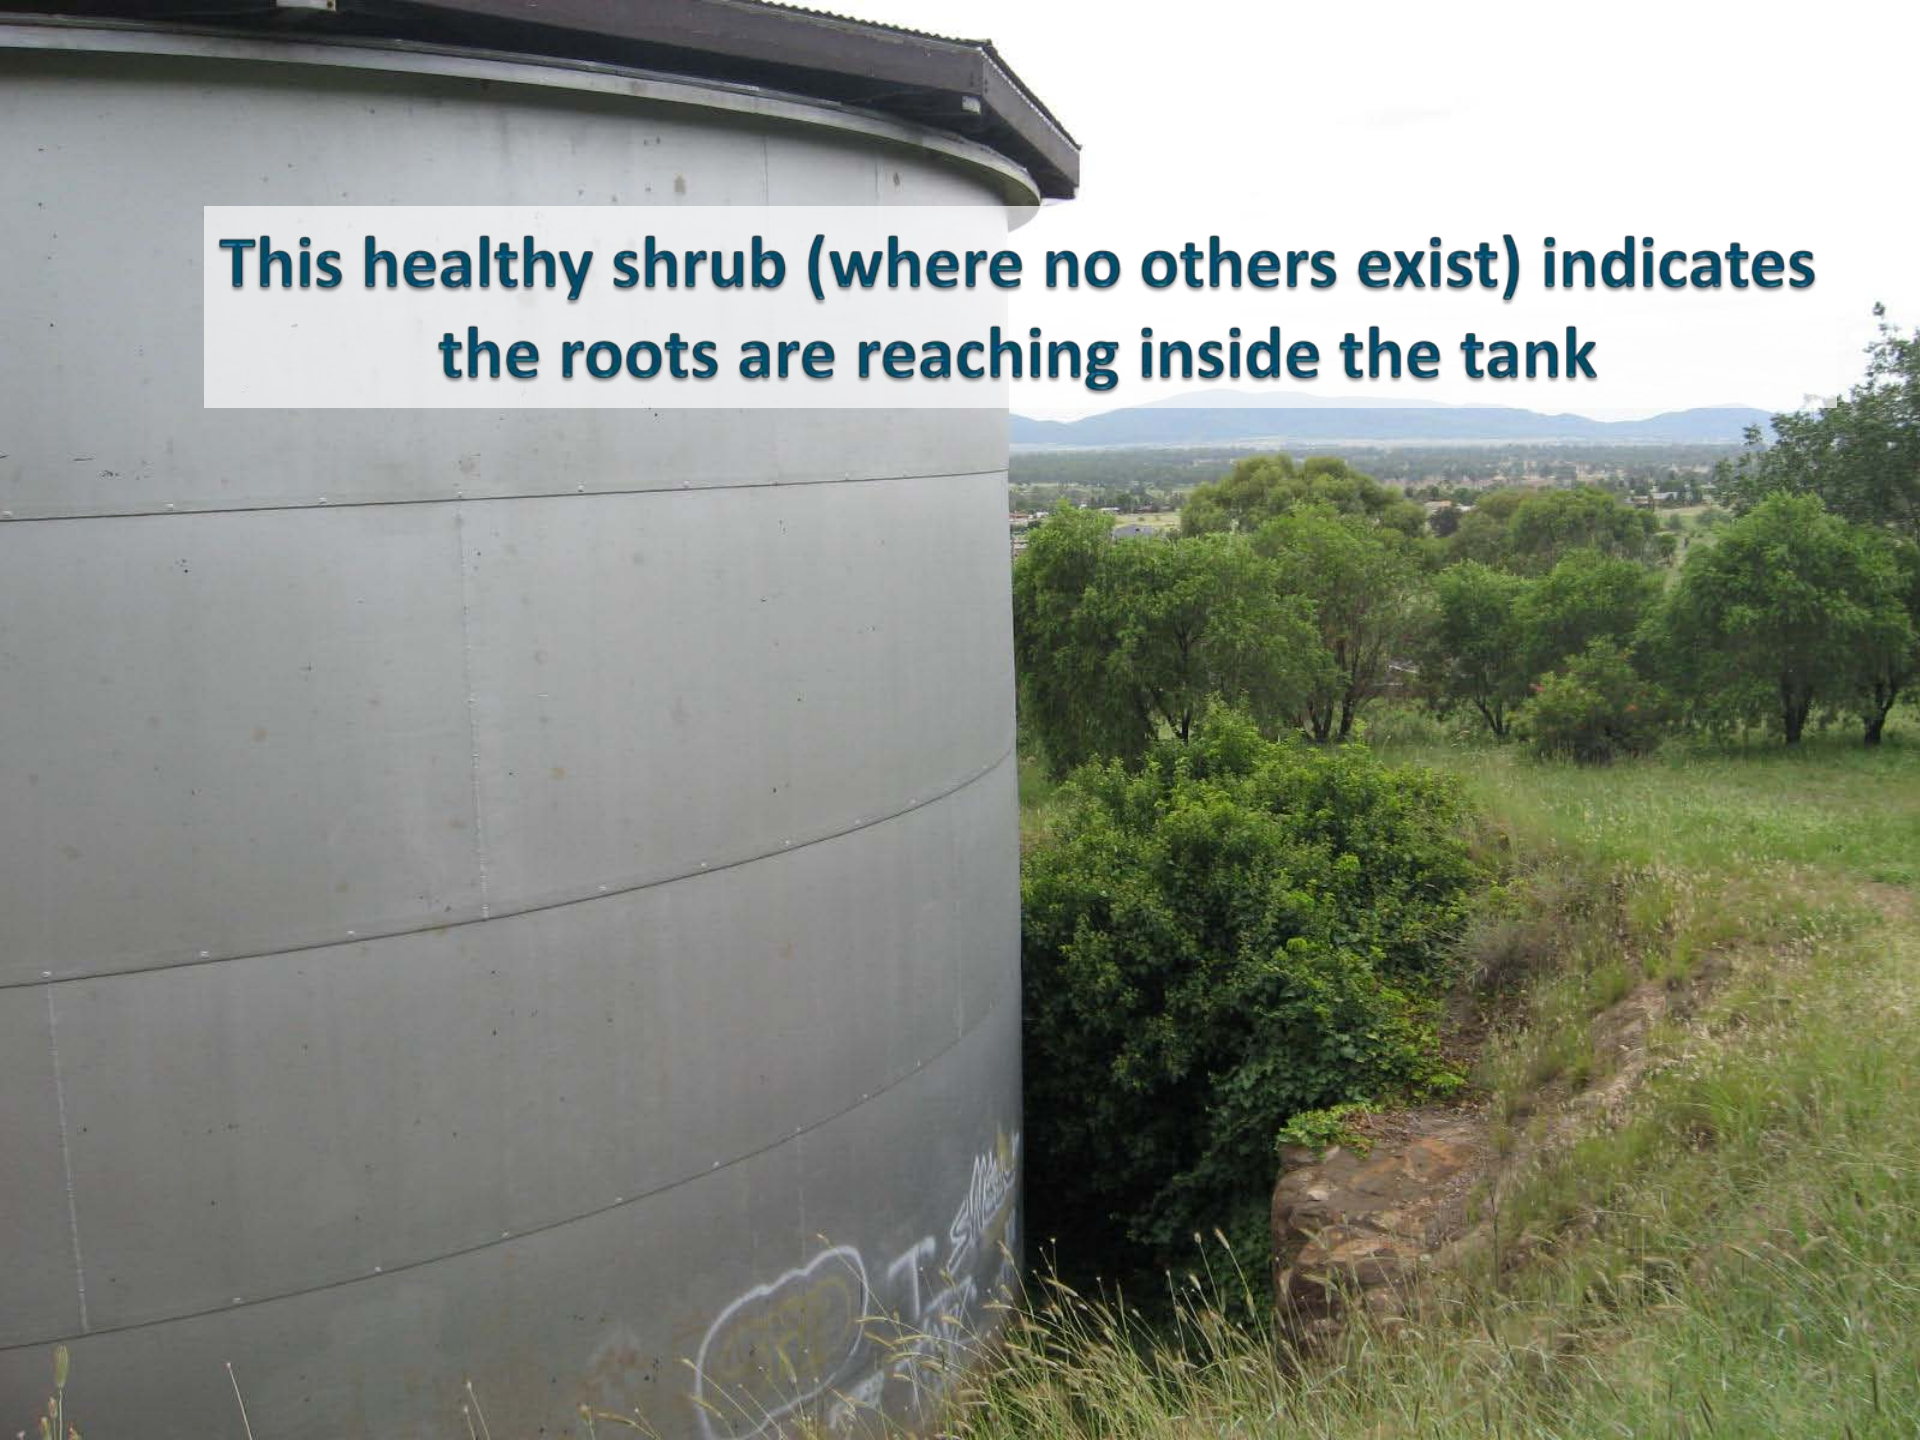
This healthy shrub (where no others exist) indicates the roots are reaching inside the tank

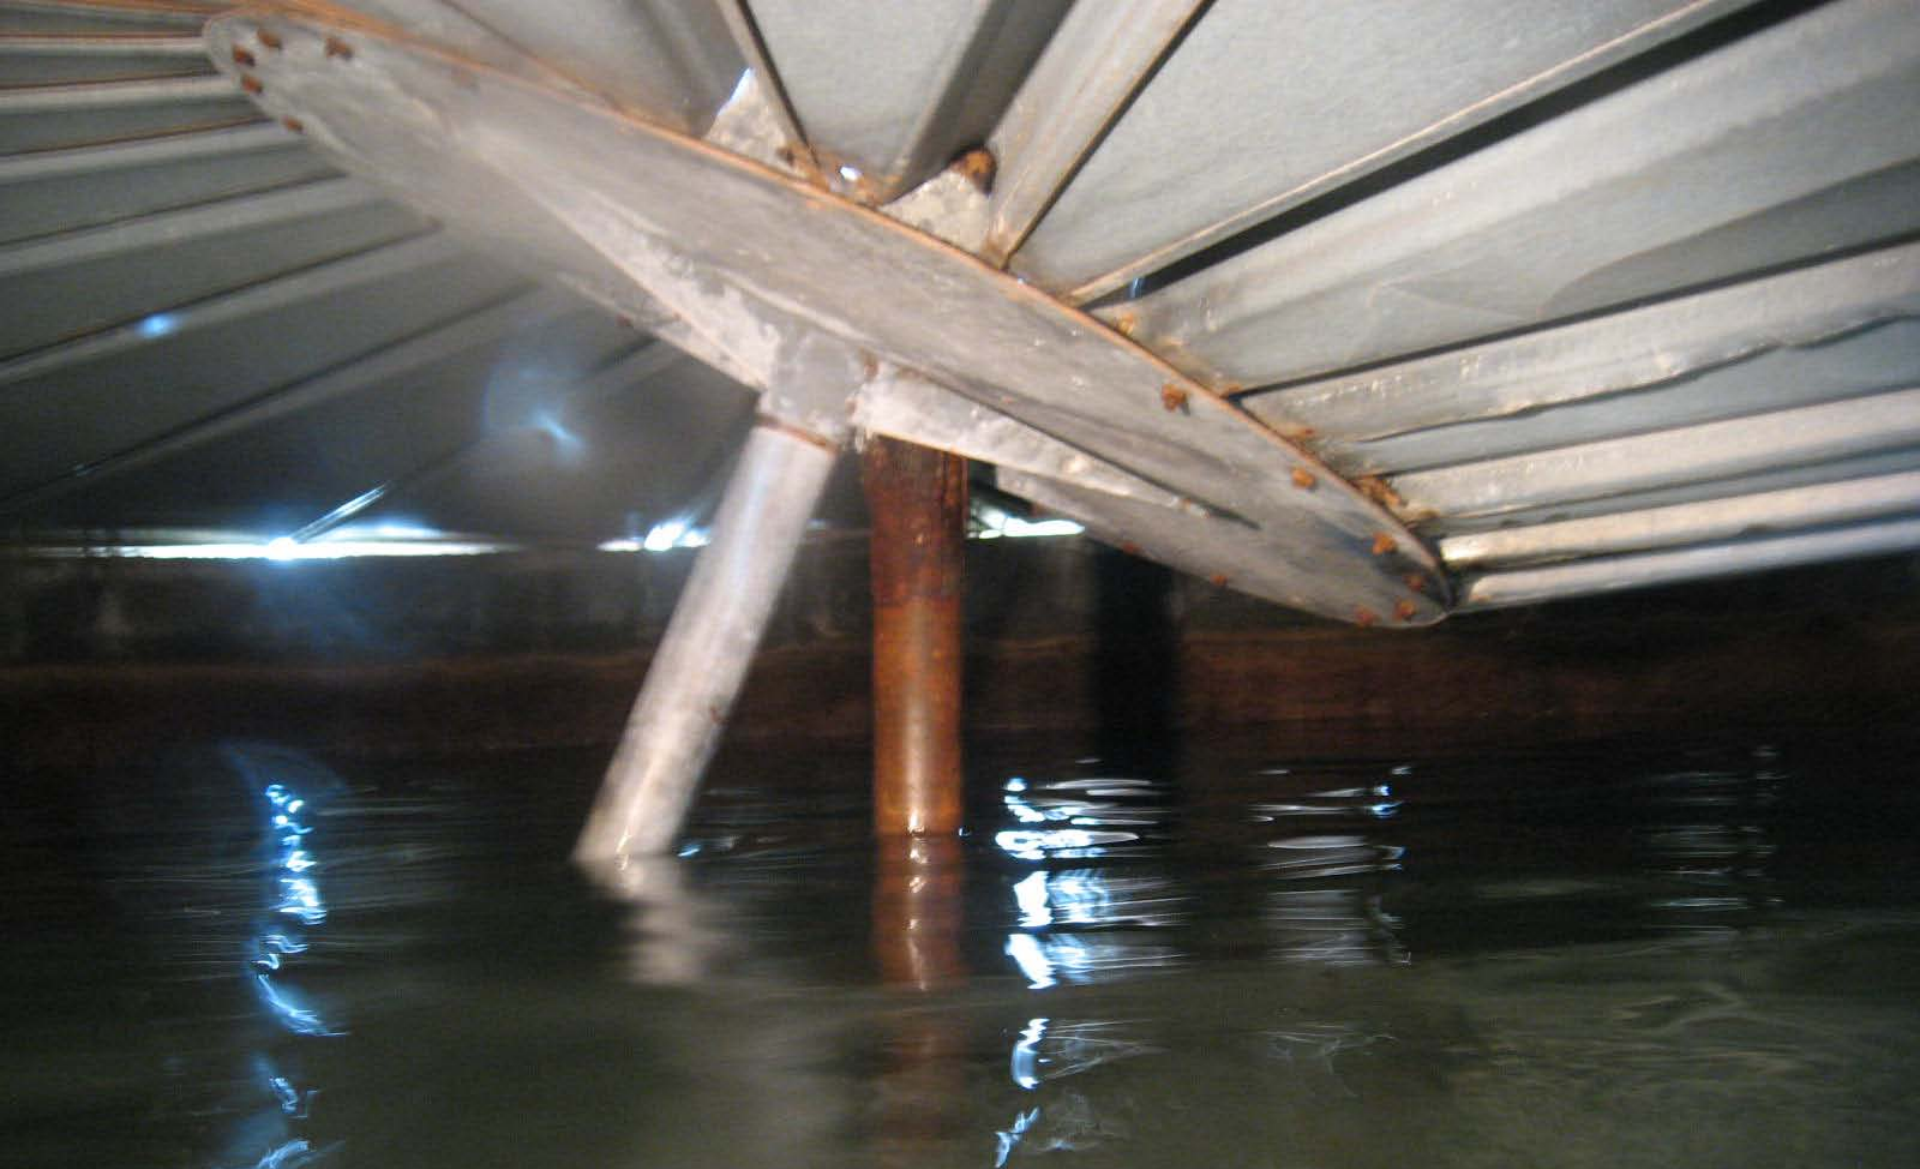
The roof area has subsided – the internal center post has most likely collapsed

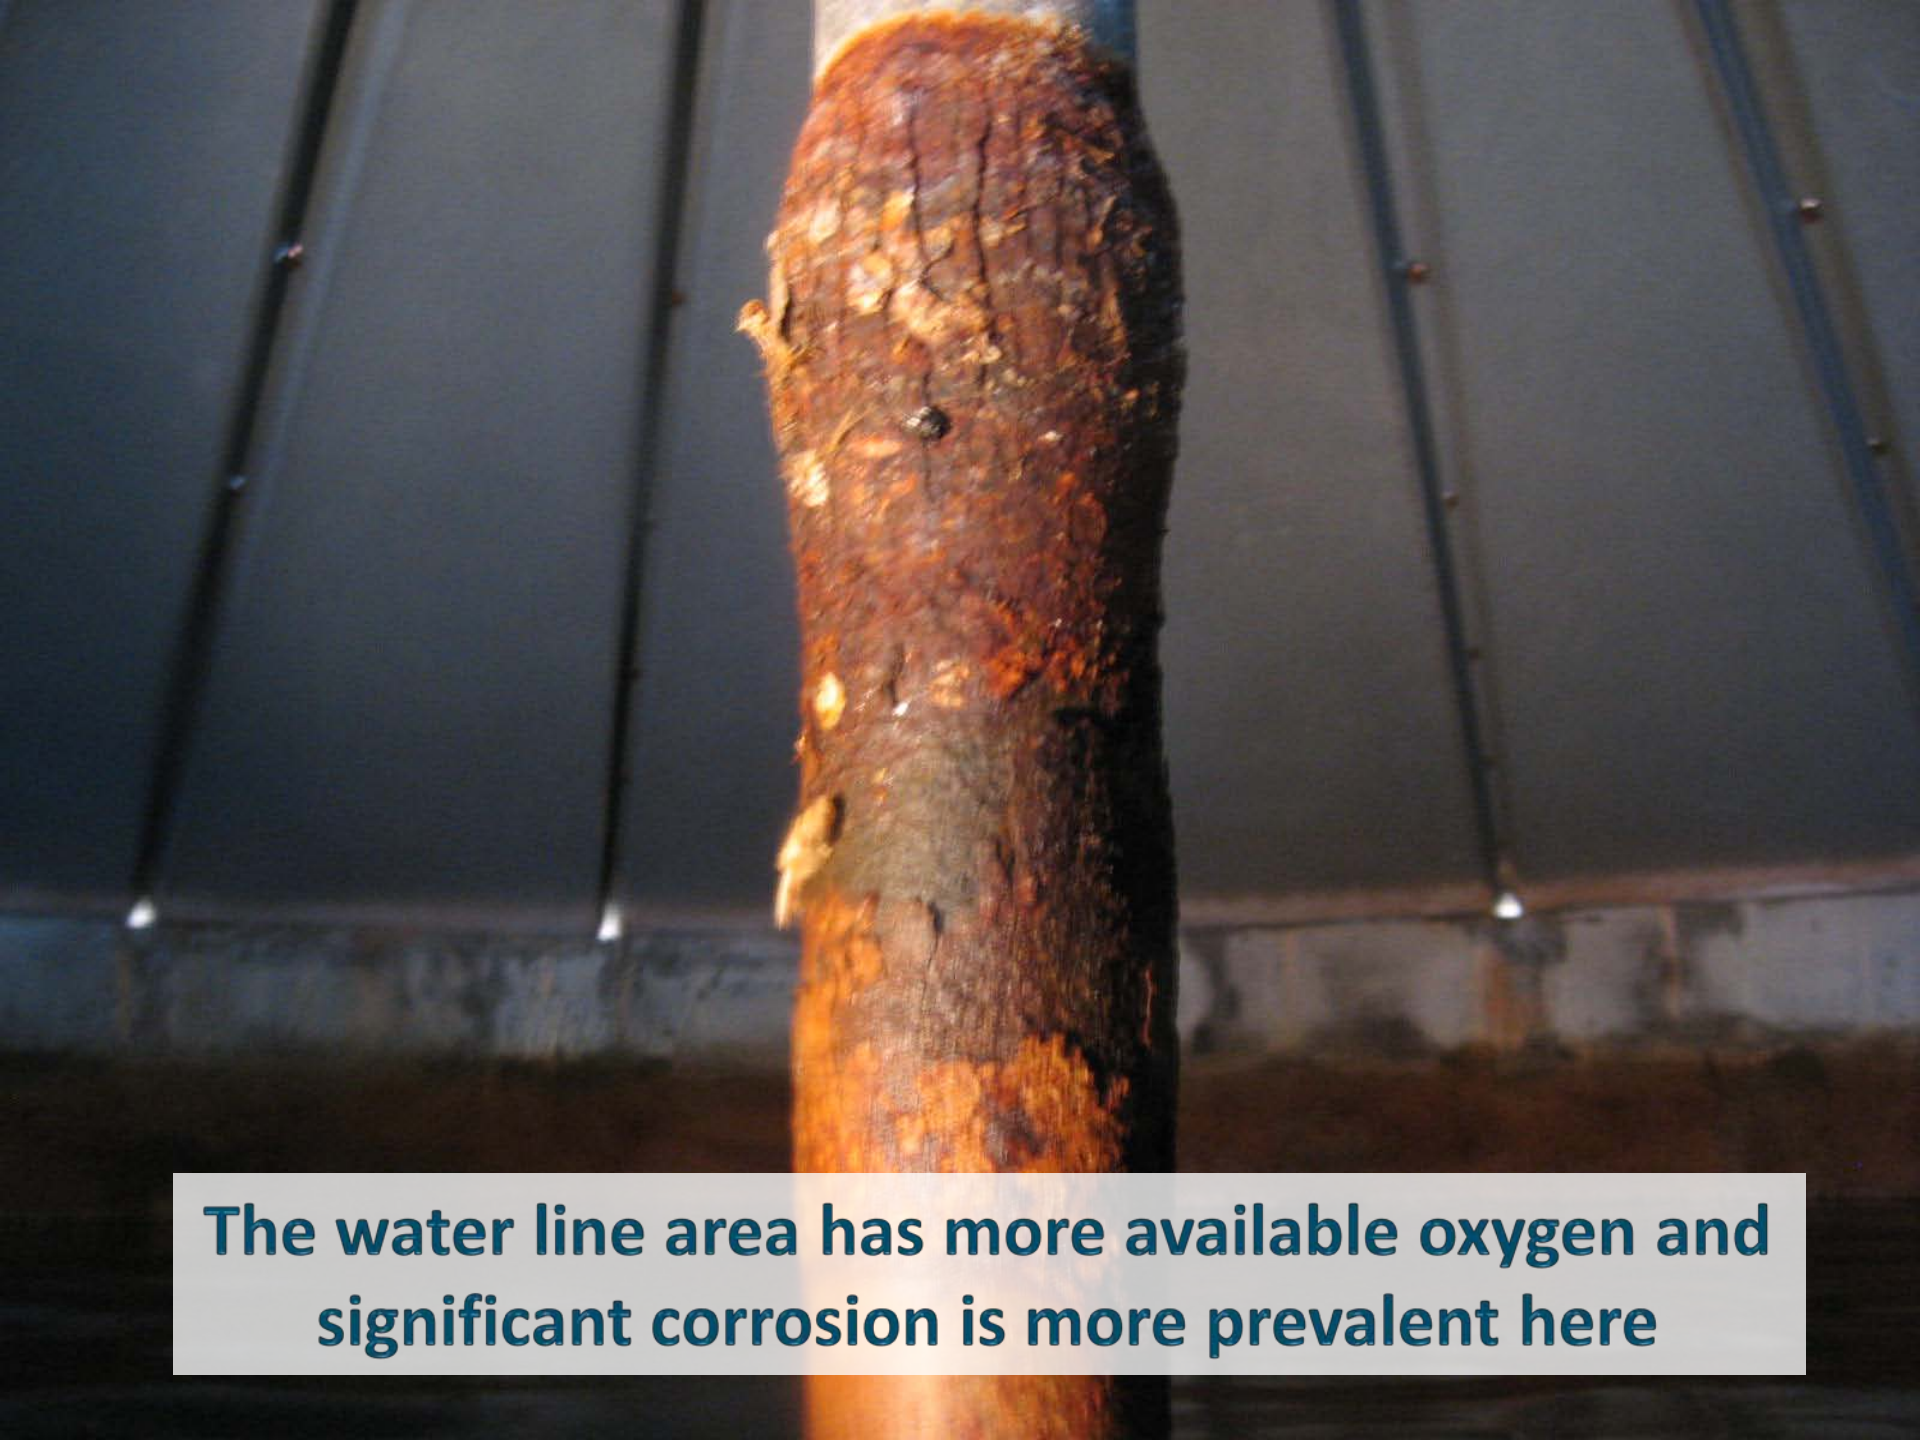
Most galvanized posts are subject to severe corrosion on the water line area

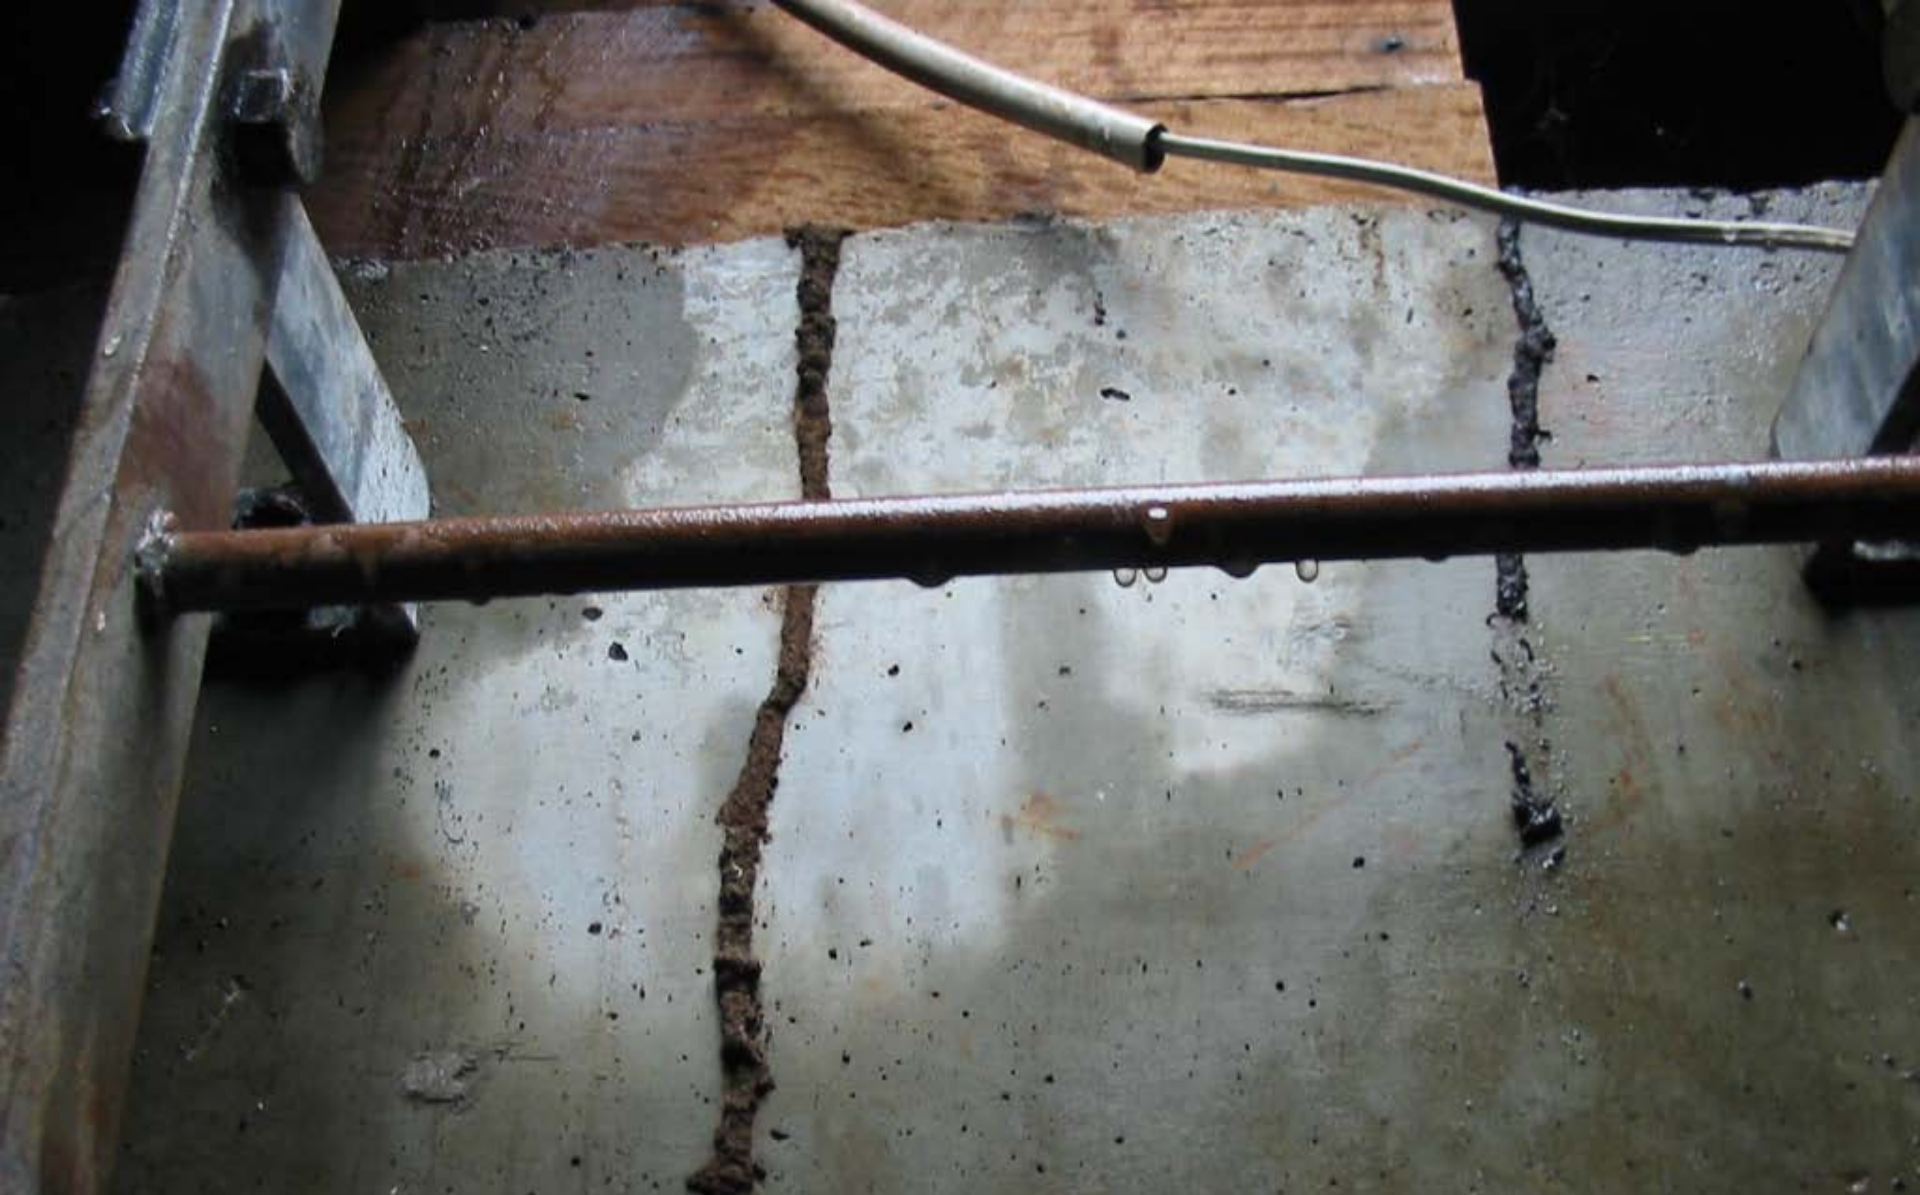
Timber roof framing is subject to termite attacks – look for ‘tracks’ leading down to the water

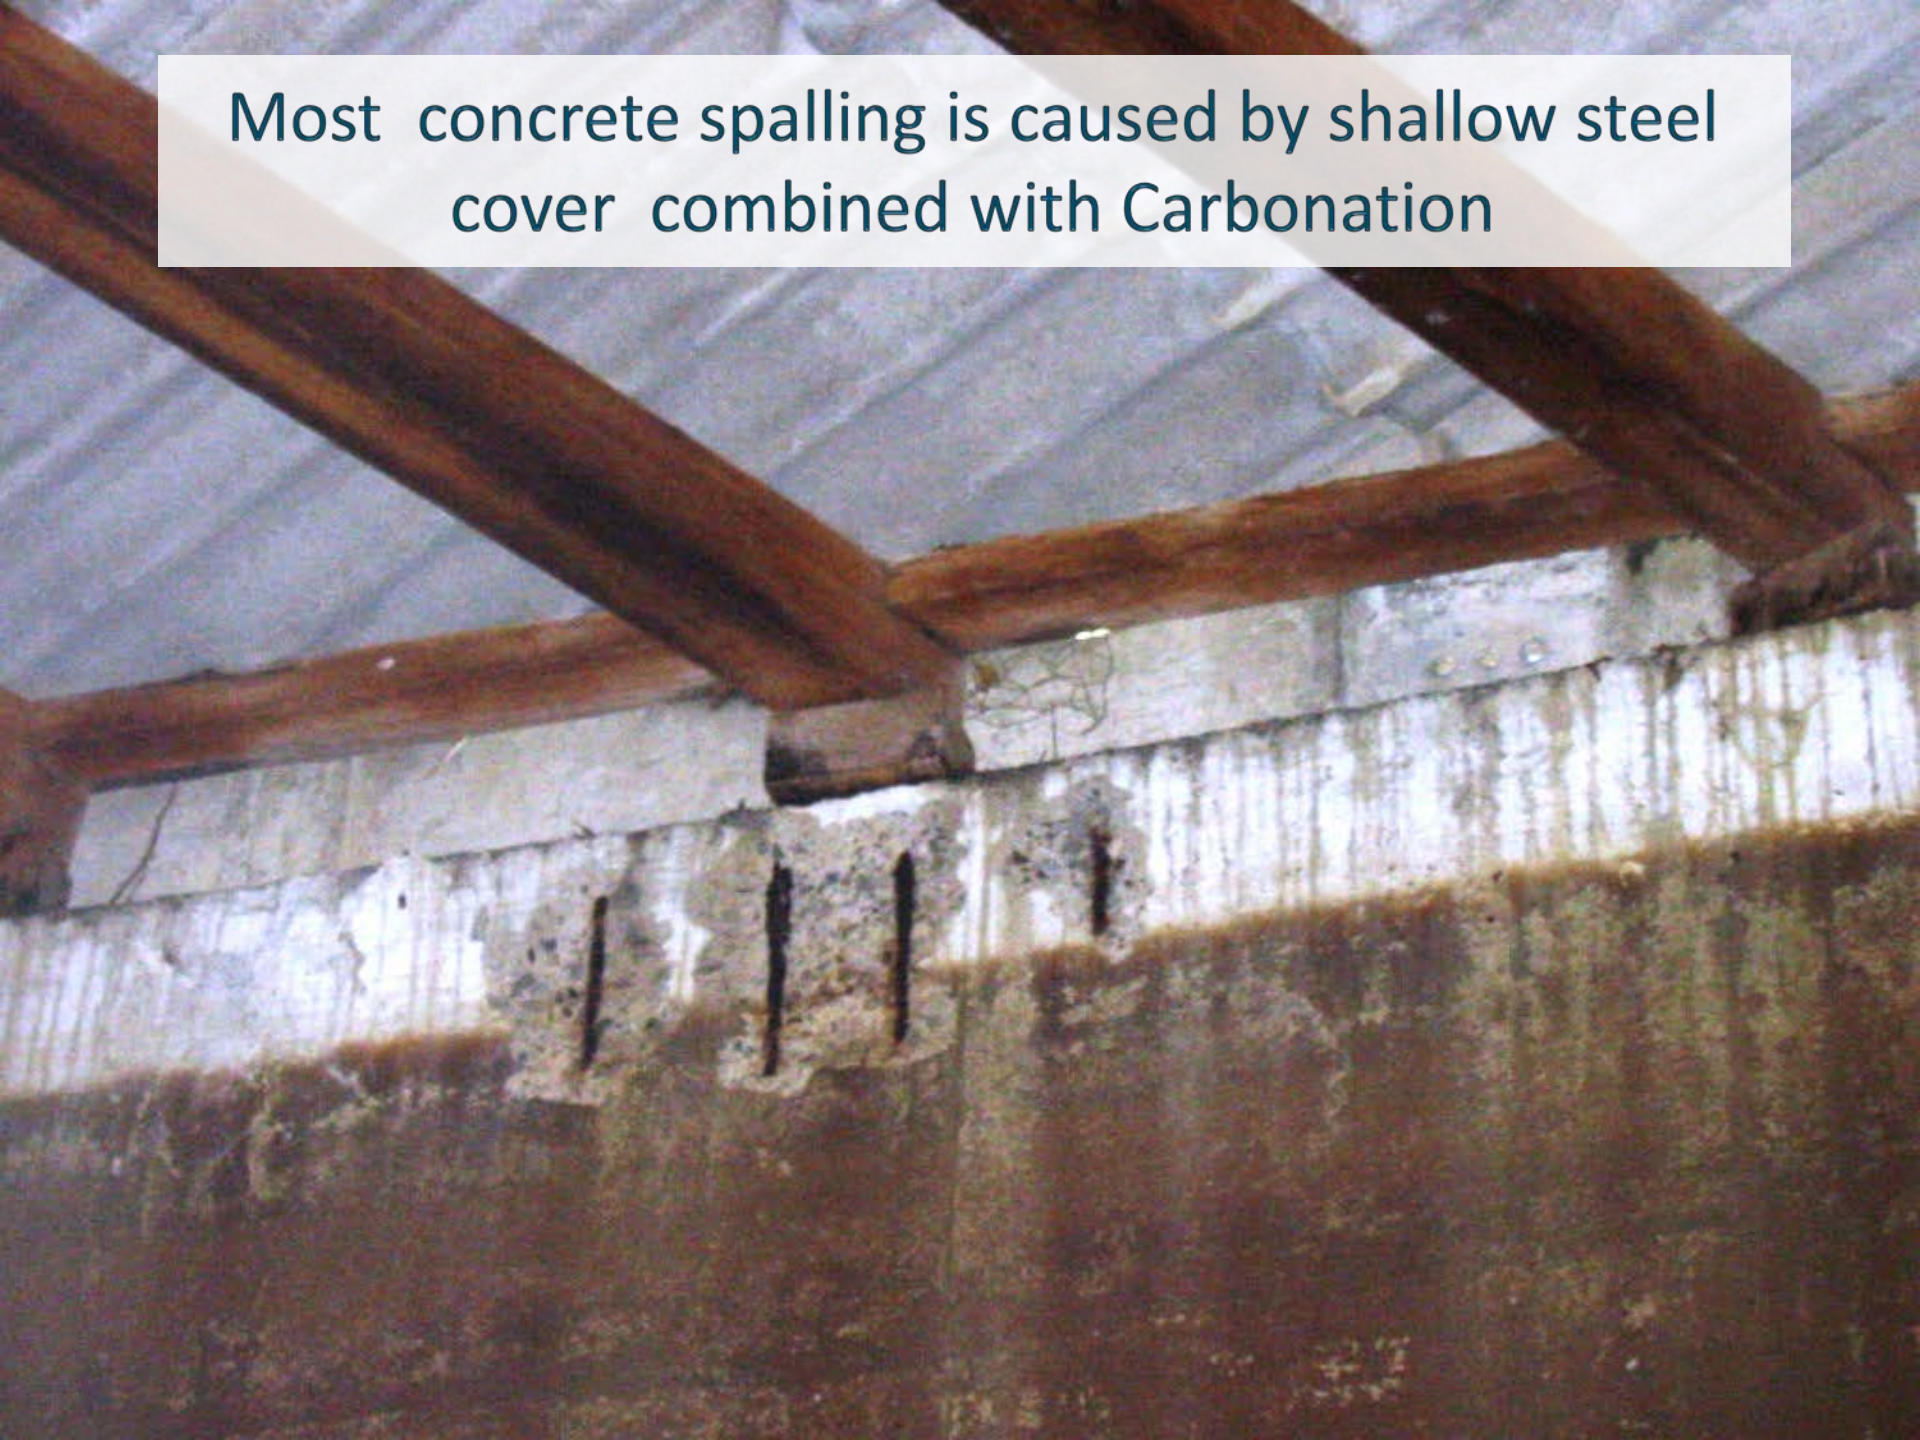
Most concrete spalling is caused by shallow steel cover combined with Carbonation
