When is Reservoir Cleaning not just Cleaning? - following the evidence trail

Jillian Busch - Data Based Solutions Pty Ltd

Dave Barry - Aqualift Potable Diving Pty Ltd

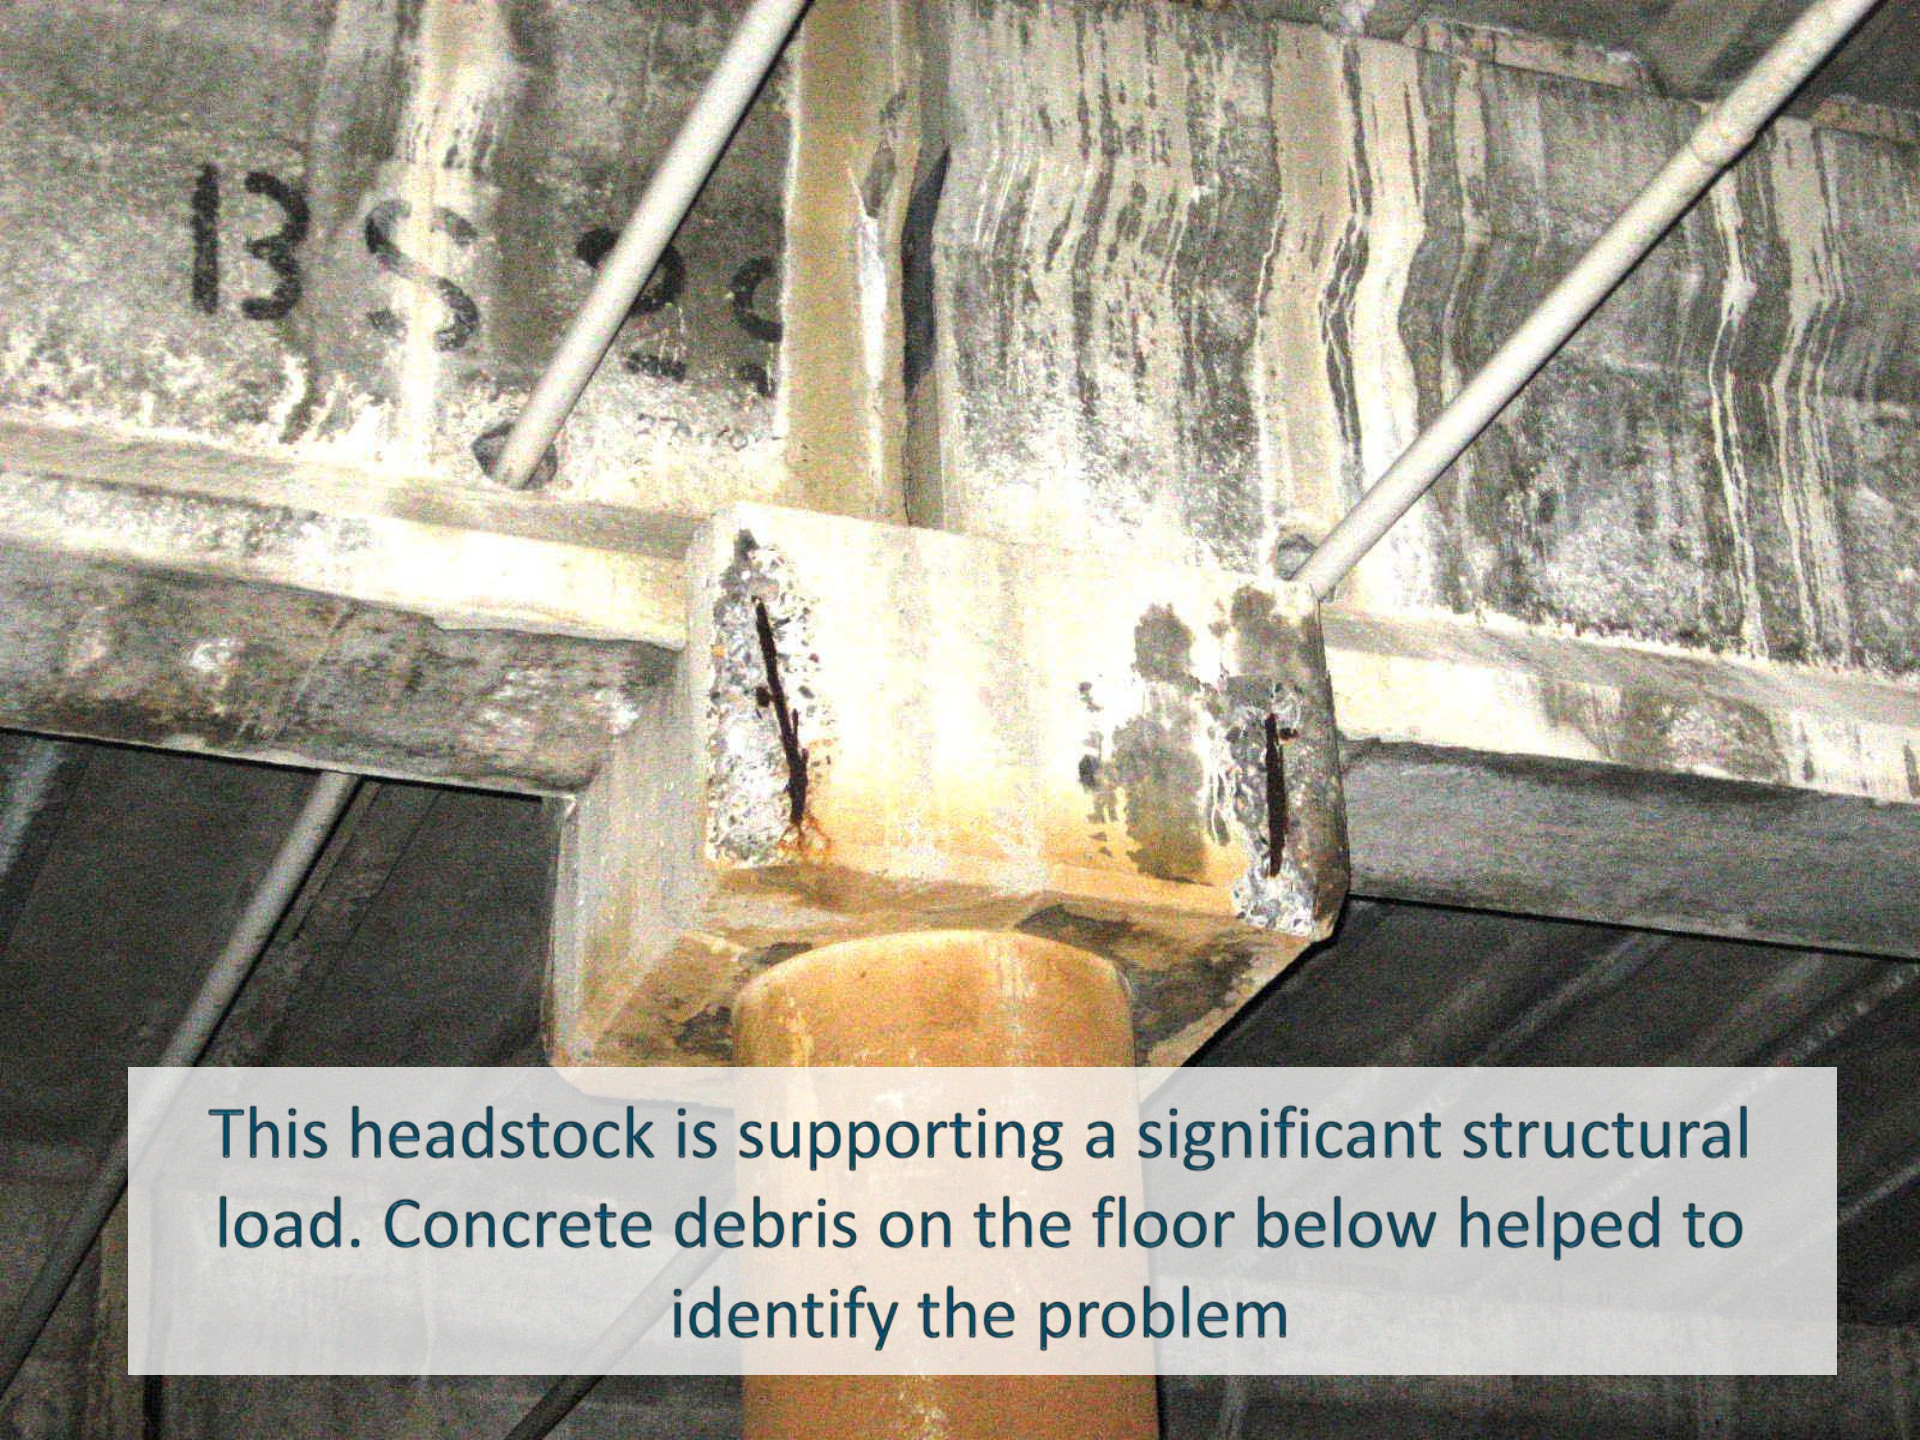
This headstock is supporting a significant structural load. Concrete debris on the floor below helped to identify the problem

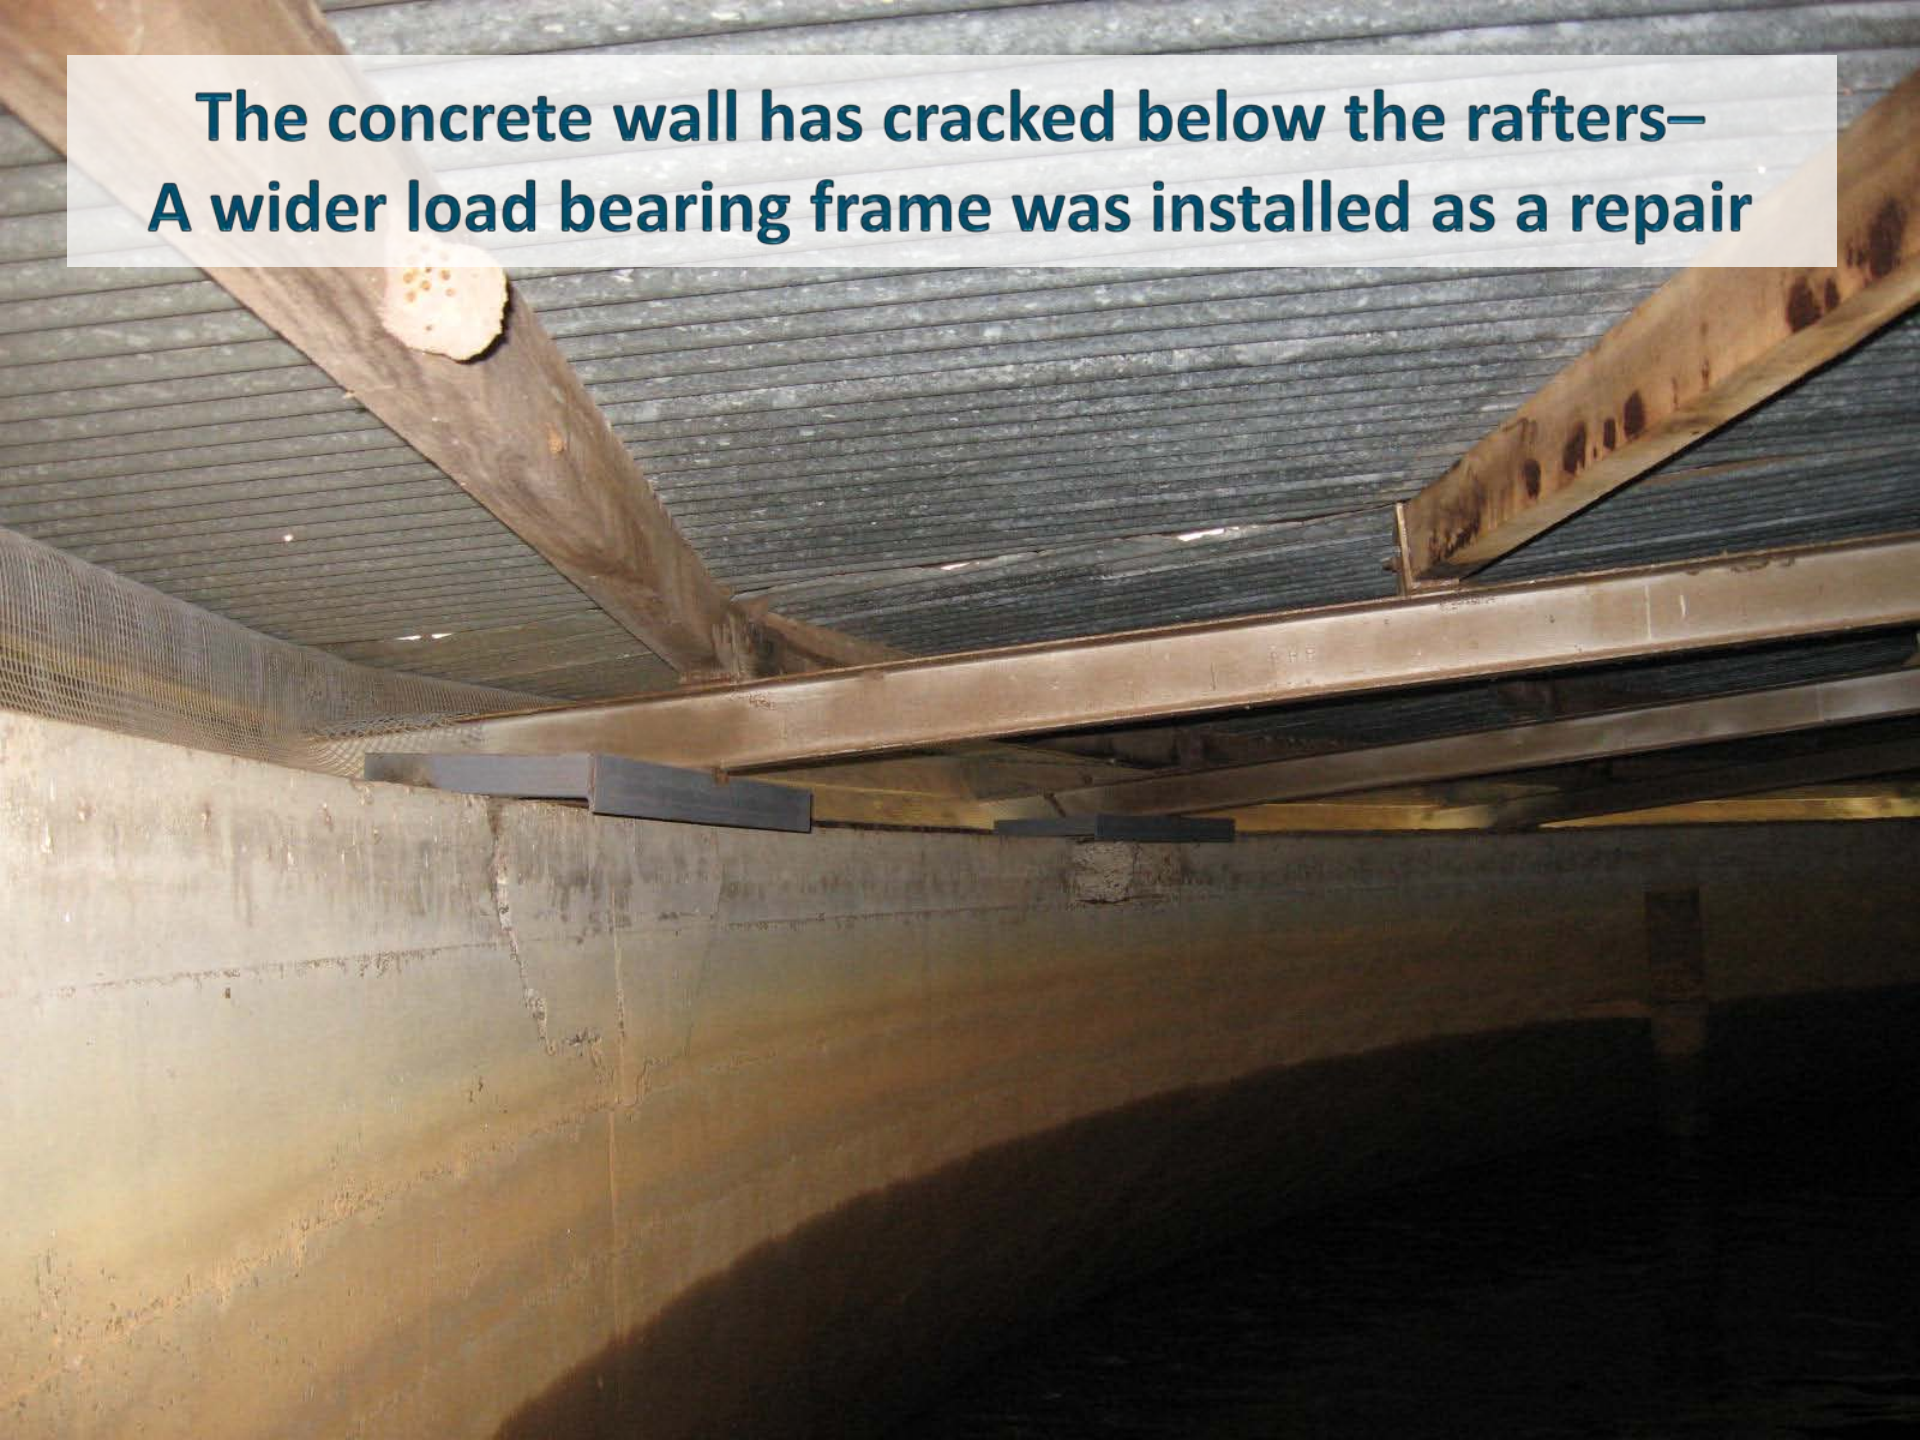
**The concrete wall has cracked below the rafters—
A wider load bearing frame was installed as a repair**

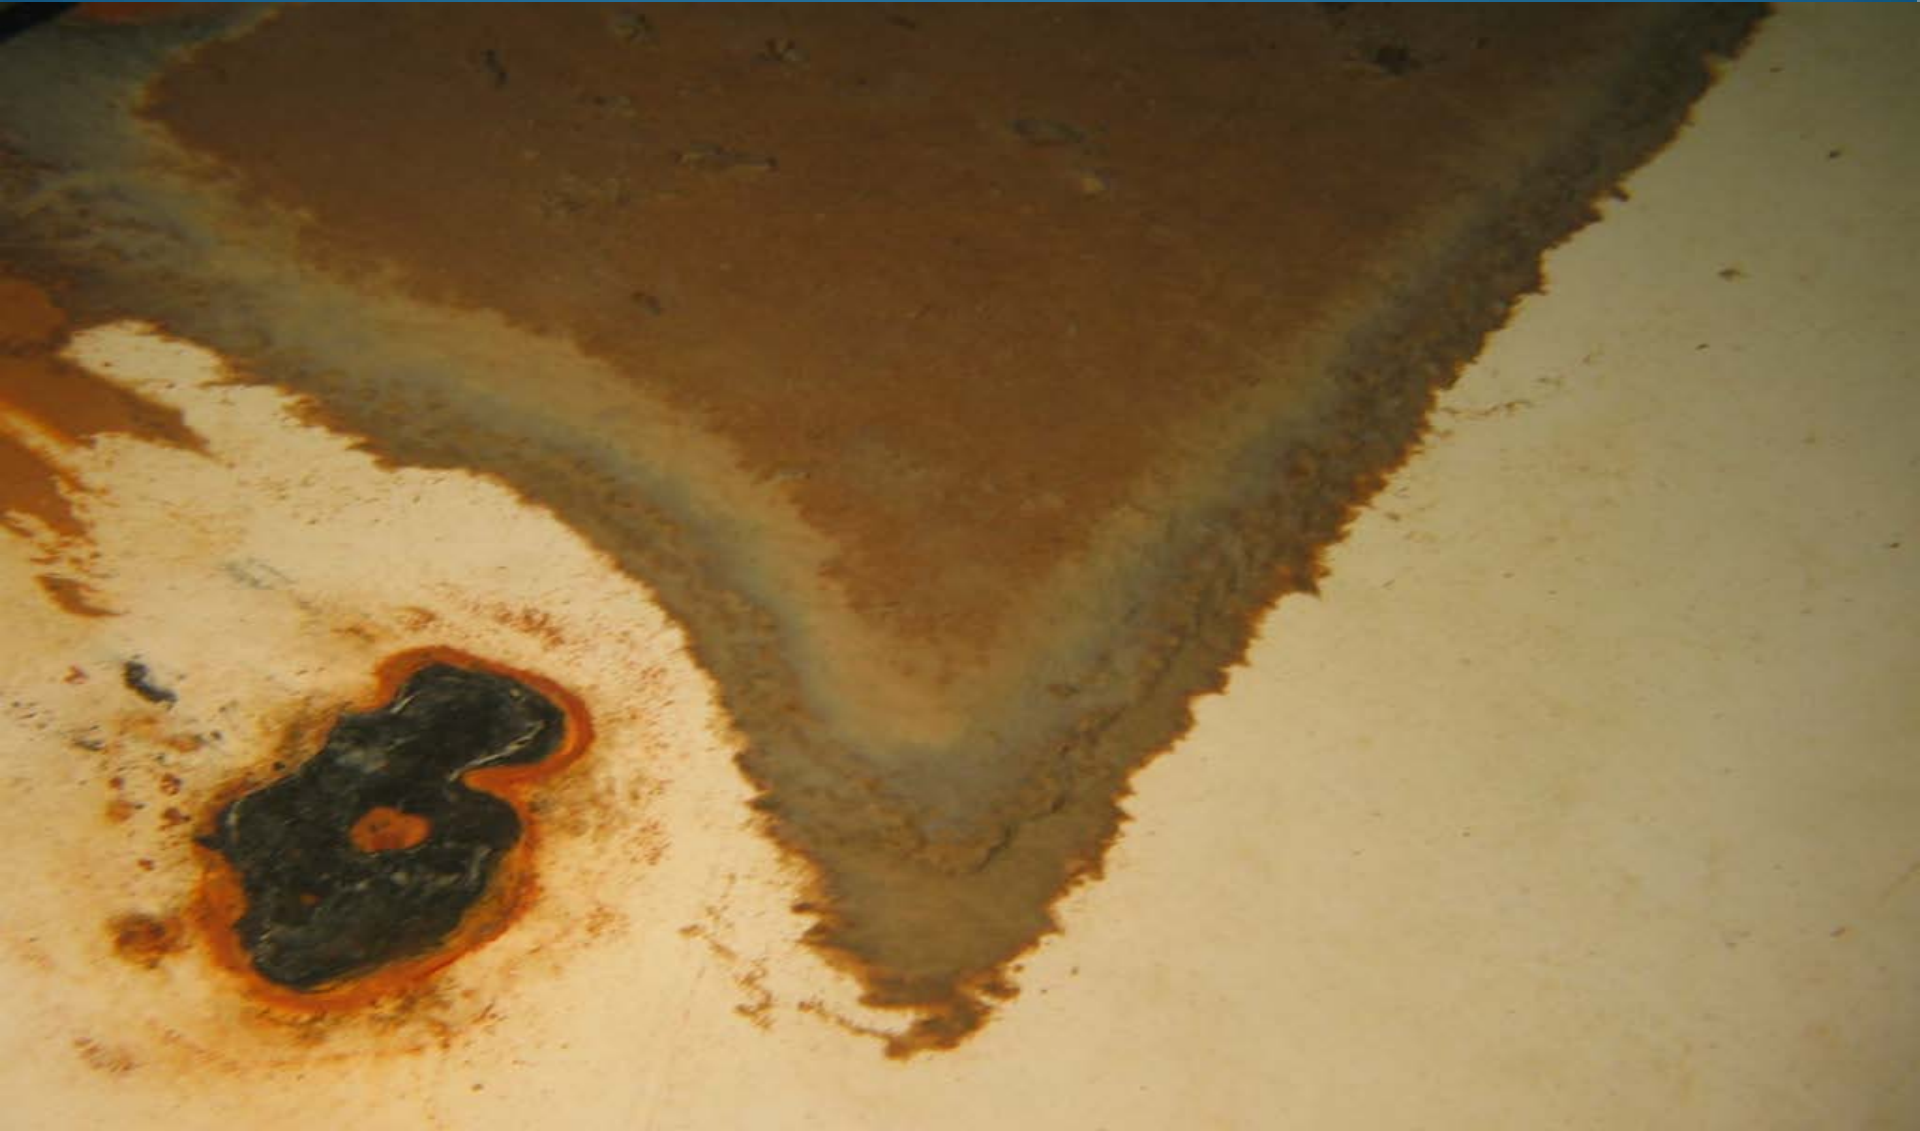
can identify performance of the water treatment process

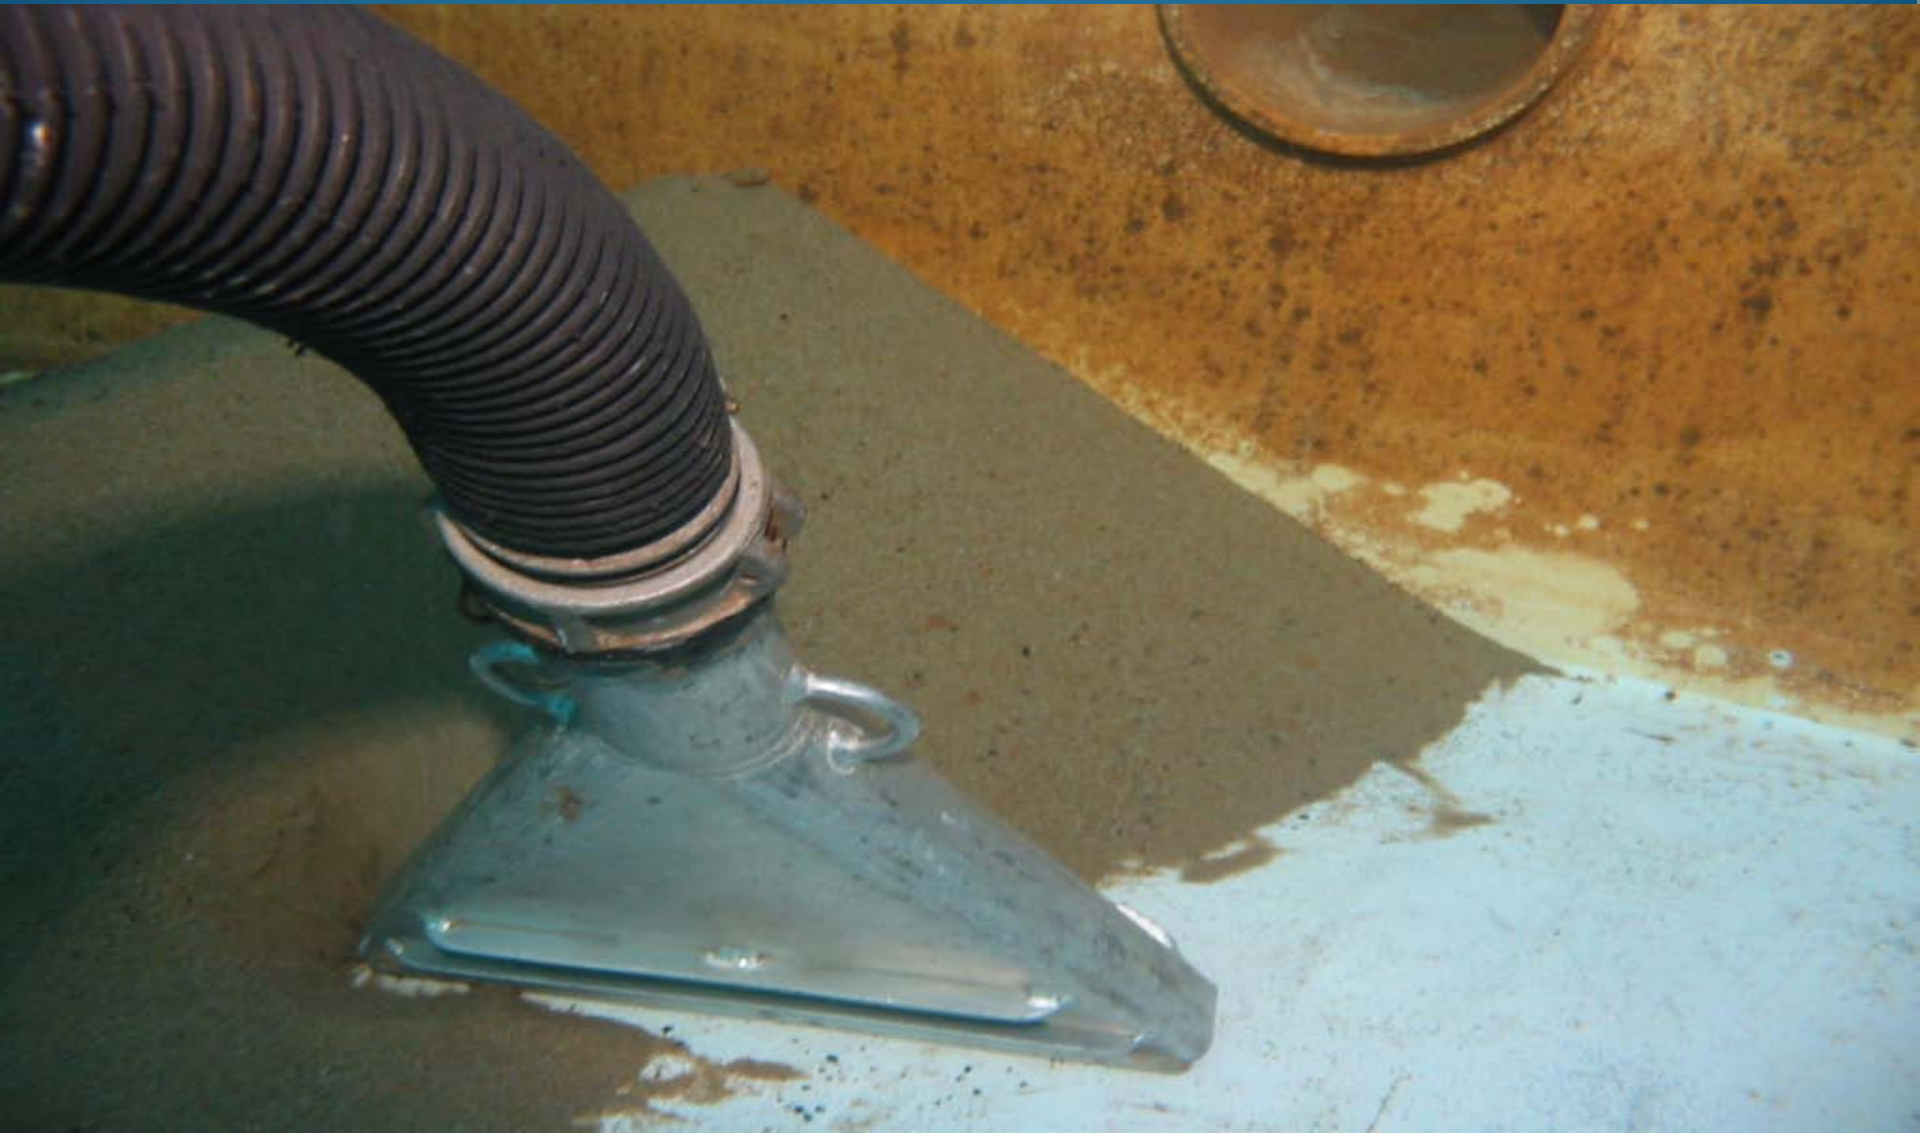
Within a bore field collection tank - sand under the inlet area indicates bore casing failure

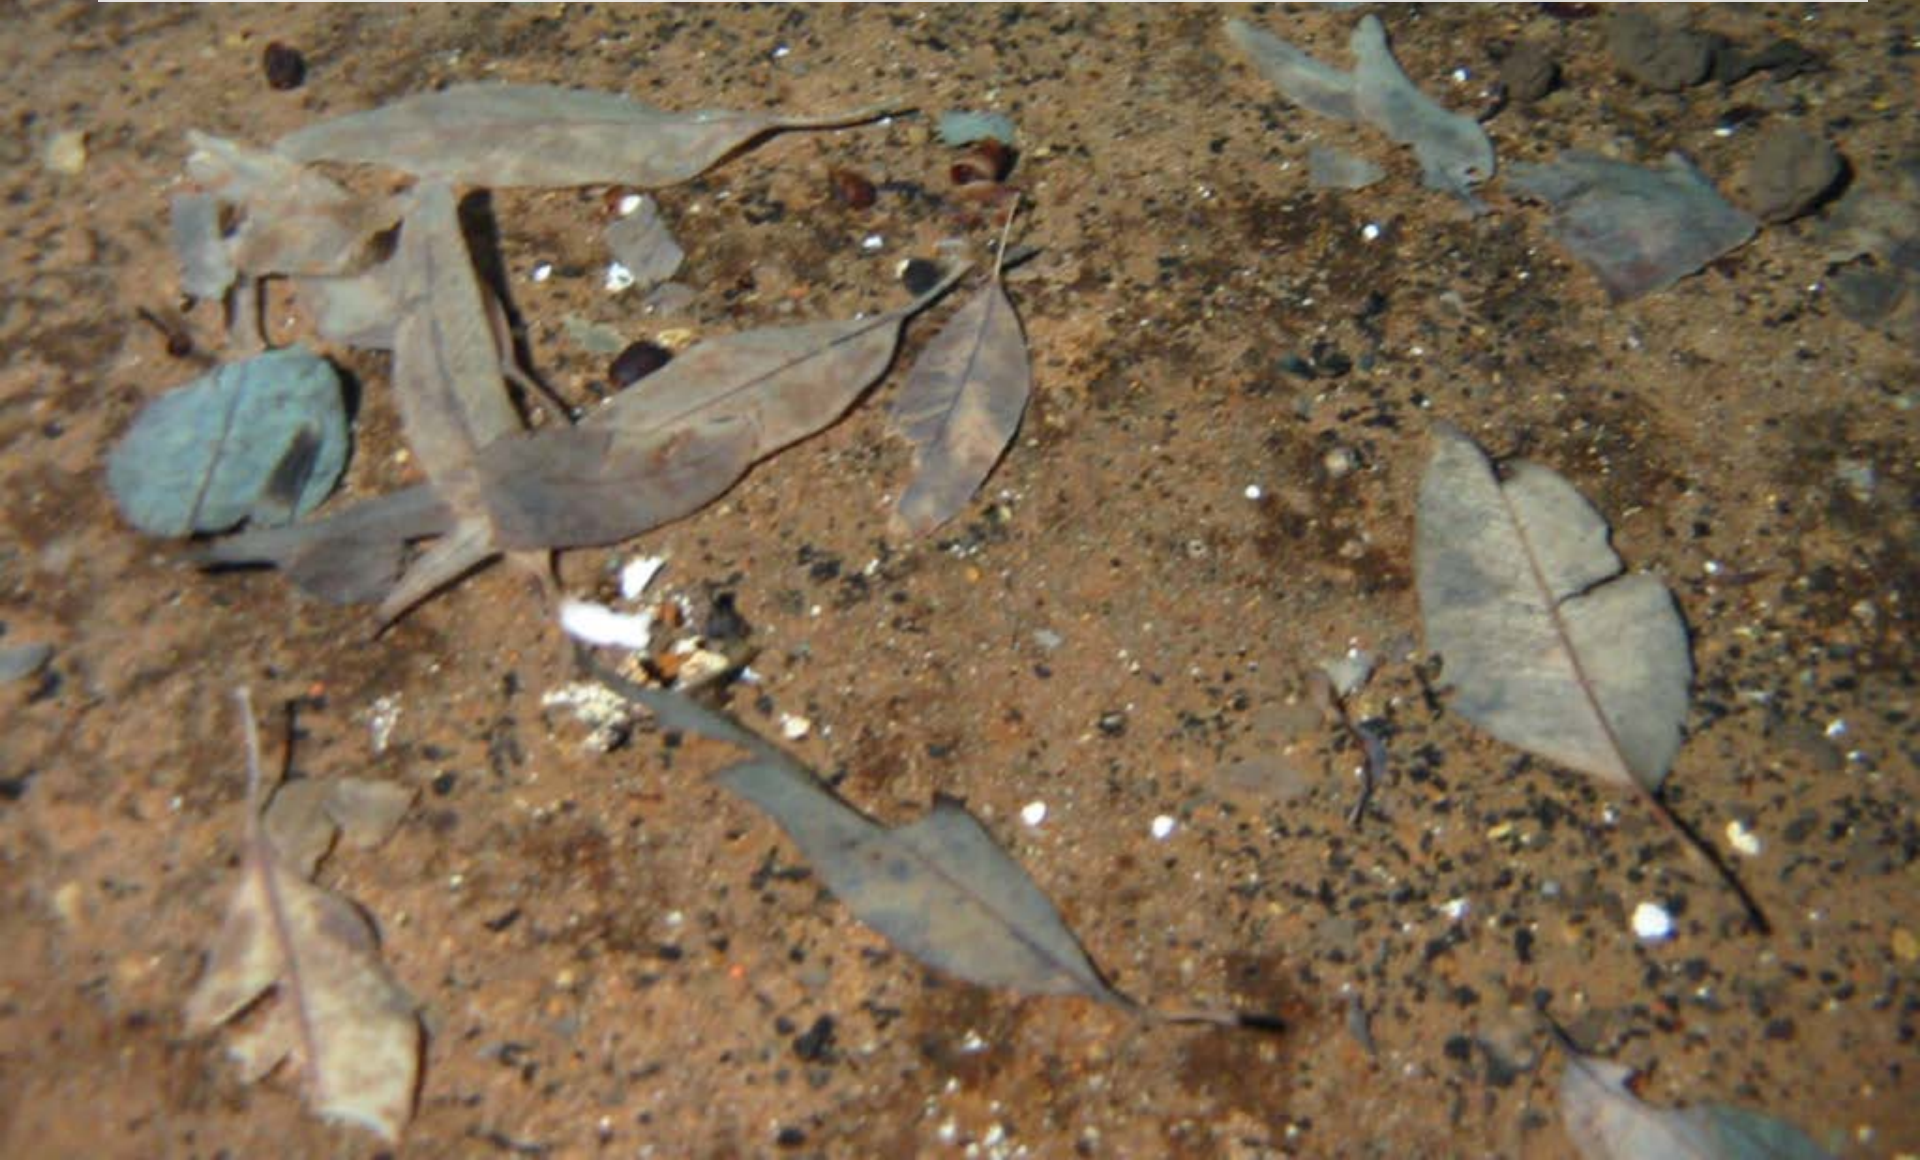
‘Dirty’ sediment indicates leaves and debris are entering the tank – the ventilation mesh proved to be defective

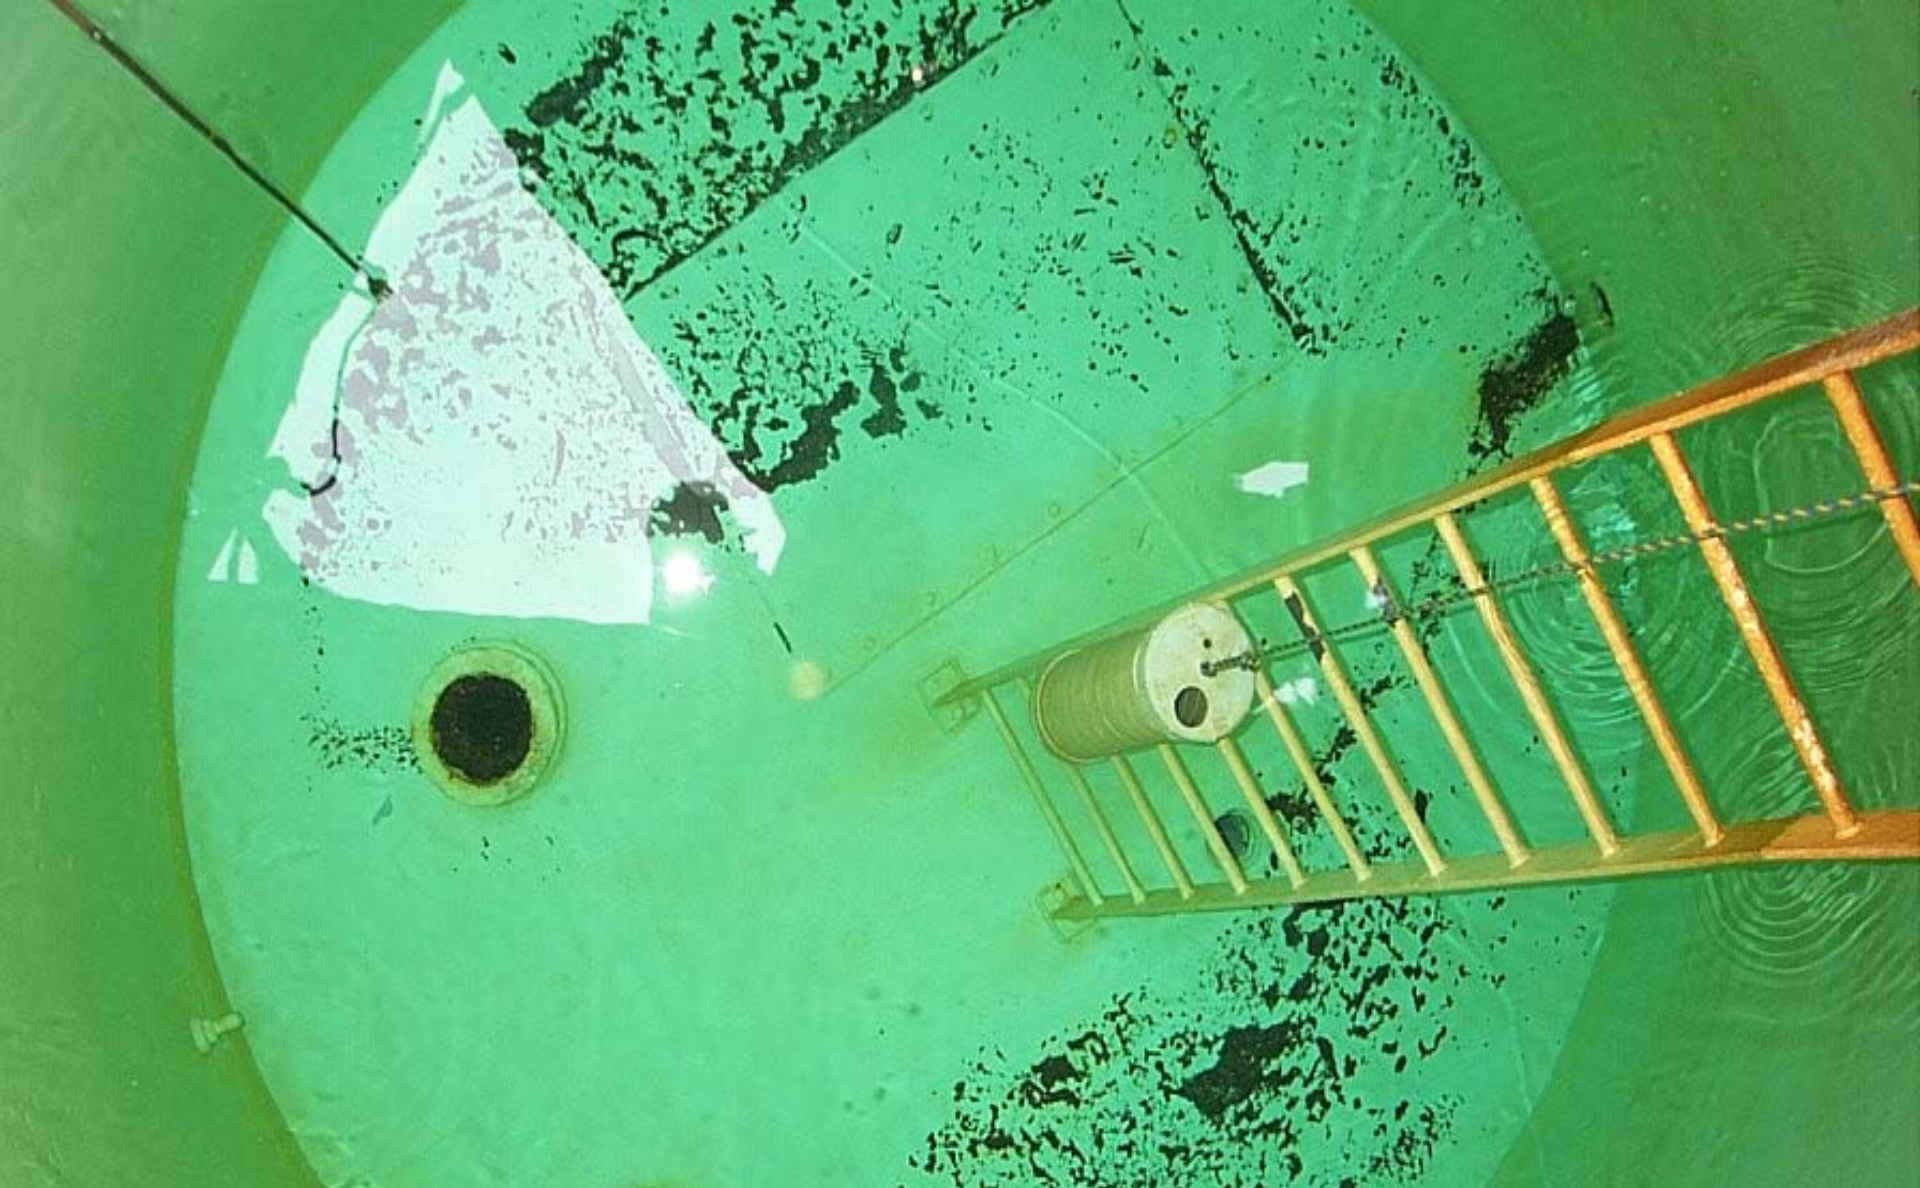
Leaves and contamination are settling on the upper wall edge and blowing back into the tank

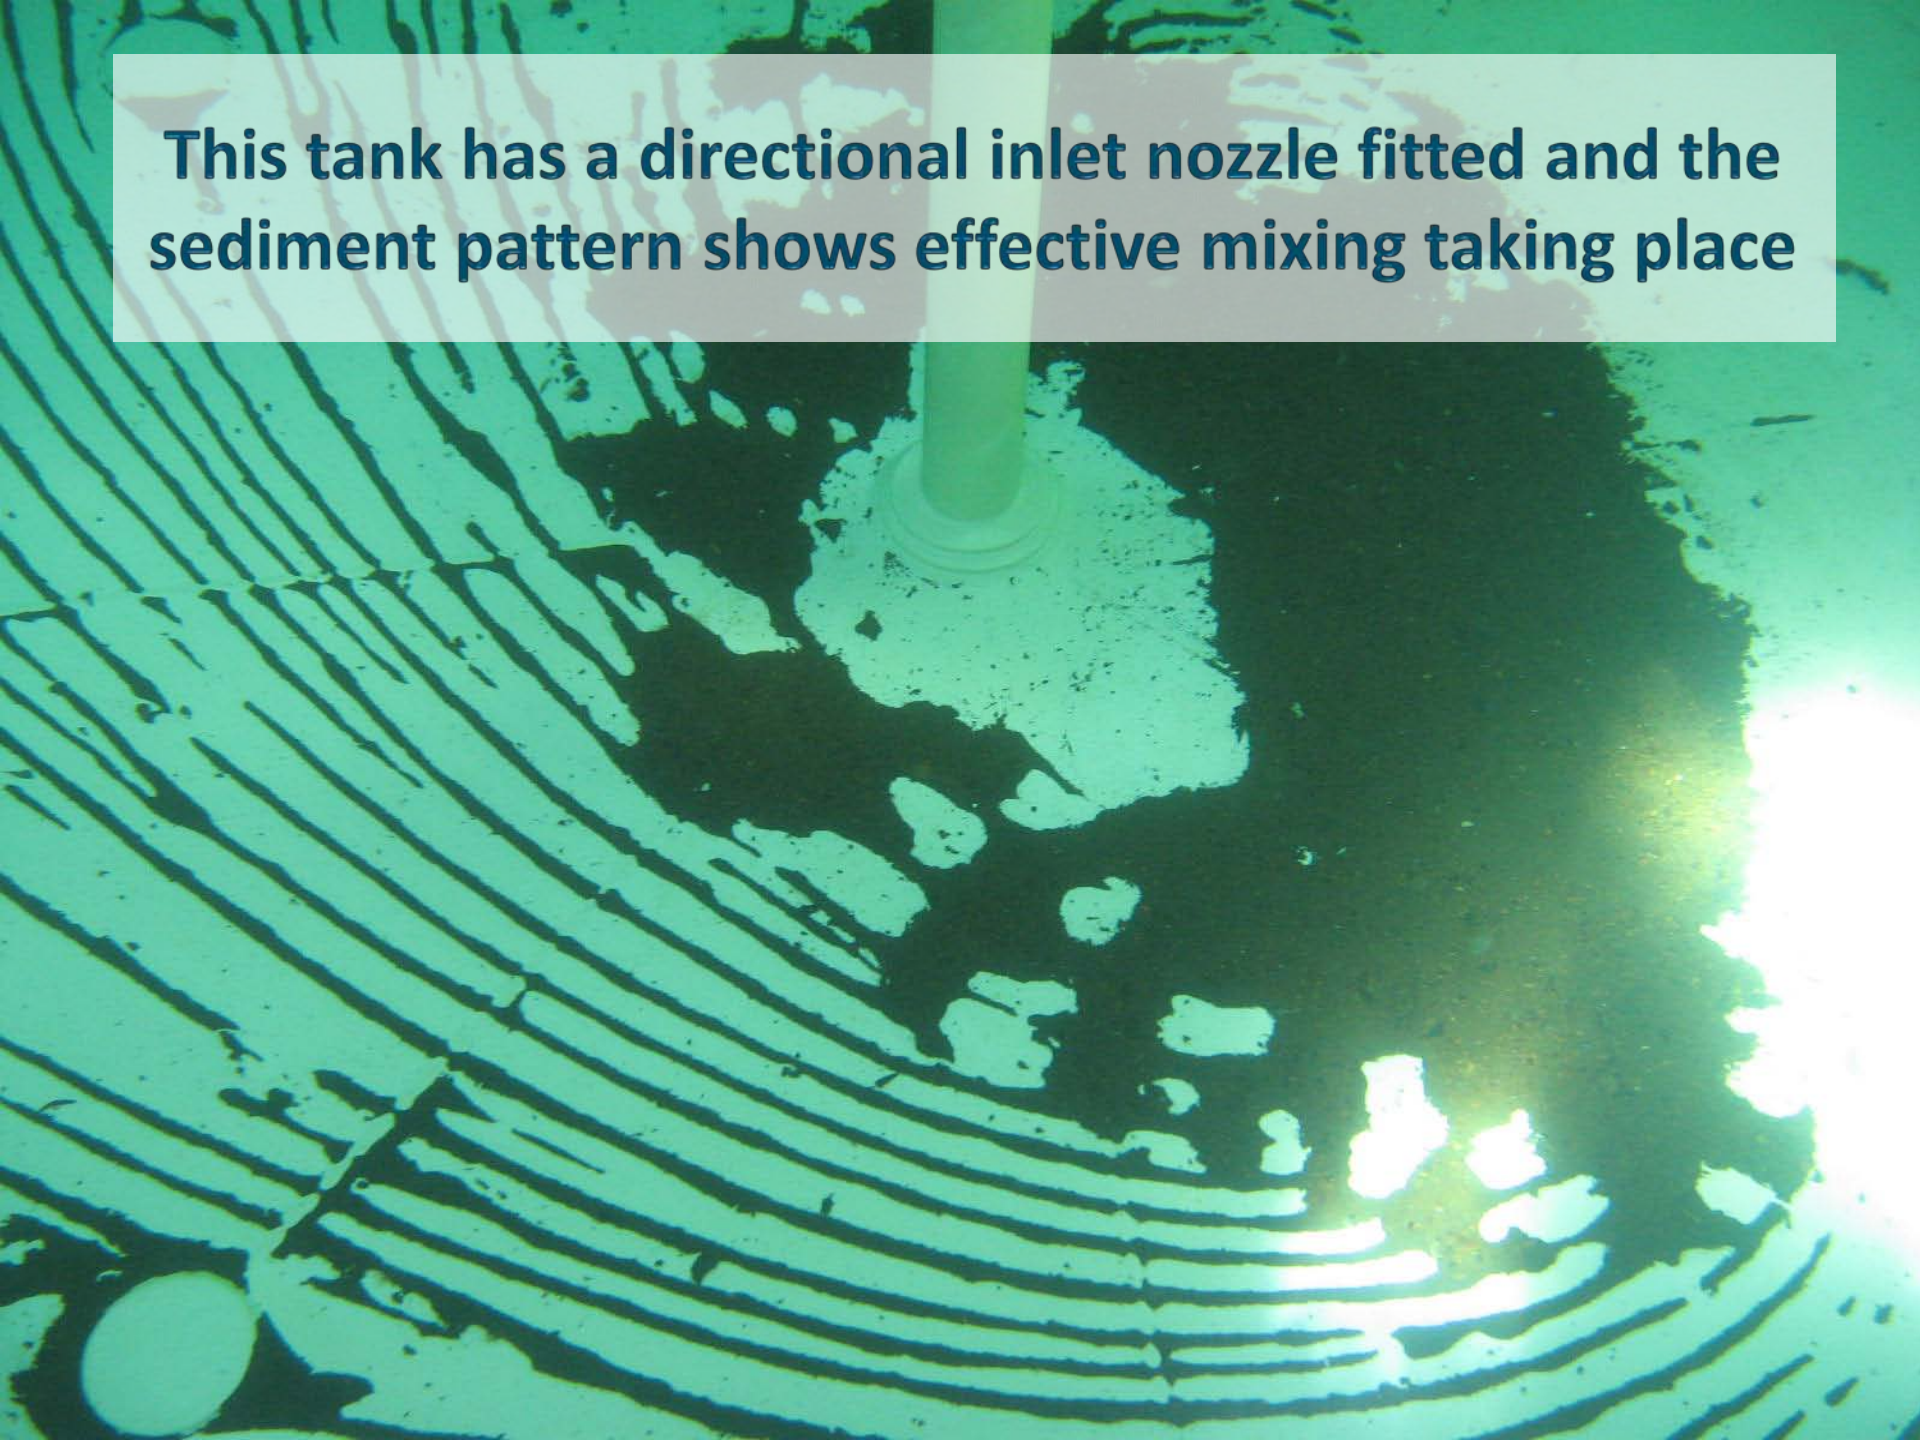
This tank has a directional inlet nozzle fitted and the sediment pattern shows effective mixing taking place

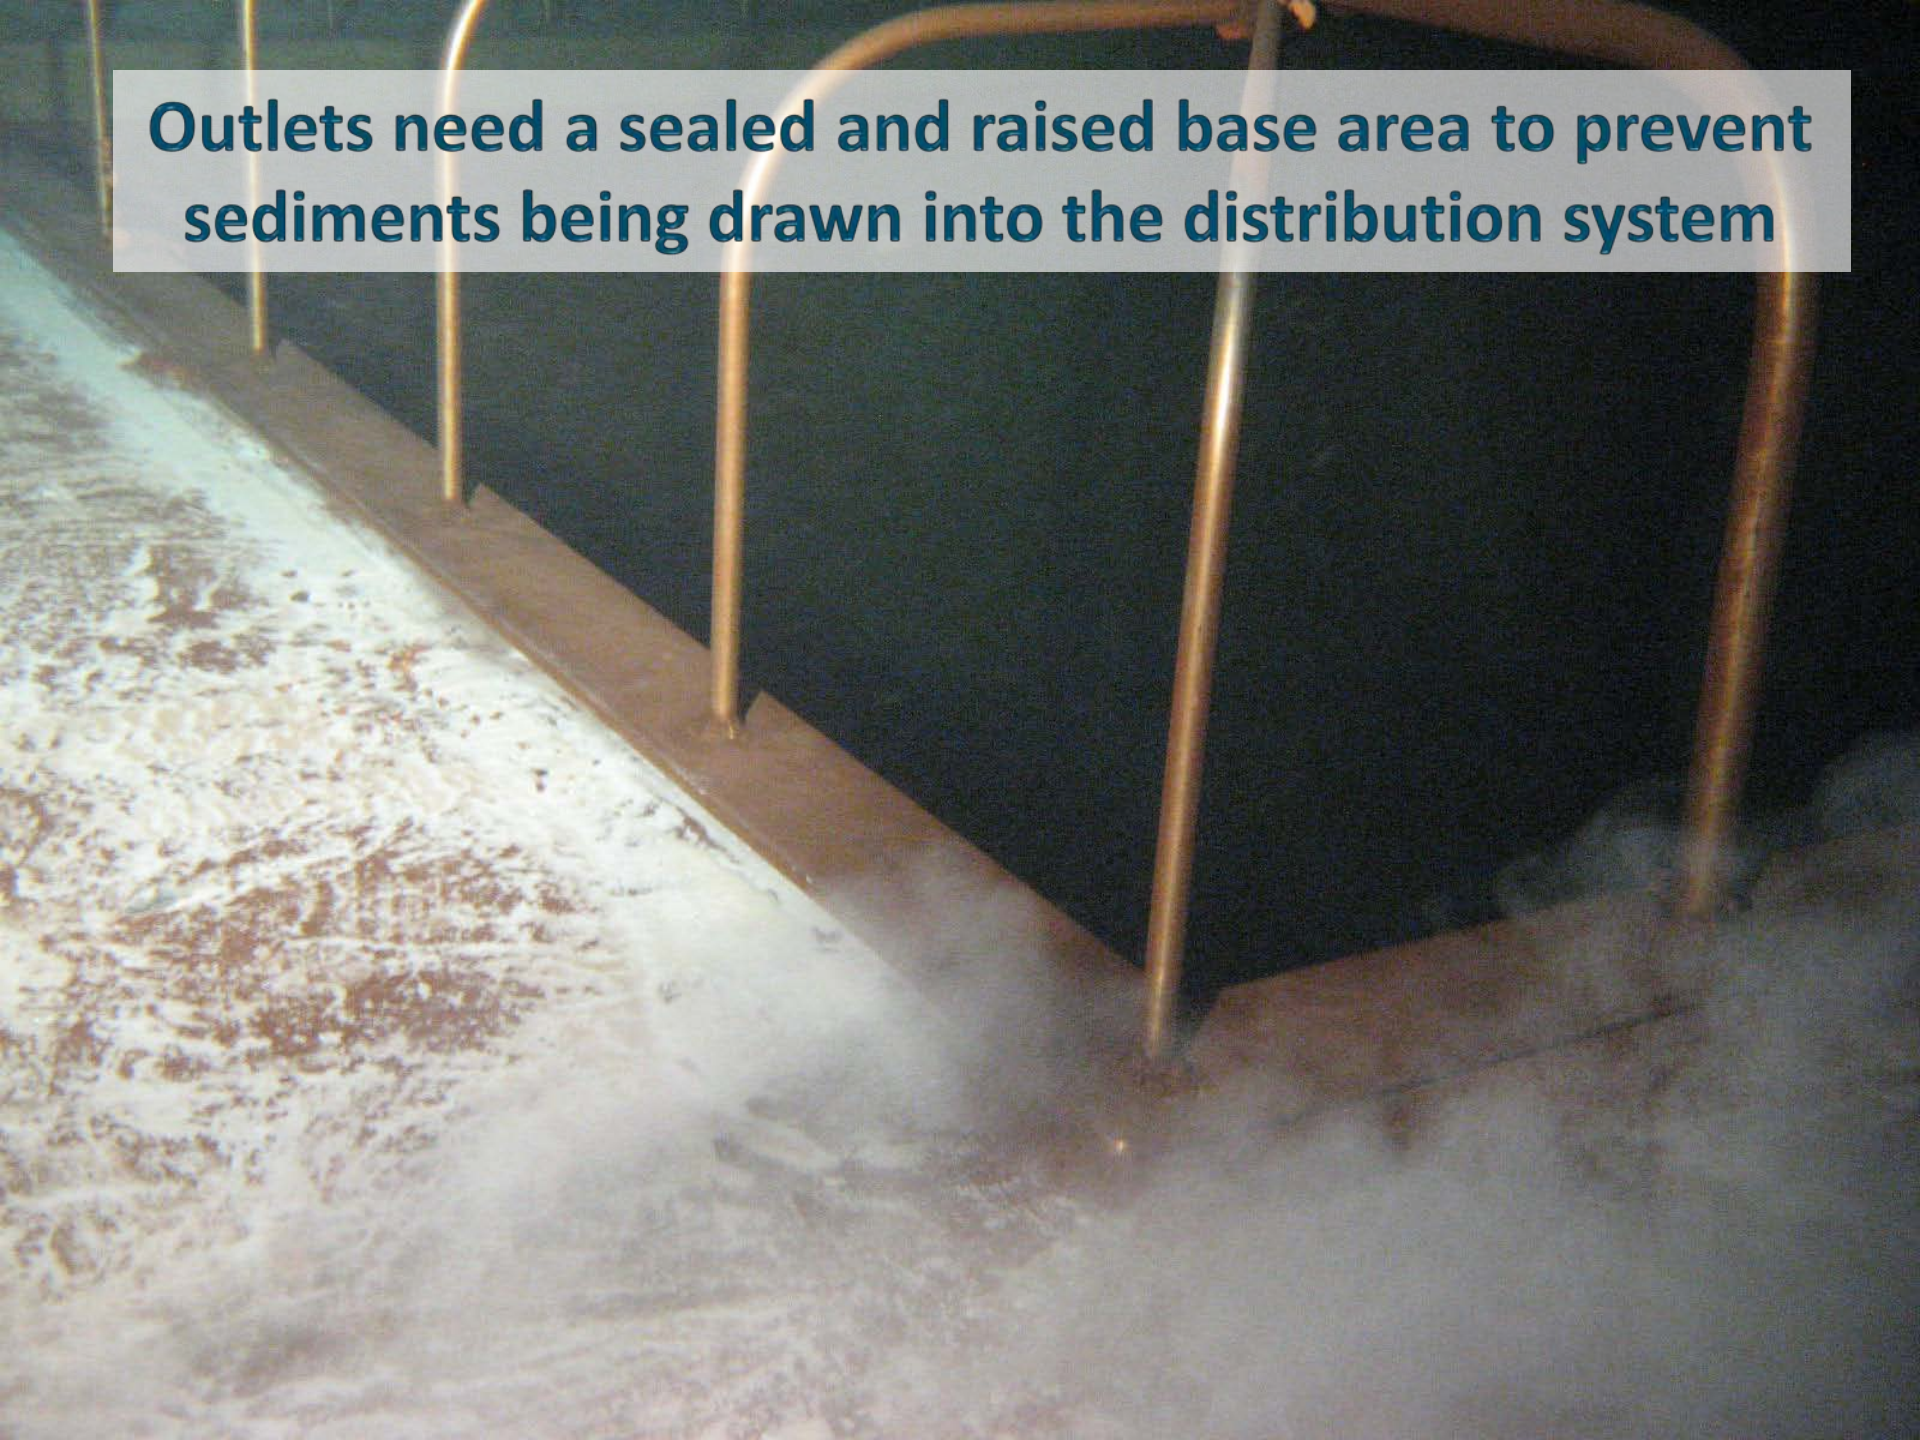
Outlets need a sealed and raised base area to prevent sediments being drawn into the distribution system

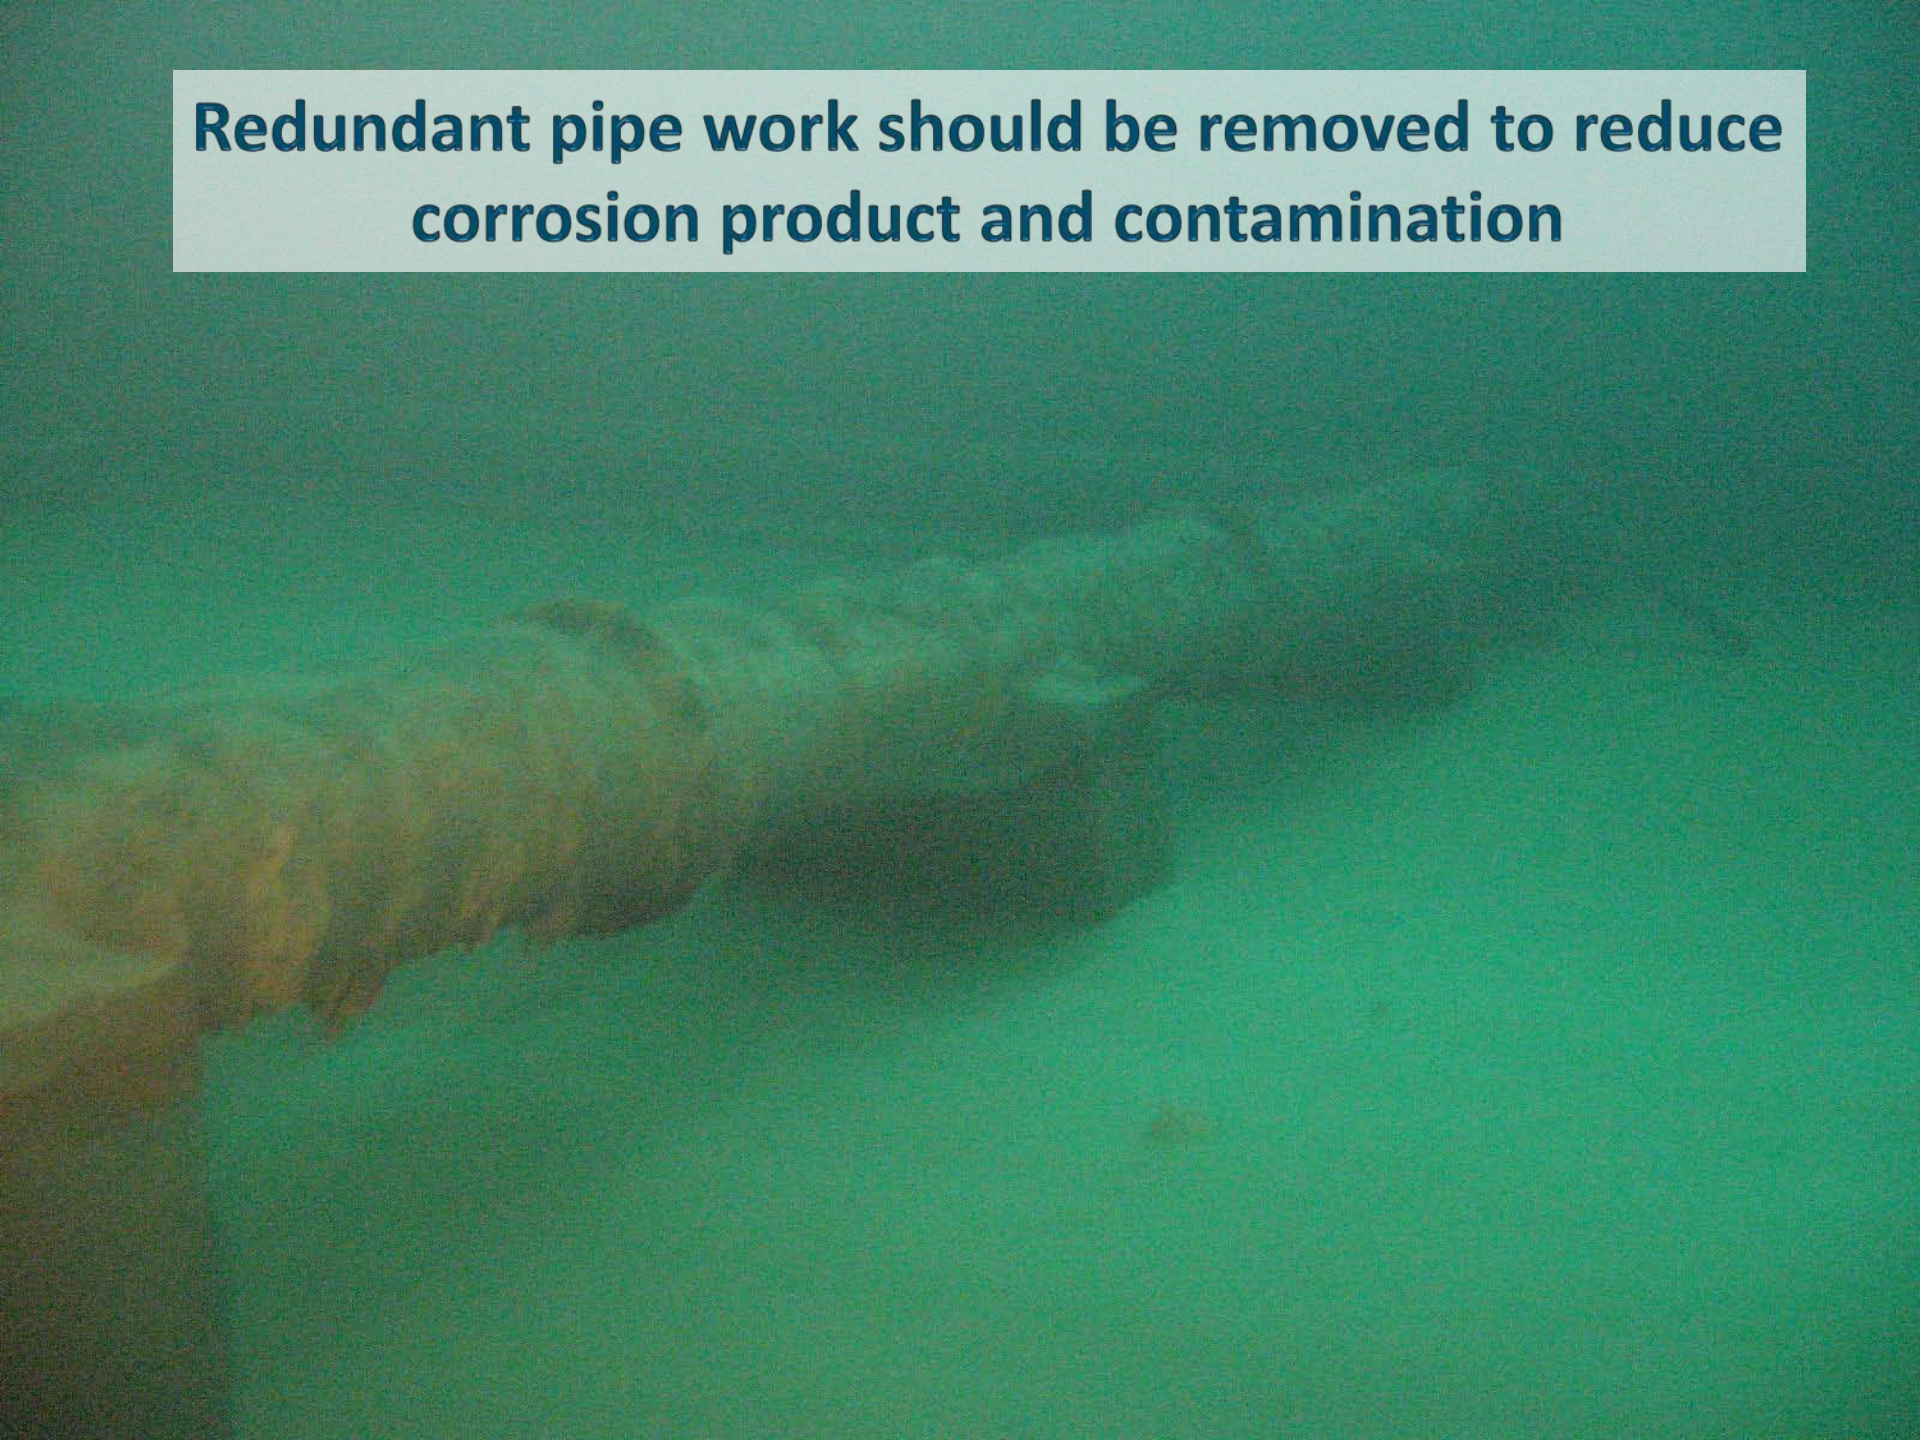
Redundant pipe work should be removed to reduce corrosion product and contamination
