When is Reservoir Cleaning not just Cleaning? - following the evidence trail

Jillian Busch - Data Based Solutions Pty Ltd

Dave Barry - Aqualift Potable Diving Pty Ltd

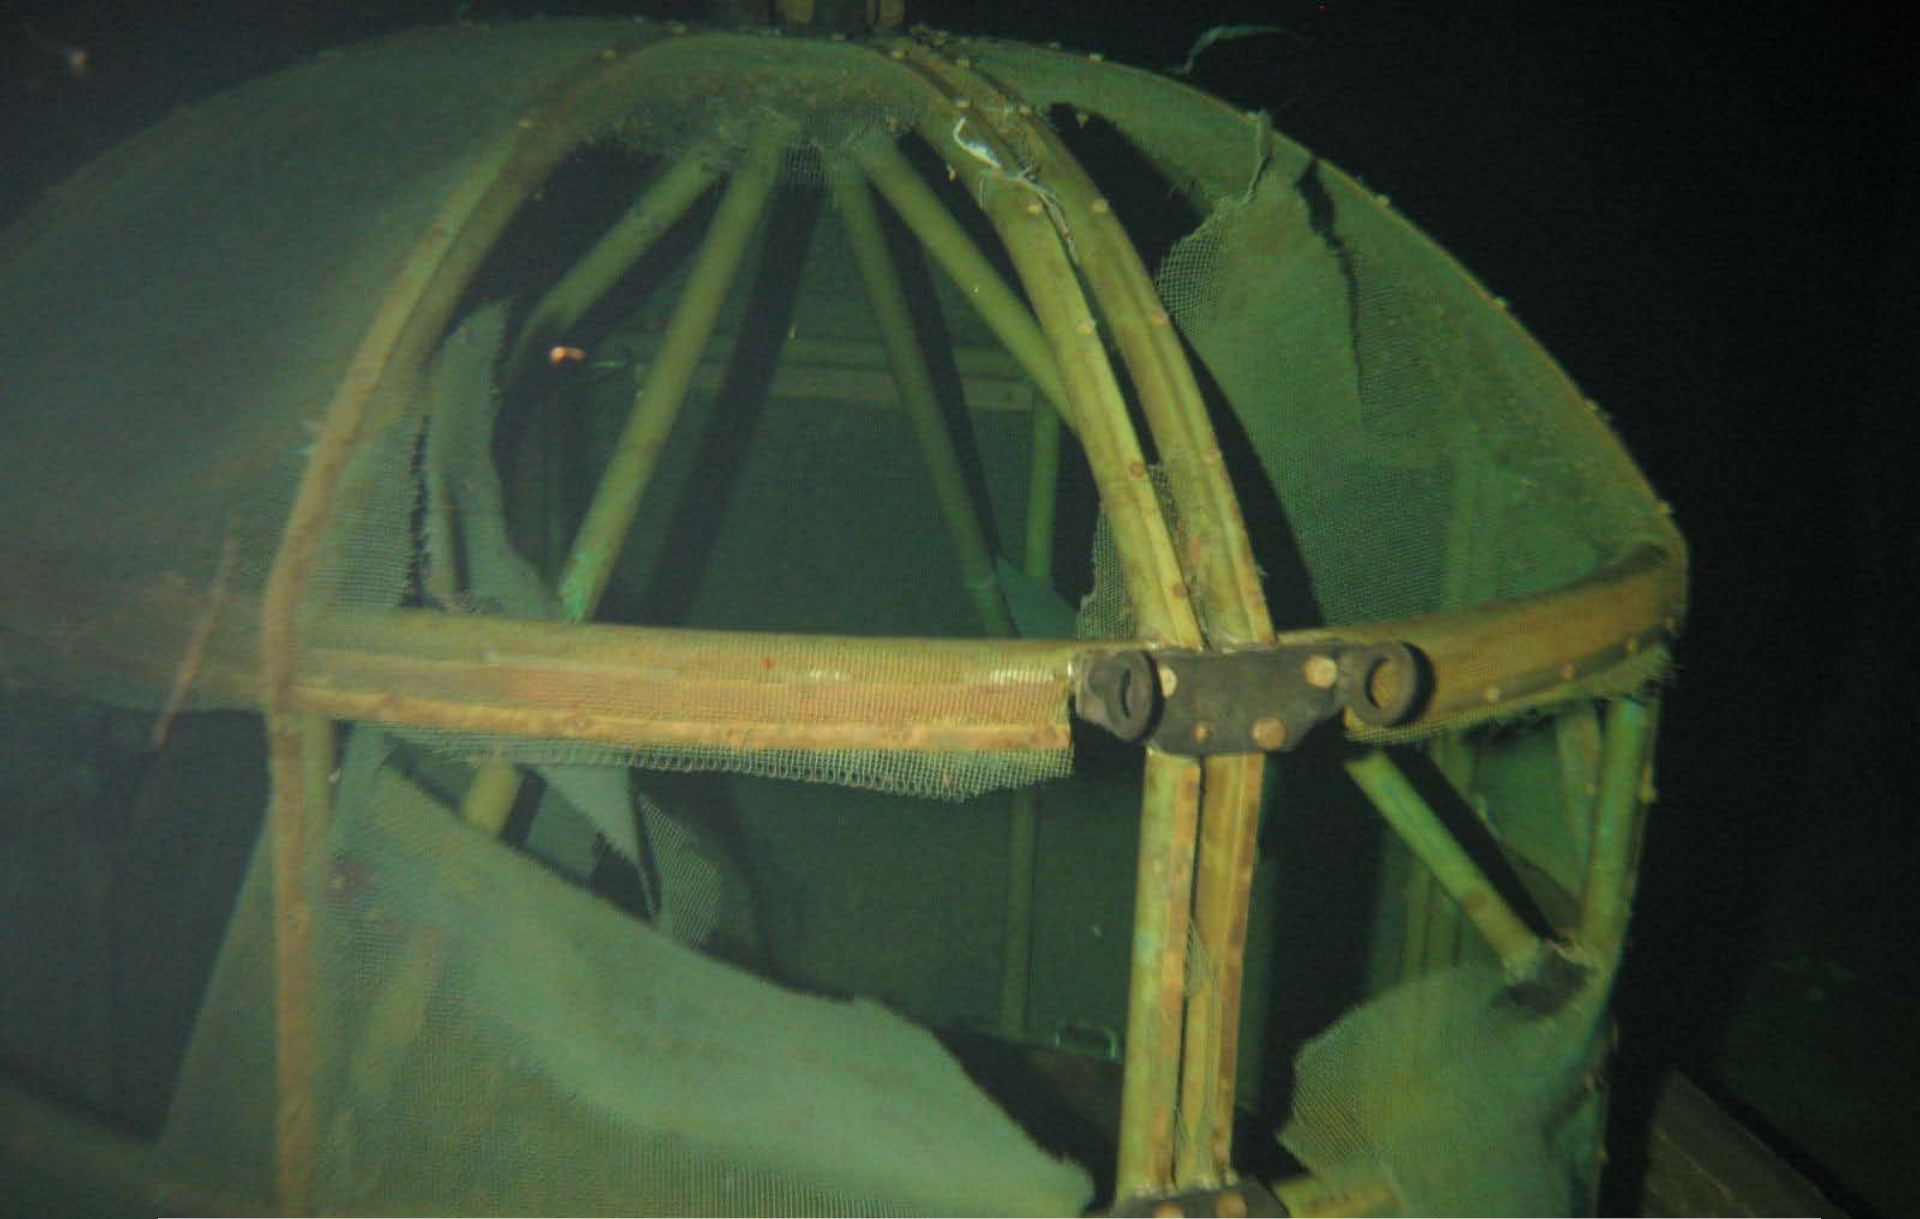
Fine mesh outlet screens allow sediments to accumulate and enter the pipe work

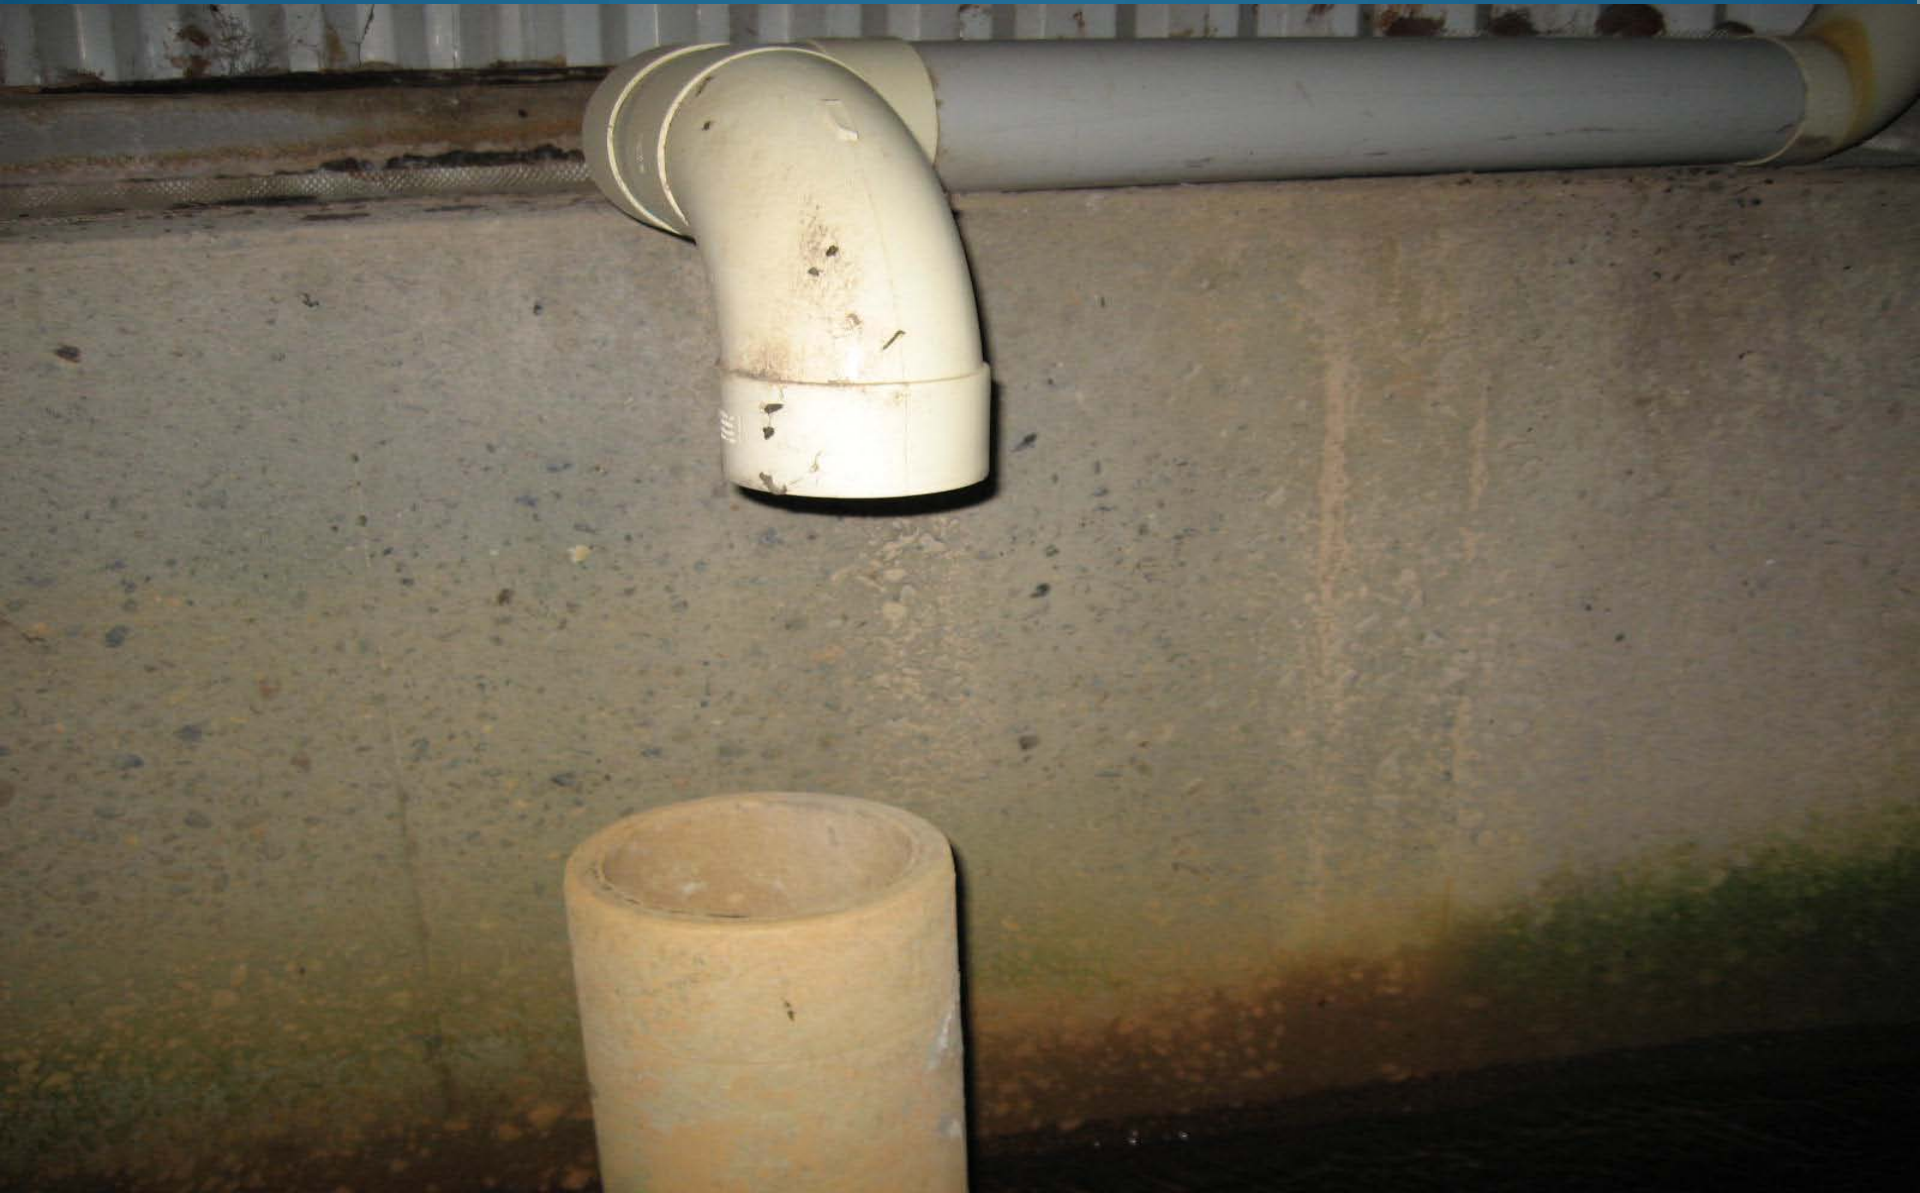
The roof gutter pipework is not connected into the overflow, allowing contamination to directly enter the tank

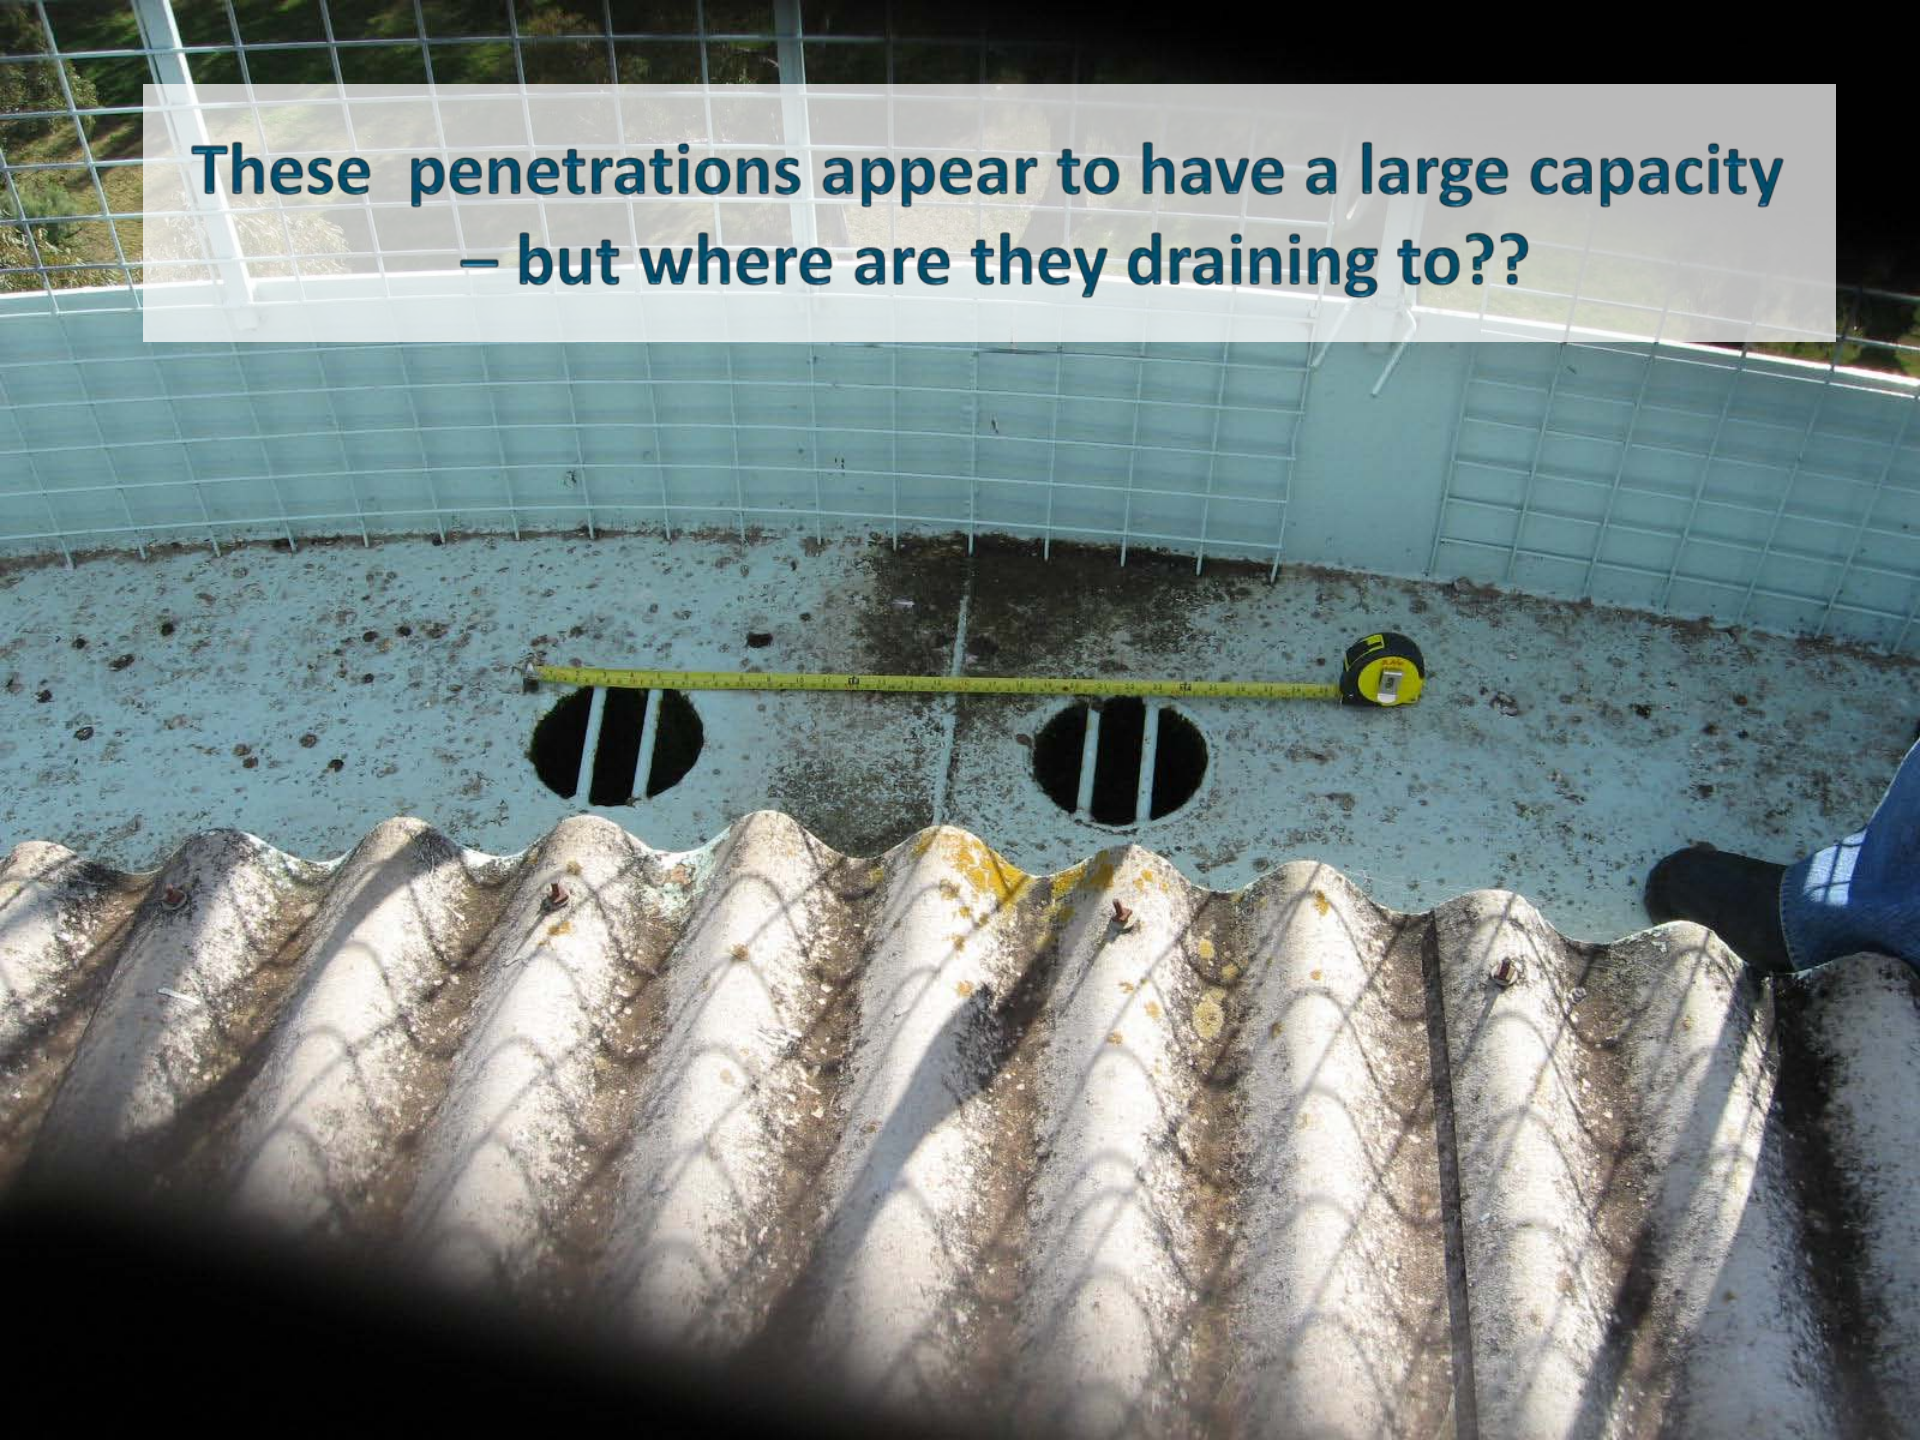
**These penetrations appear to have a large capacity
– but where are they draining to??**

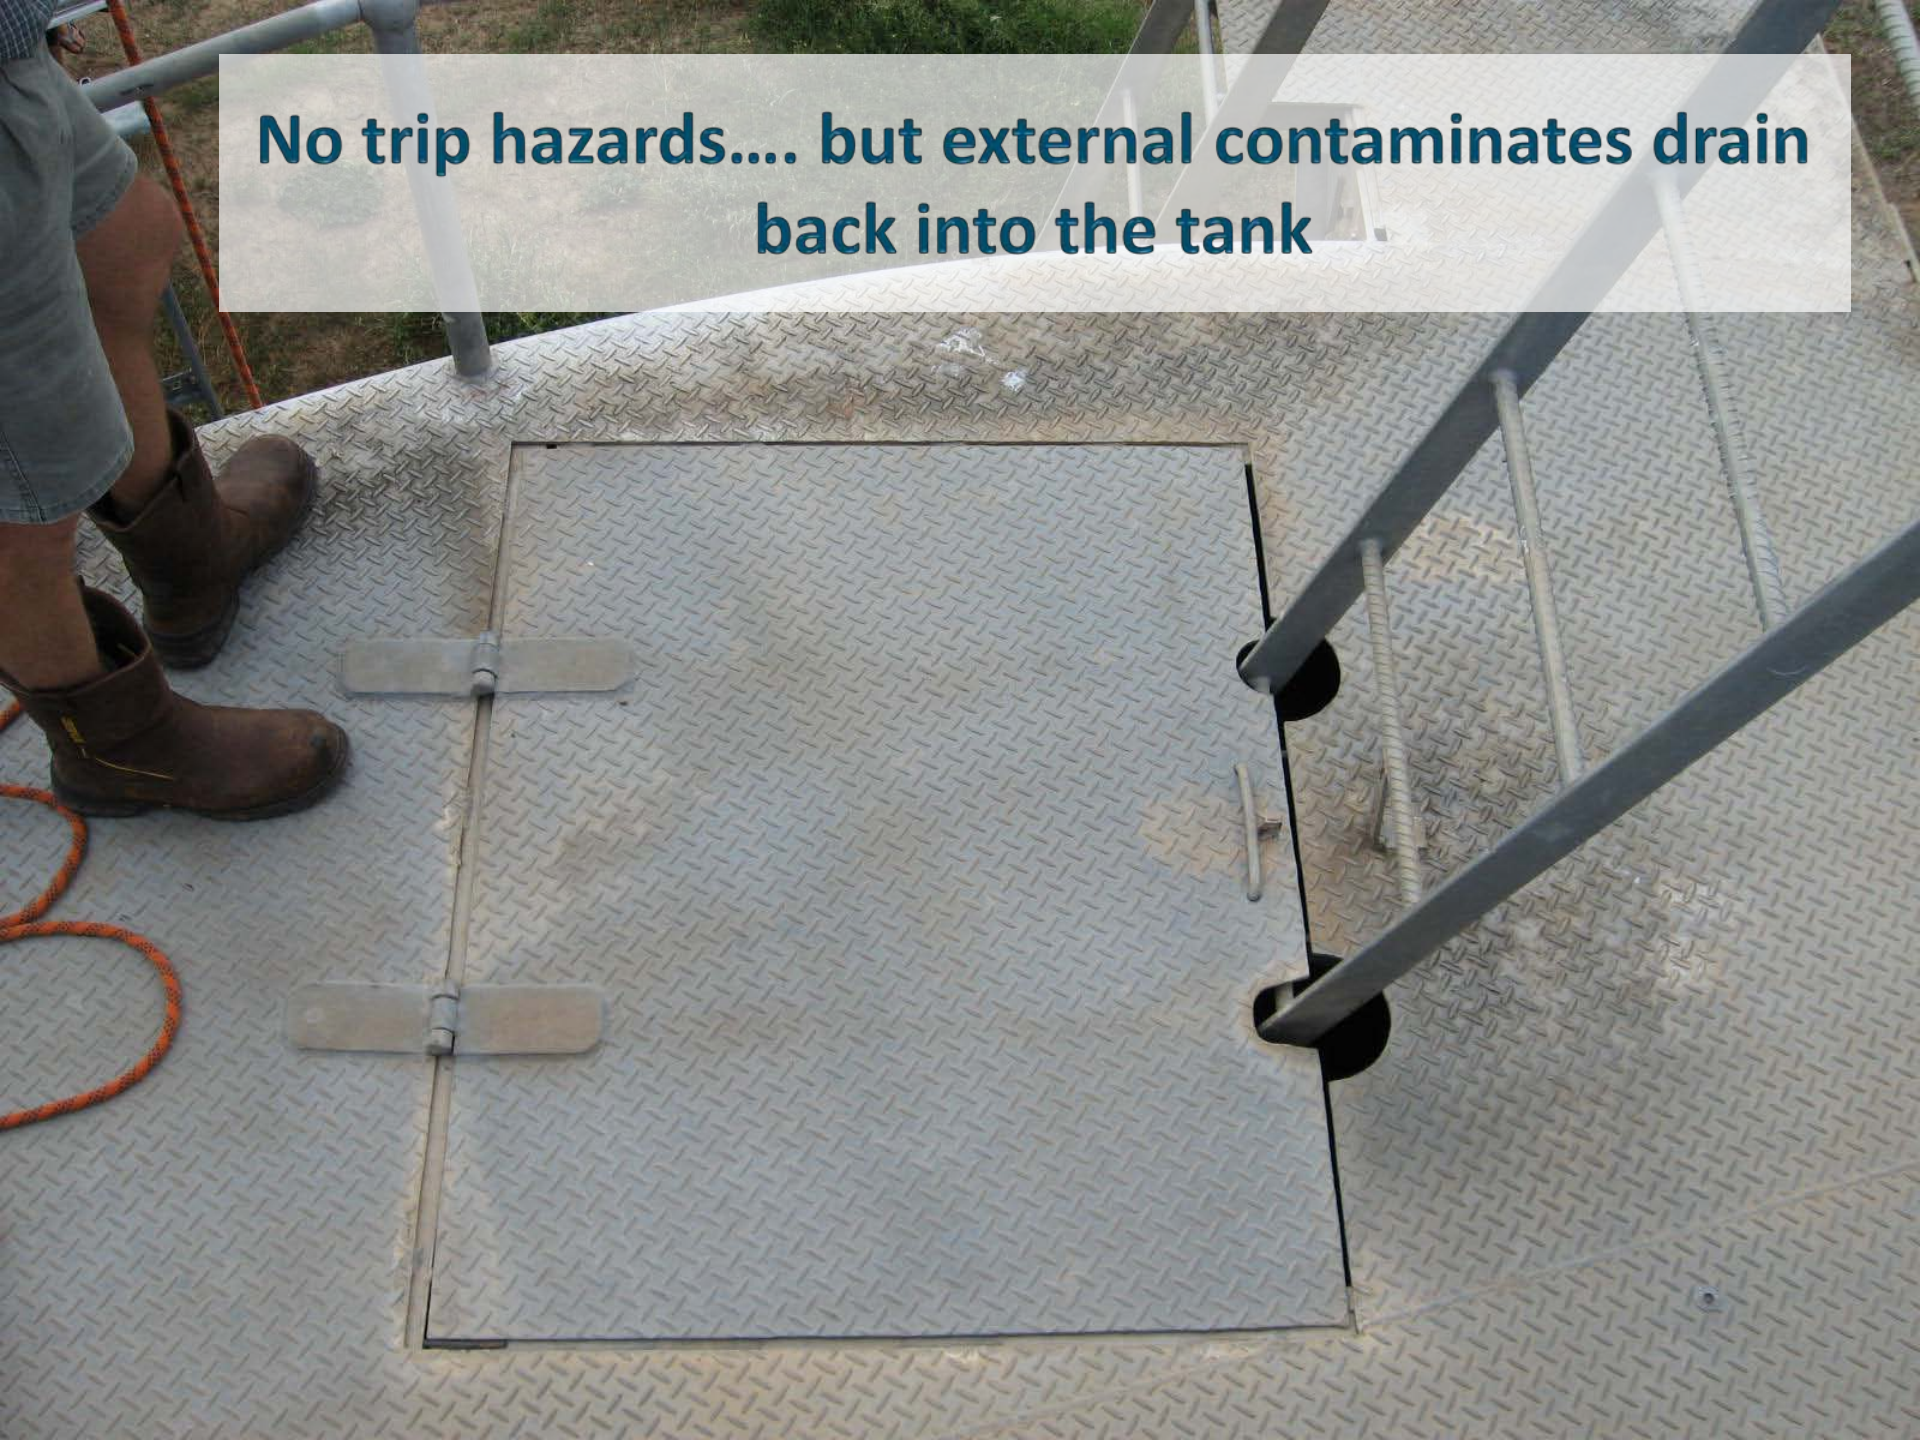
No trip hazards.... but external contaminates drain back into the tank

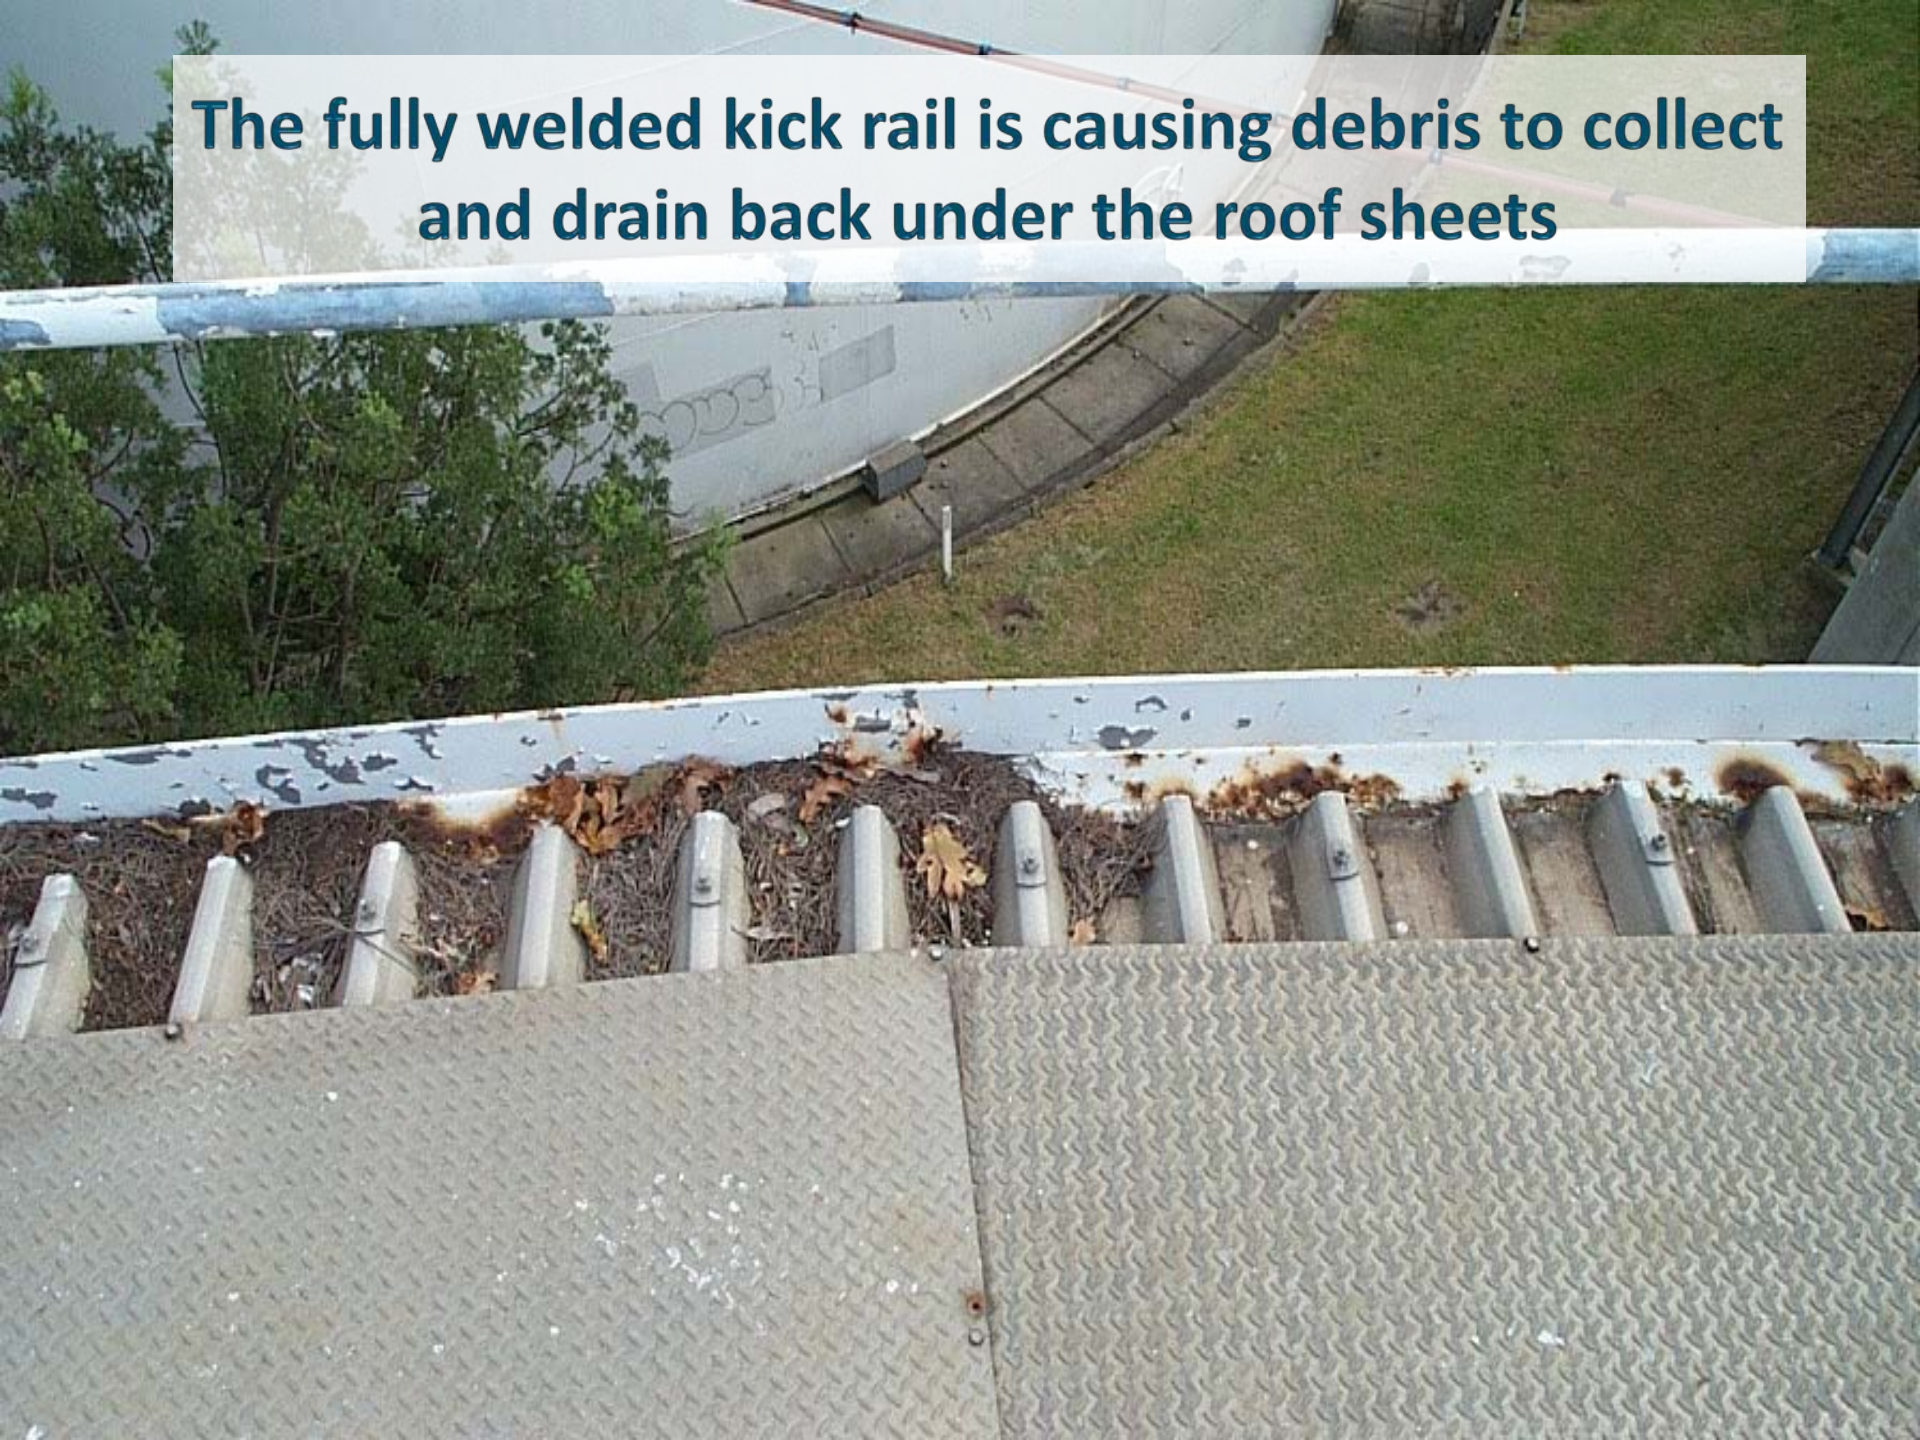
The fully welded kick rail is causing debris to collect and drain back under the roof sheets

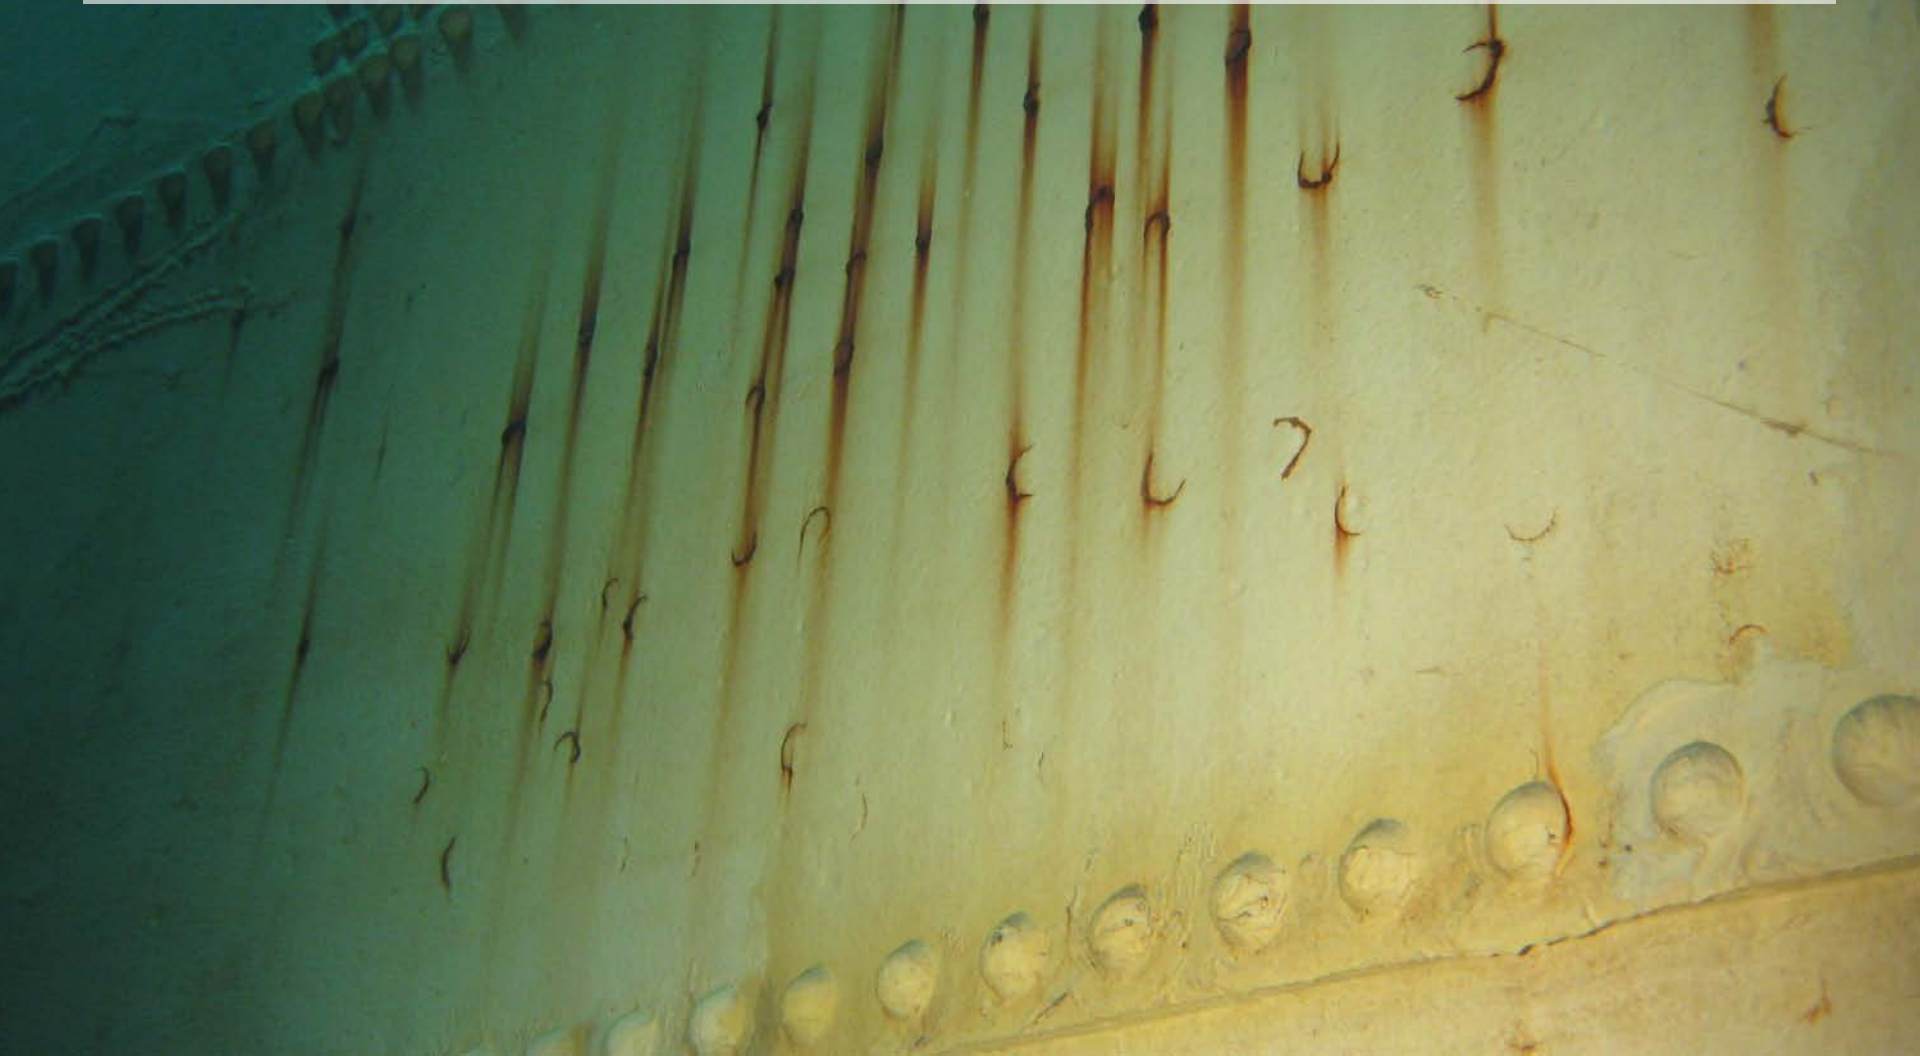
Coating defects can be passivated by installing an impressed CP system – allowing an otherwise defective coating to achieve its designed life expectancy

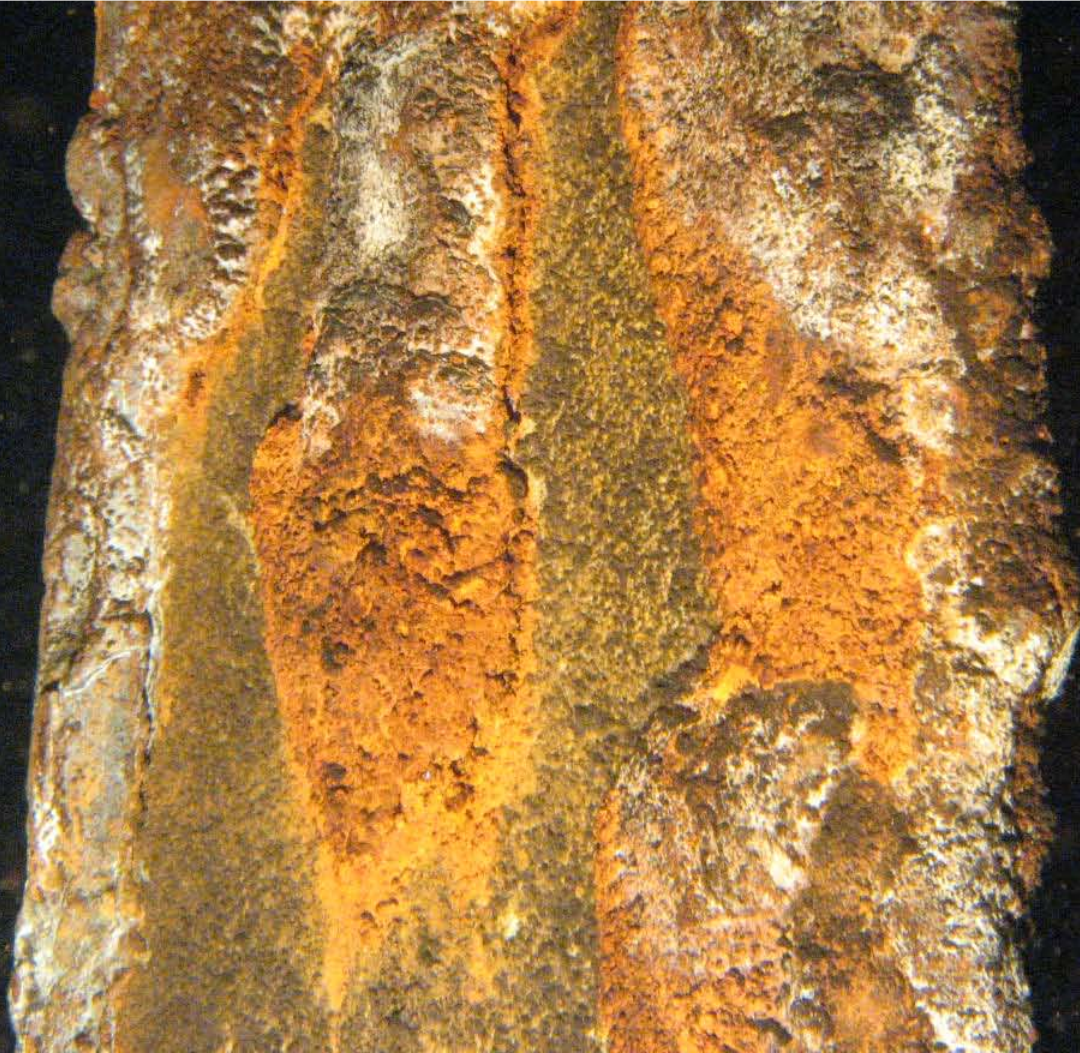
This gal column was heavily corroded, but the CP system is passivating the active corrosion – the white calcareous material is the by-product of this process

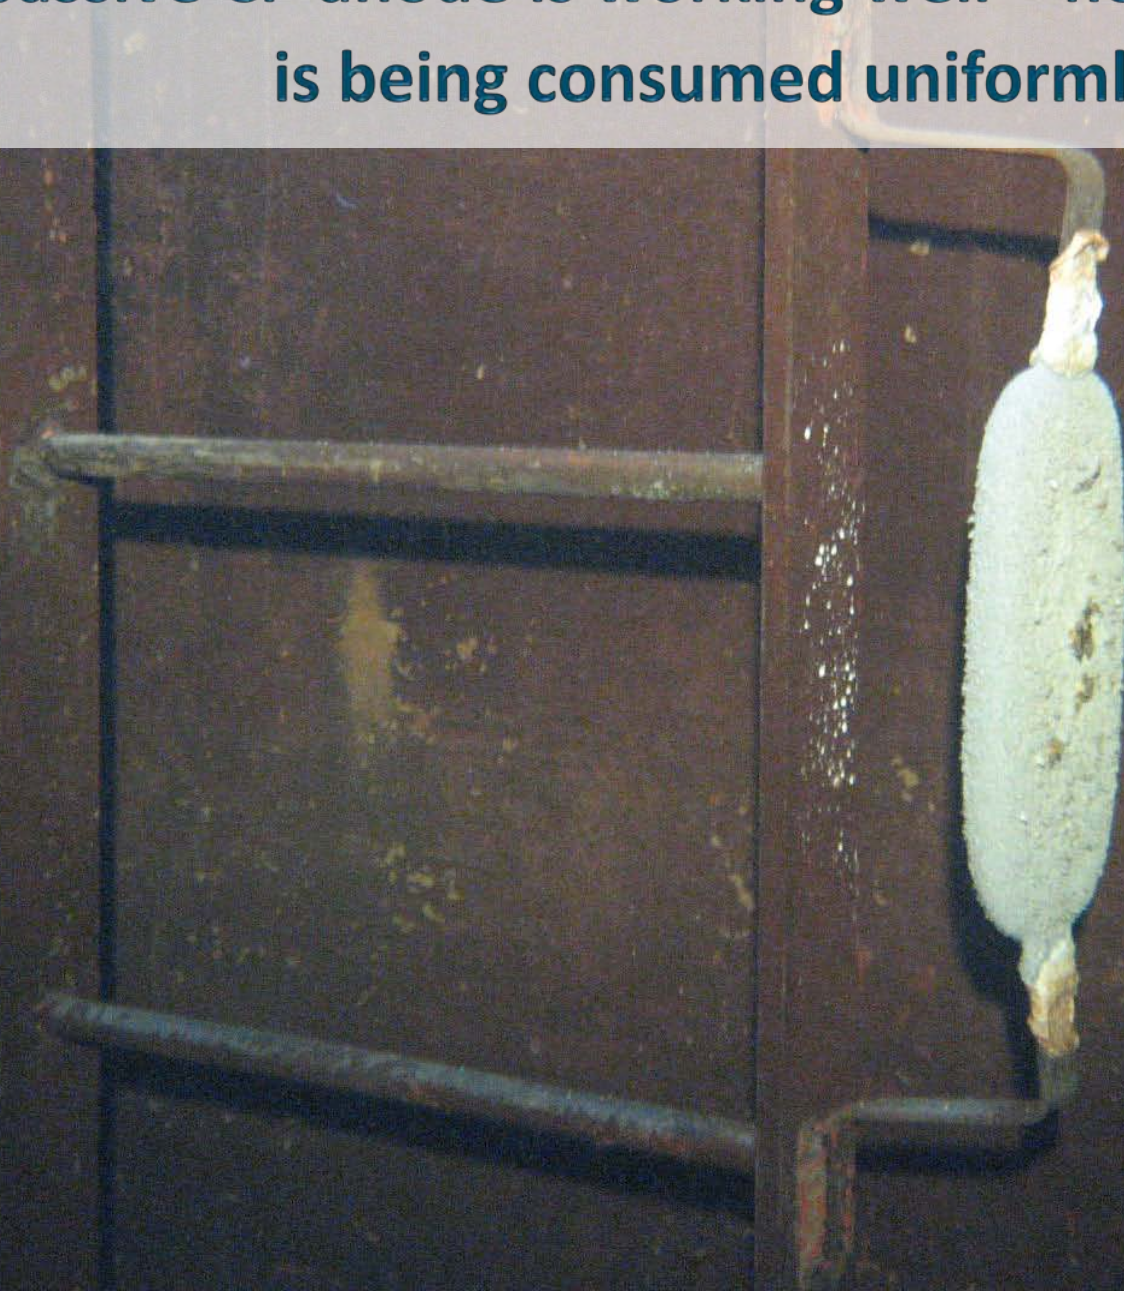
This passive CP anode is working well – note the material is being consumed uniformly

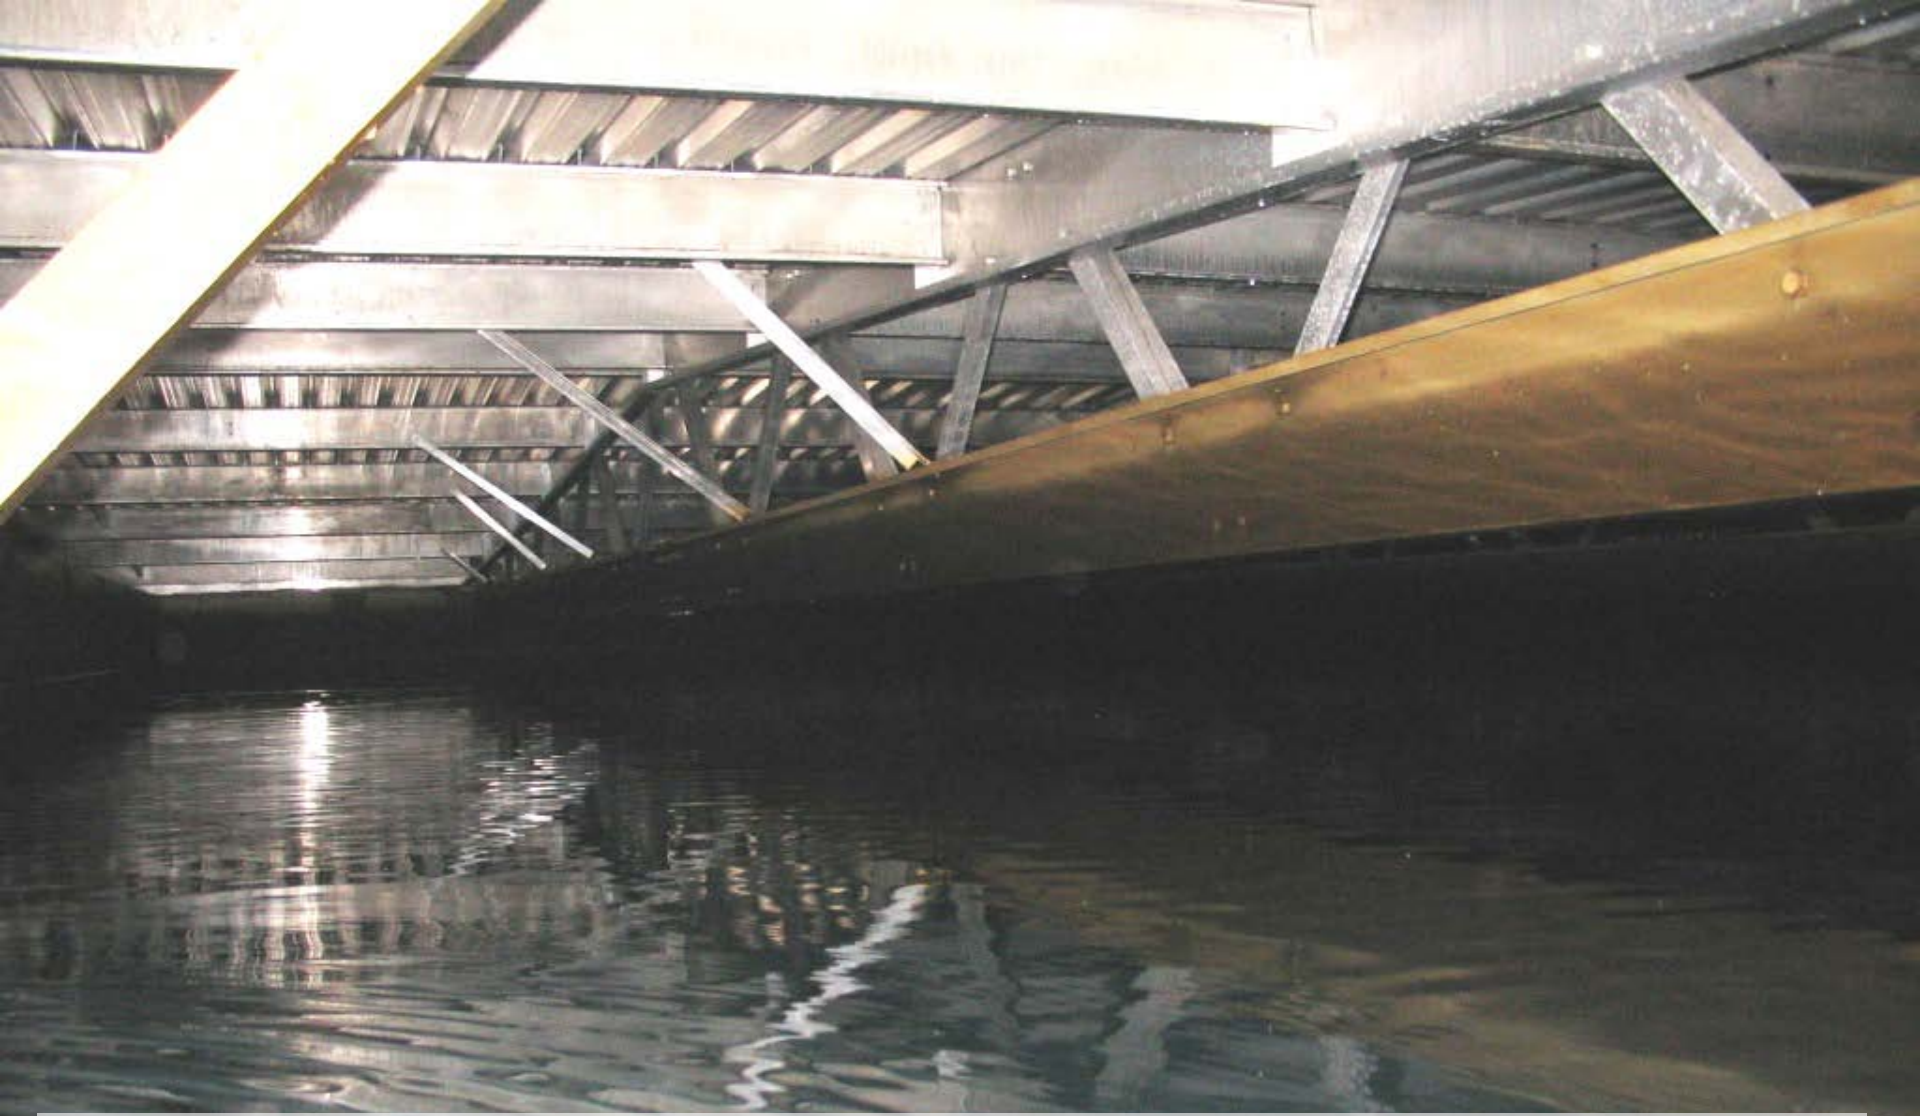
**The water level has been set too high
- causing corrosion on the roof beam**

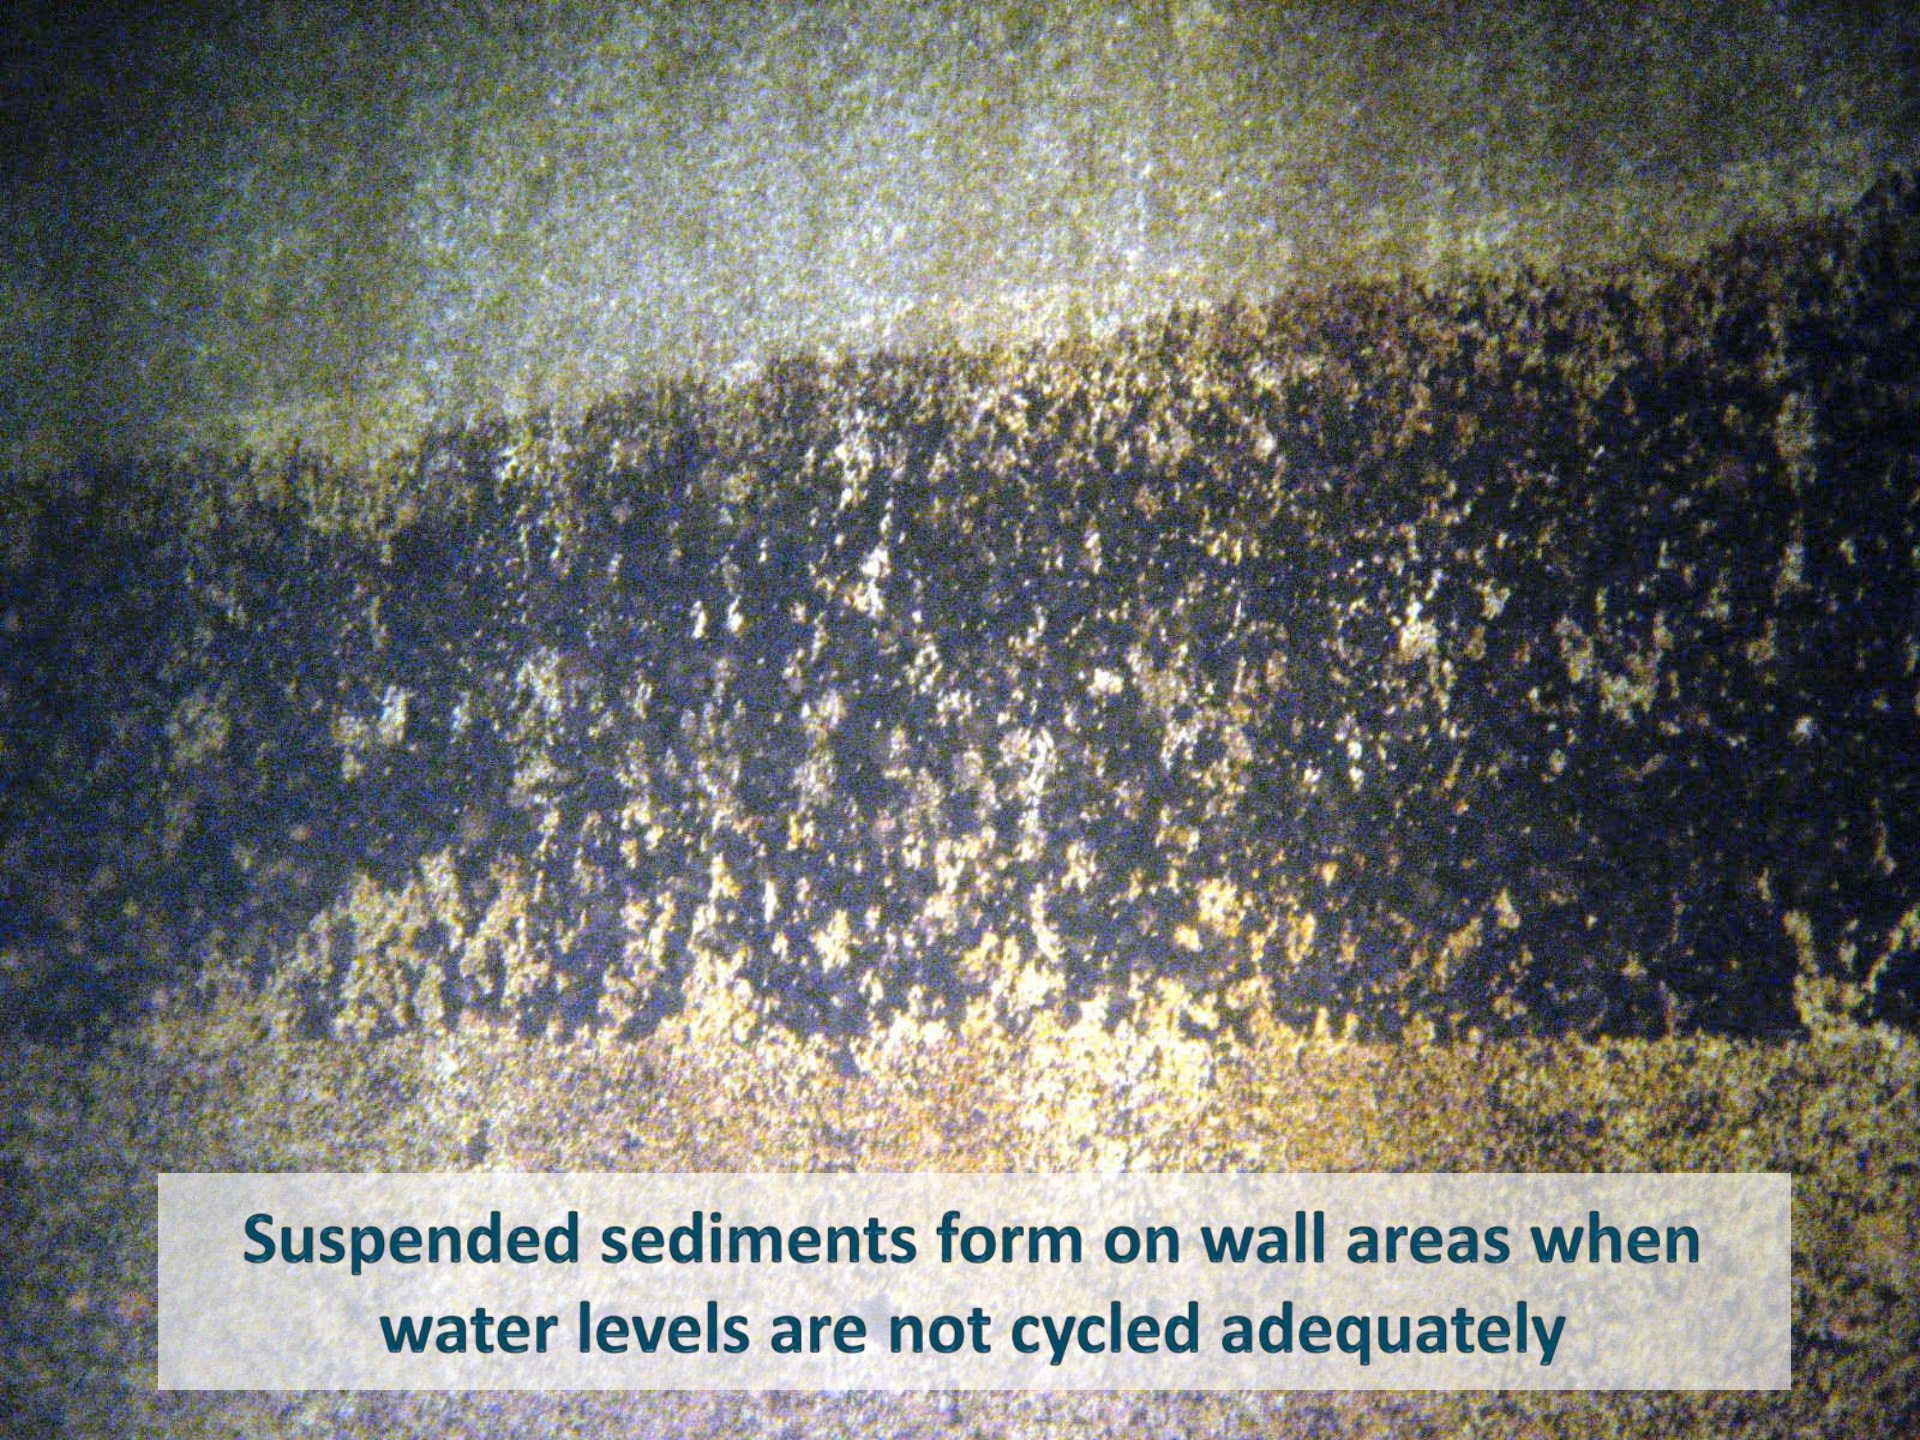
The water levels were not re-set after a new roof was installed – corrosion is forming around the SS joining bolts
