When is Reservoir Cleaning not just Cleaning? - following the evidence trail

Jillian Busch - Data Based Solutions Pty Ltd

Dave Barry - Aqualift Potable Diving Pty Ltd

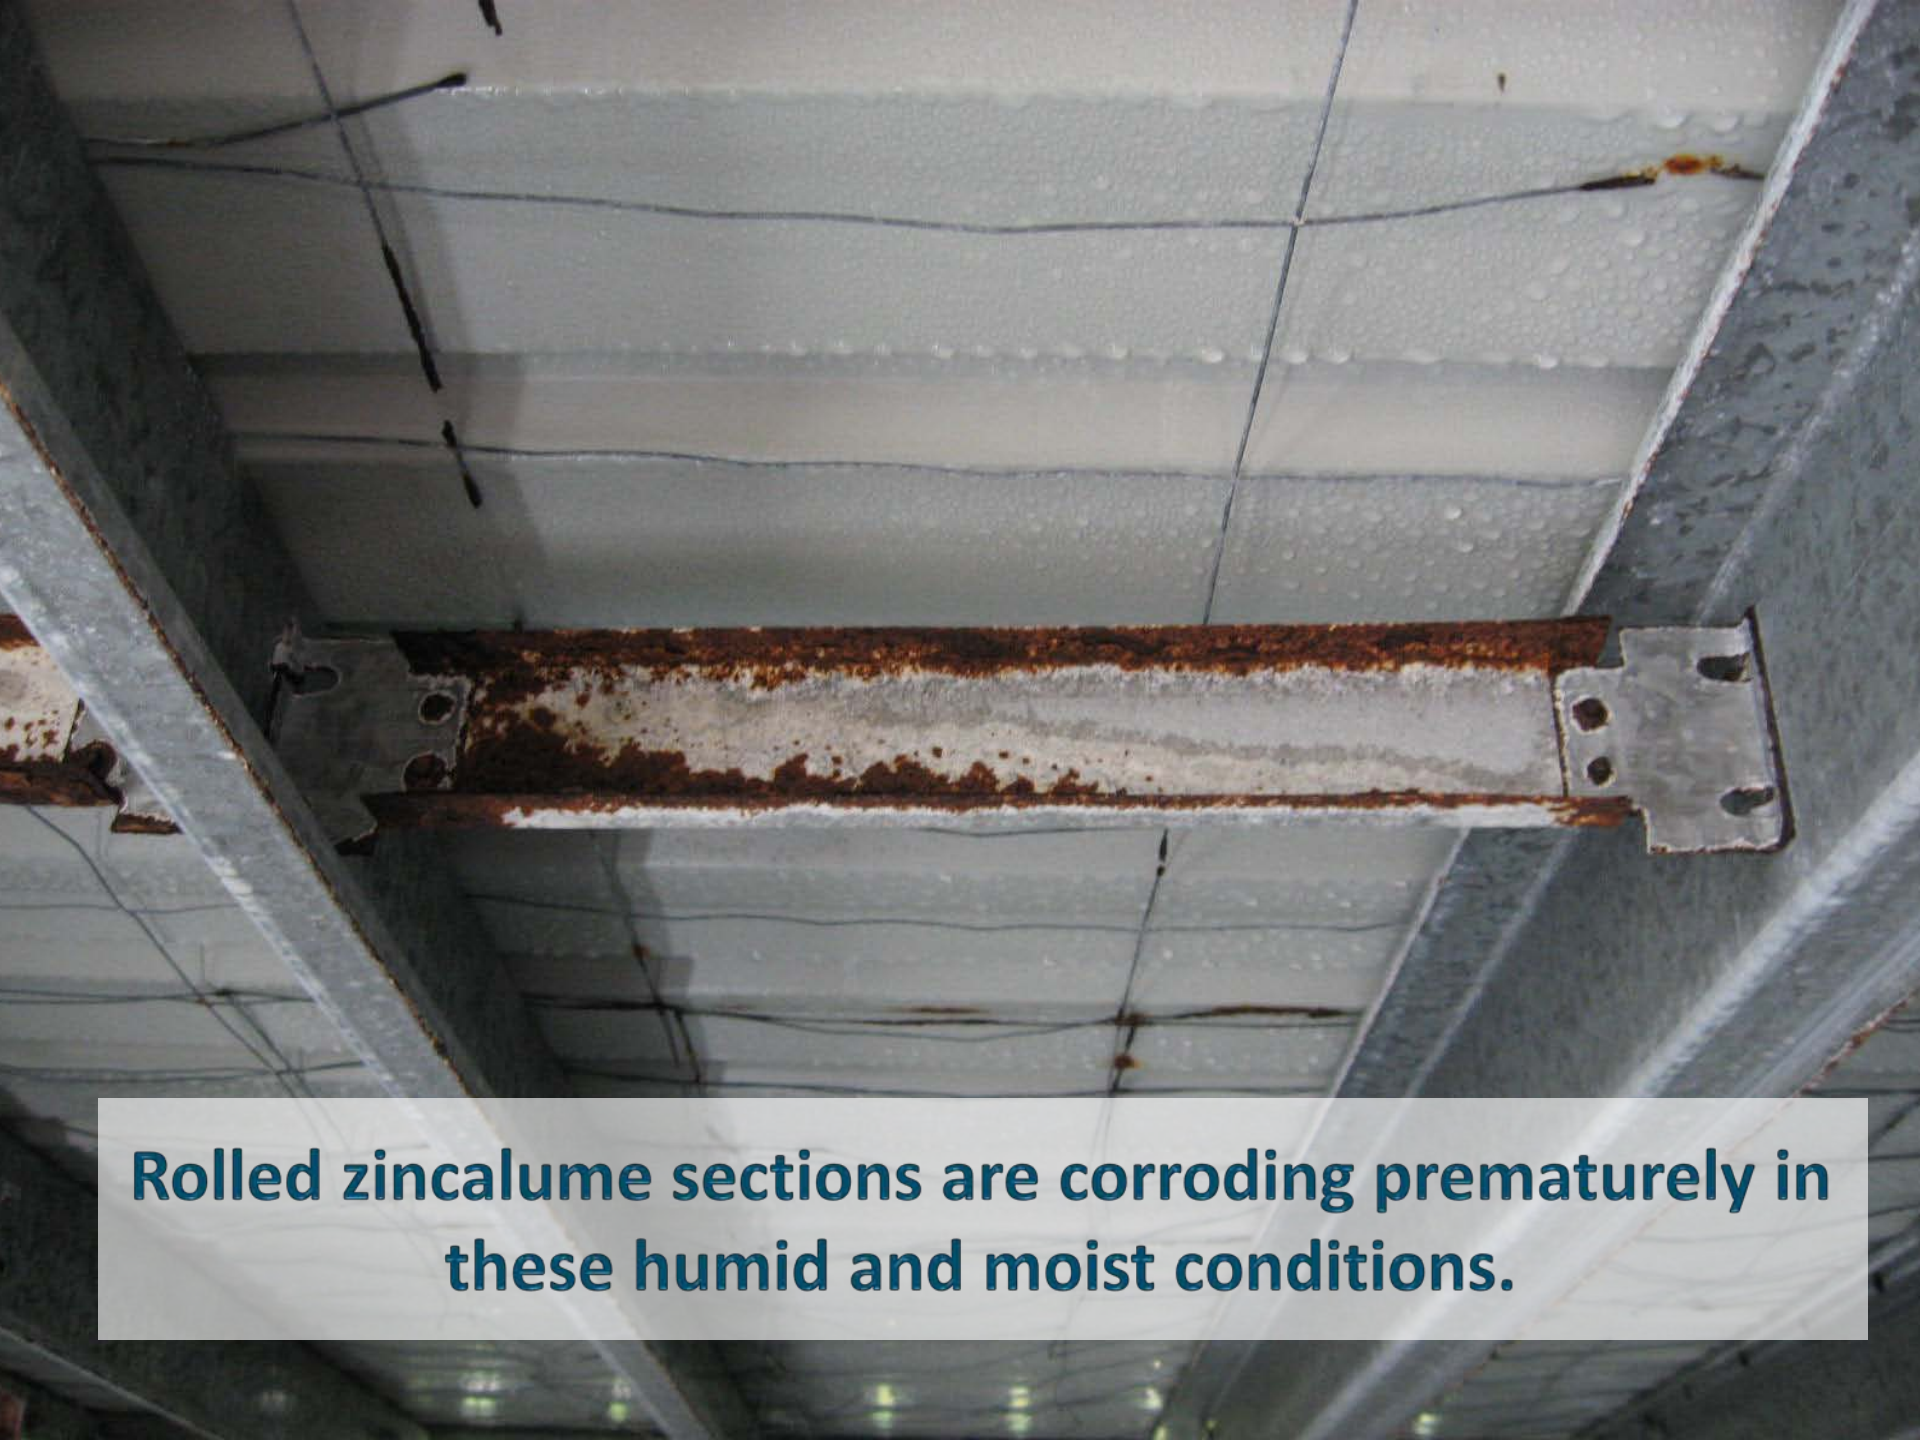
Rolled zincalume sections are corroding prematurely in these humid and moist conditions.

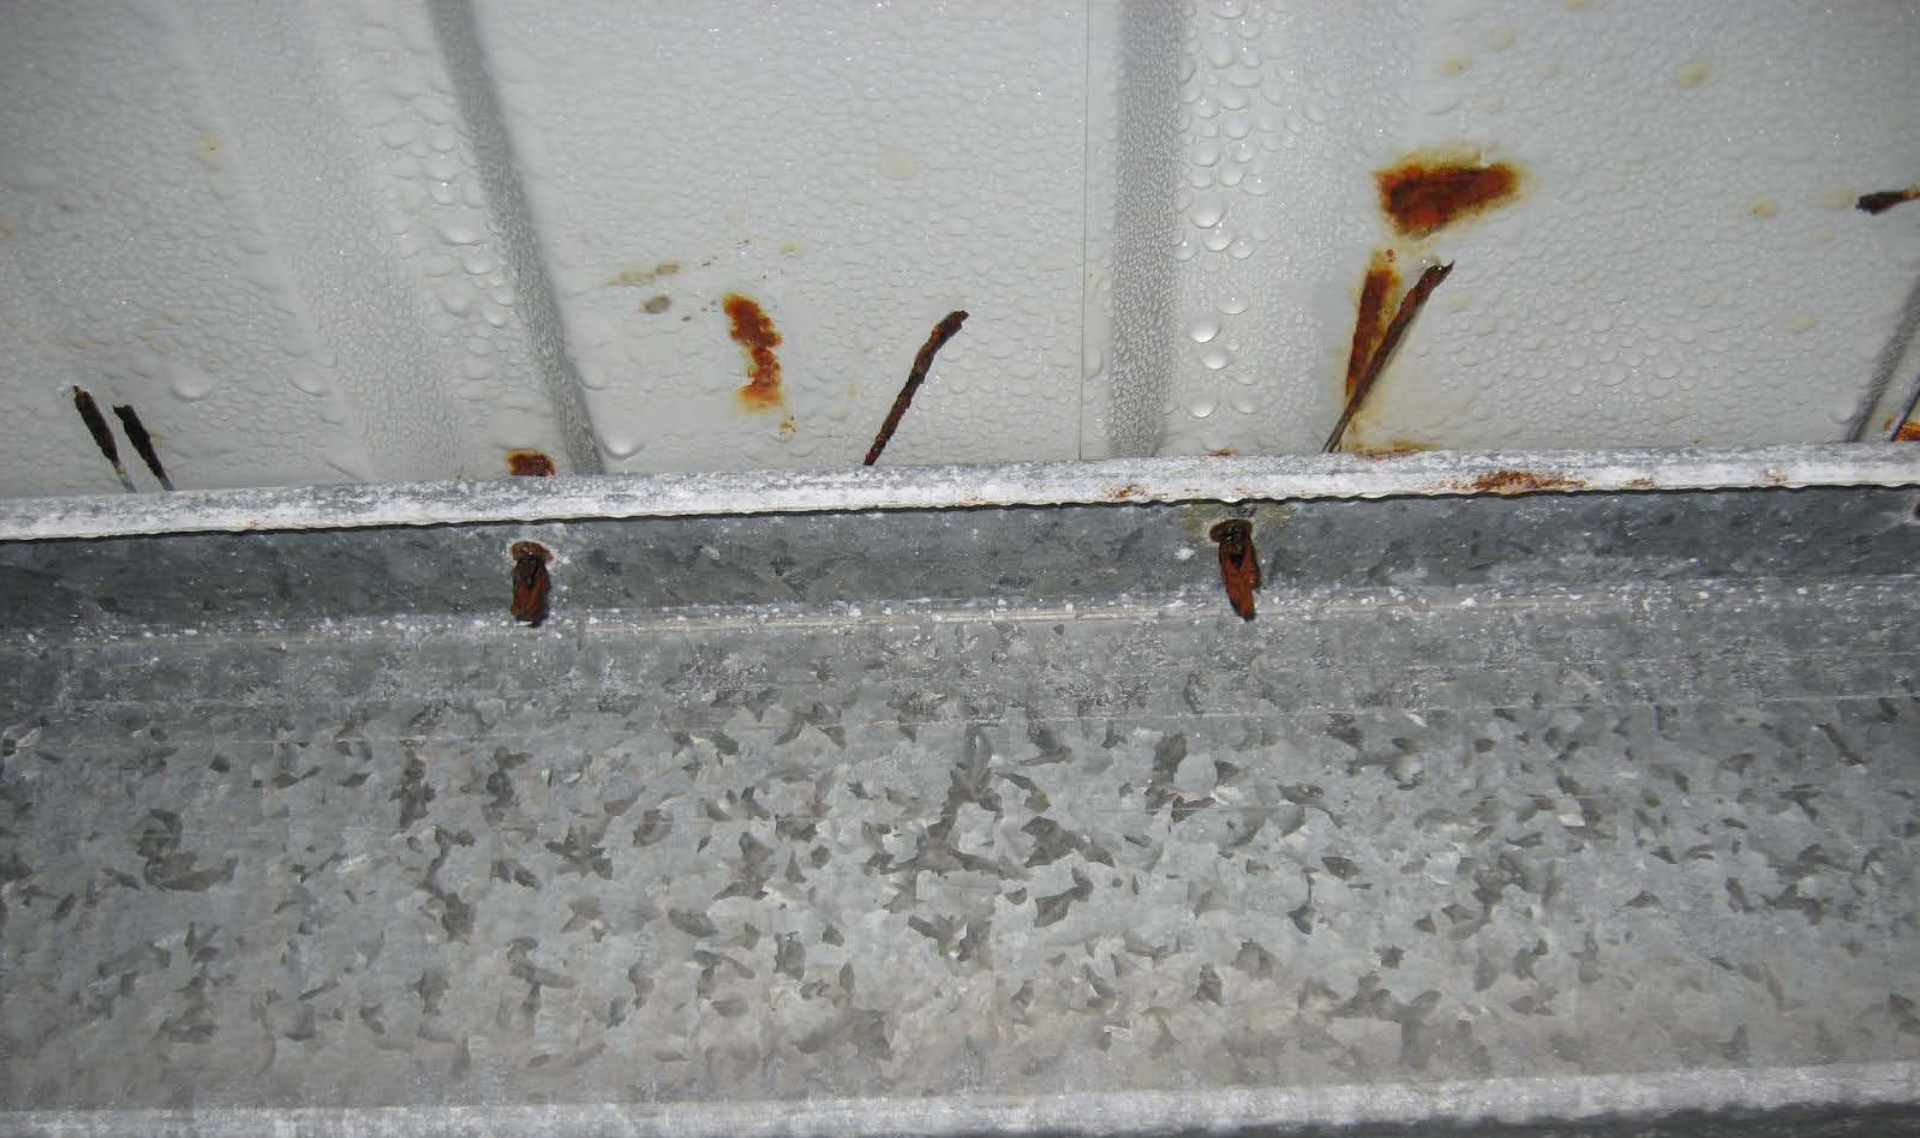
There are poor quality roof fixing screws on the market these days – this roof structure is only 7 years old

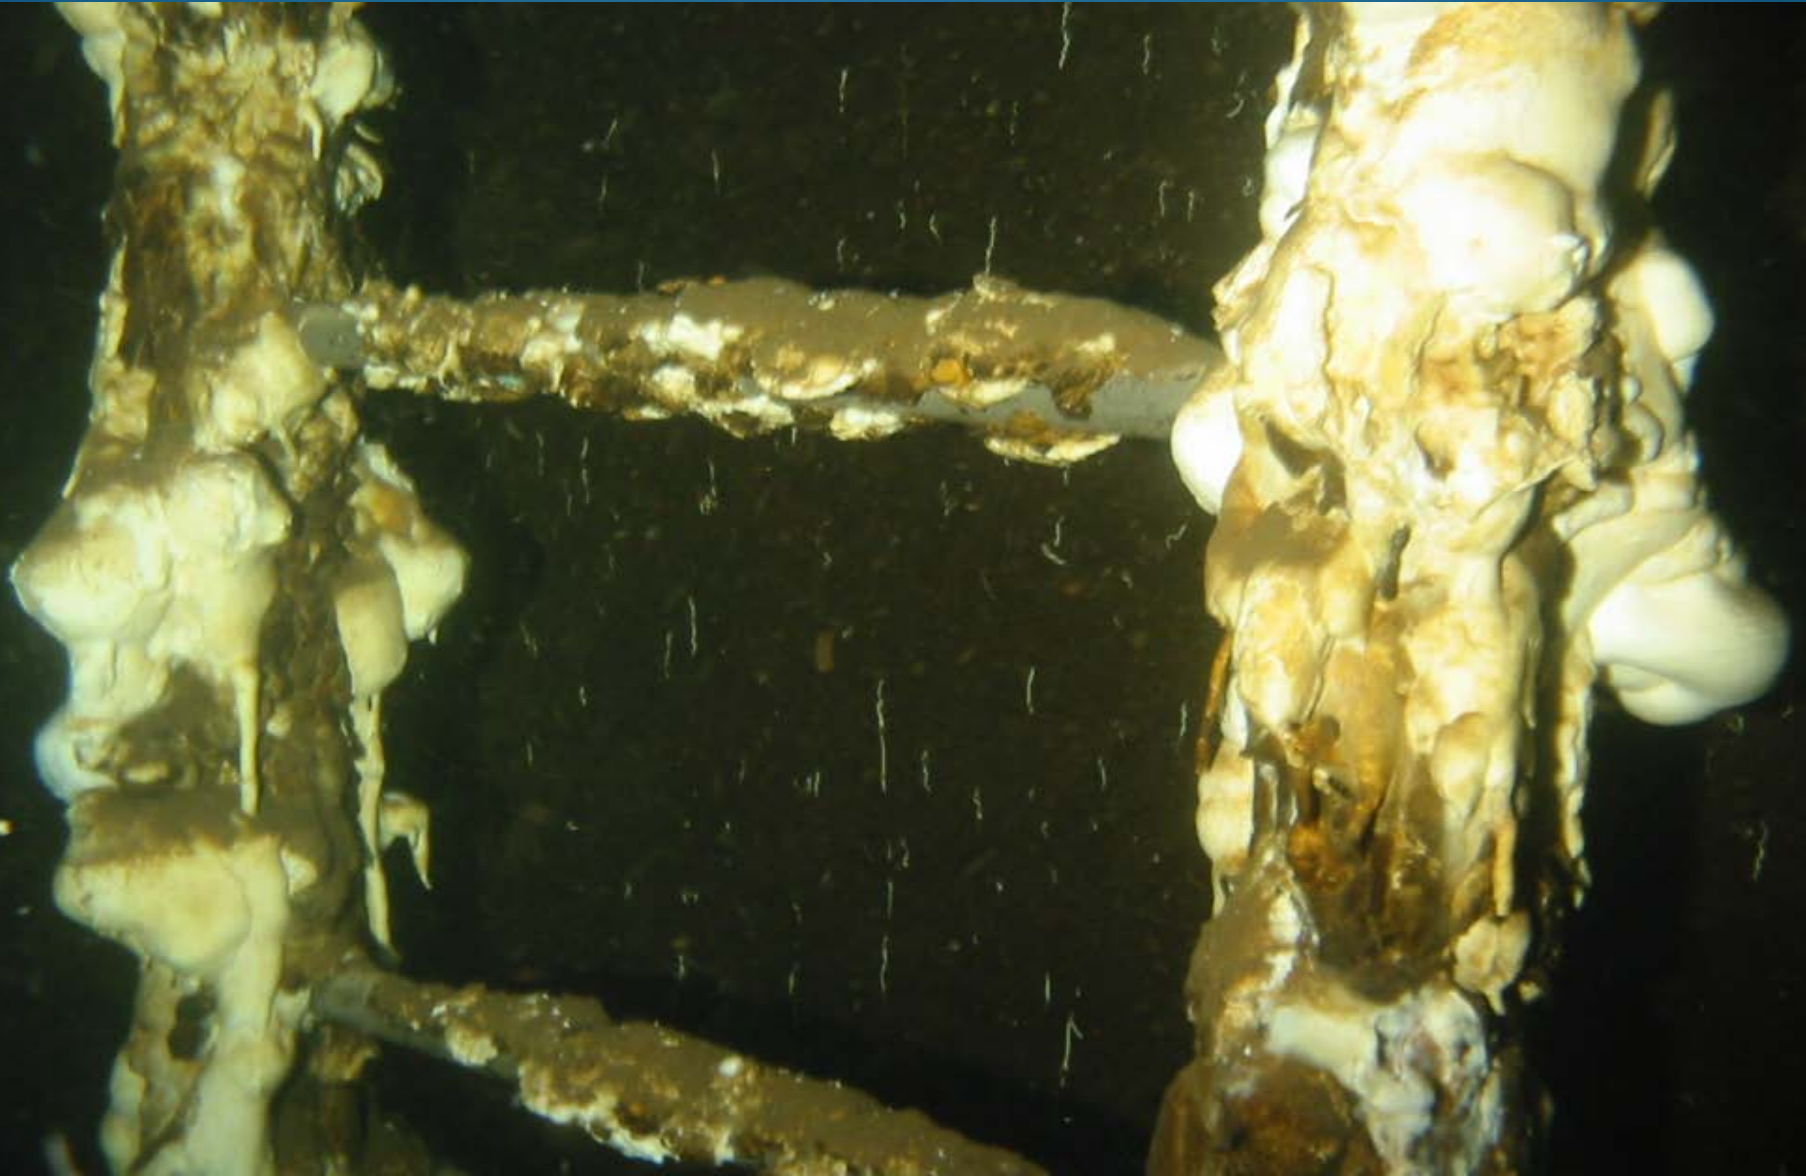
Aluminum corrodes when submerged - also entrapping sediments and affecting the water quality

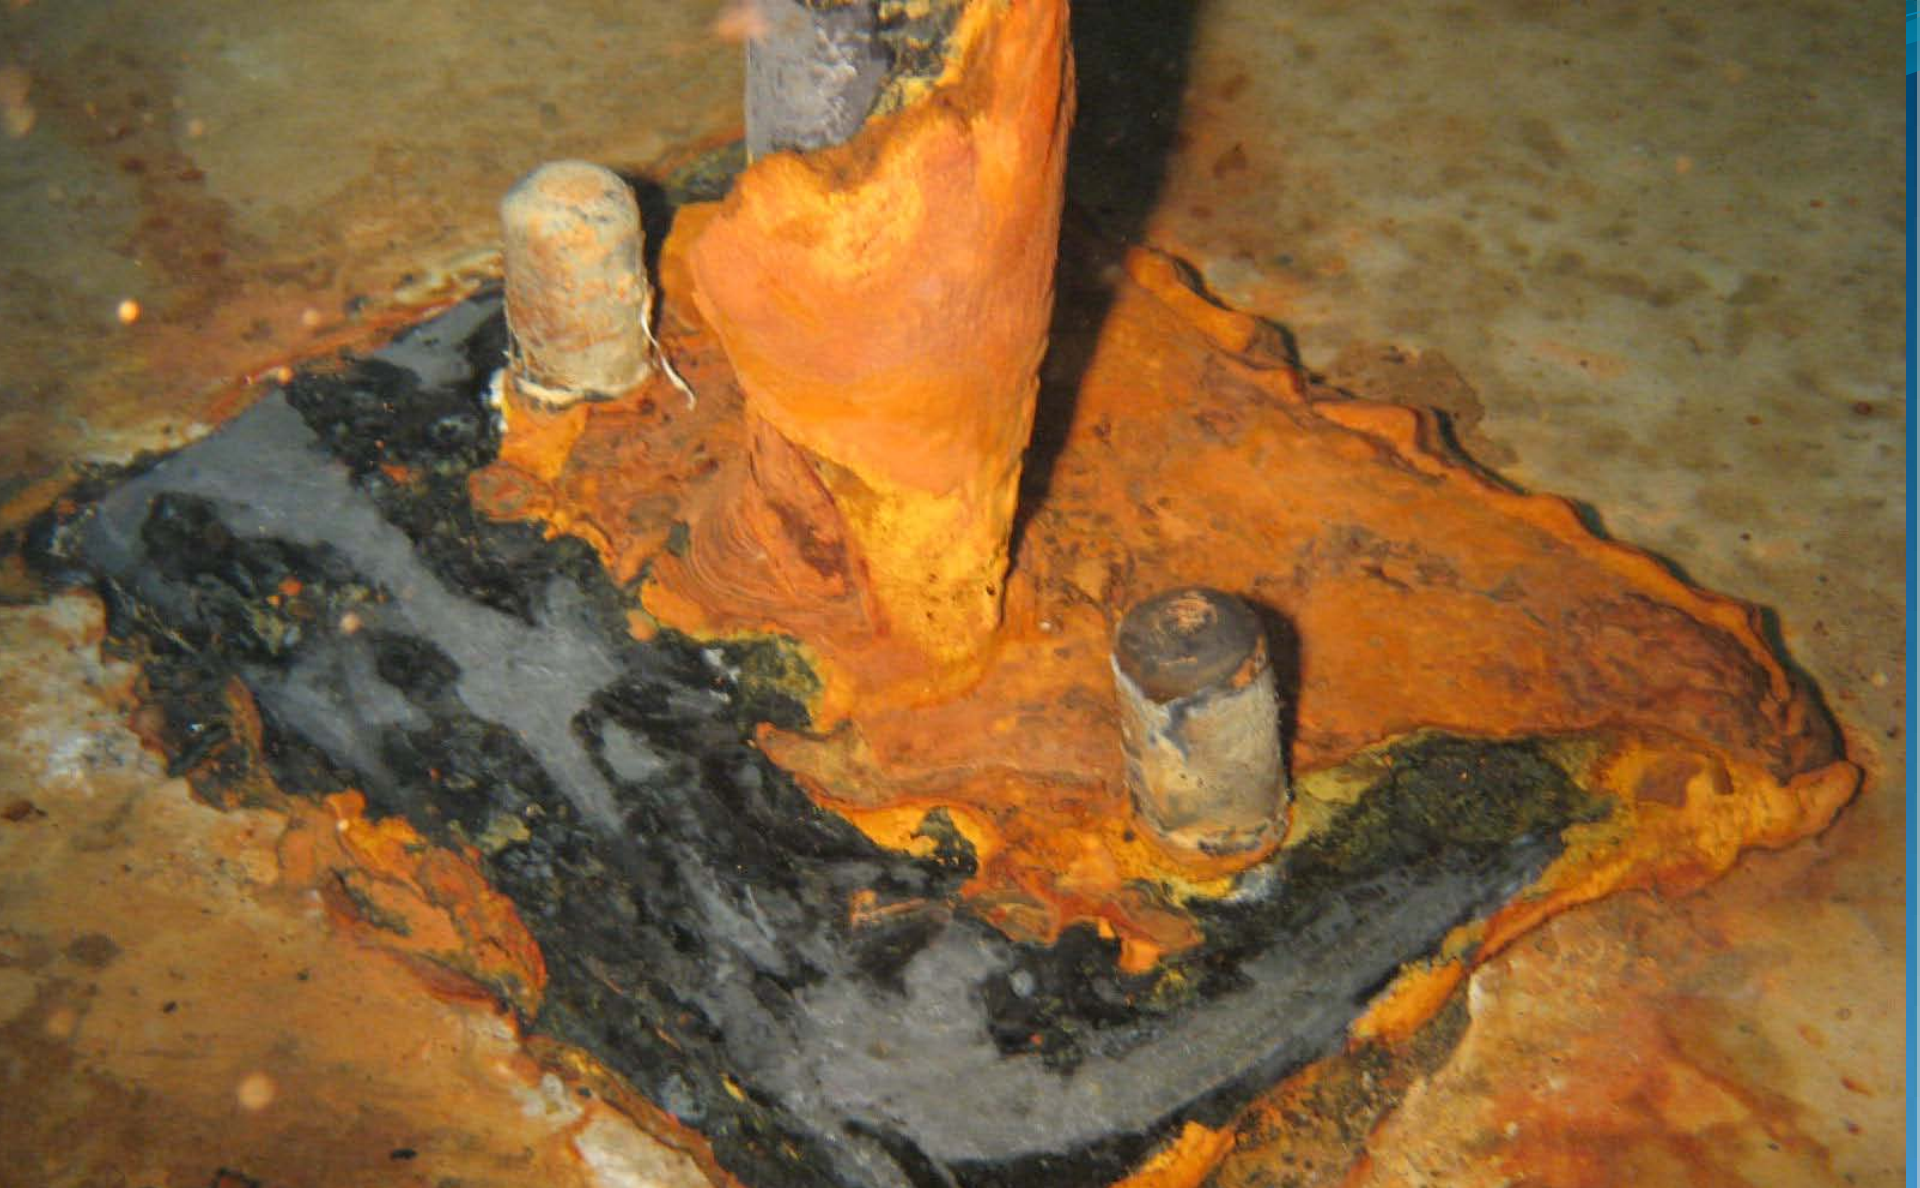
This ladder should have been epoxy coated rather than galvanized

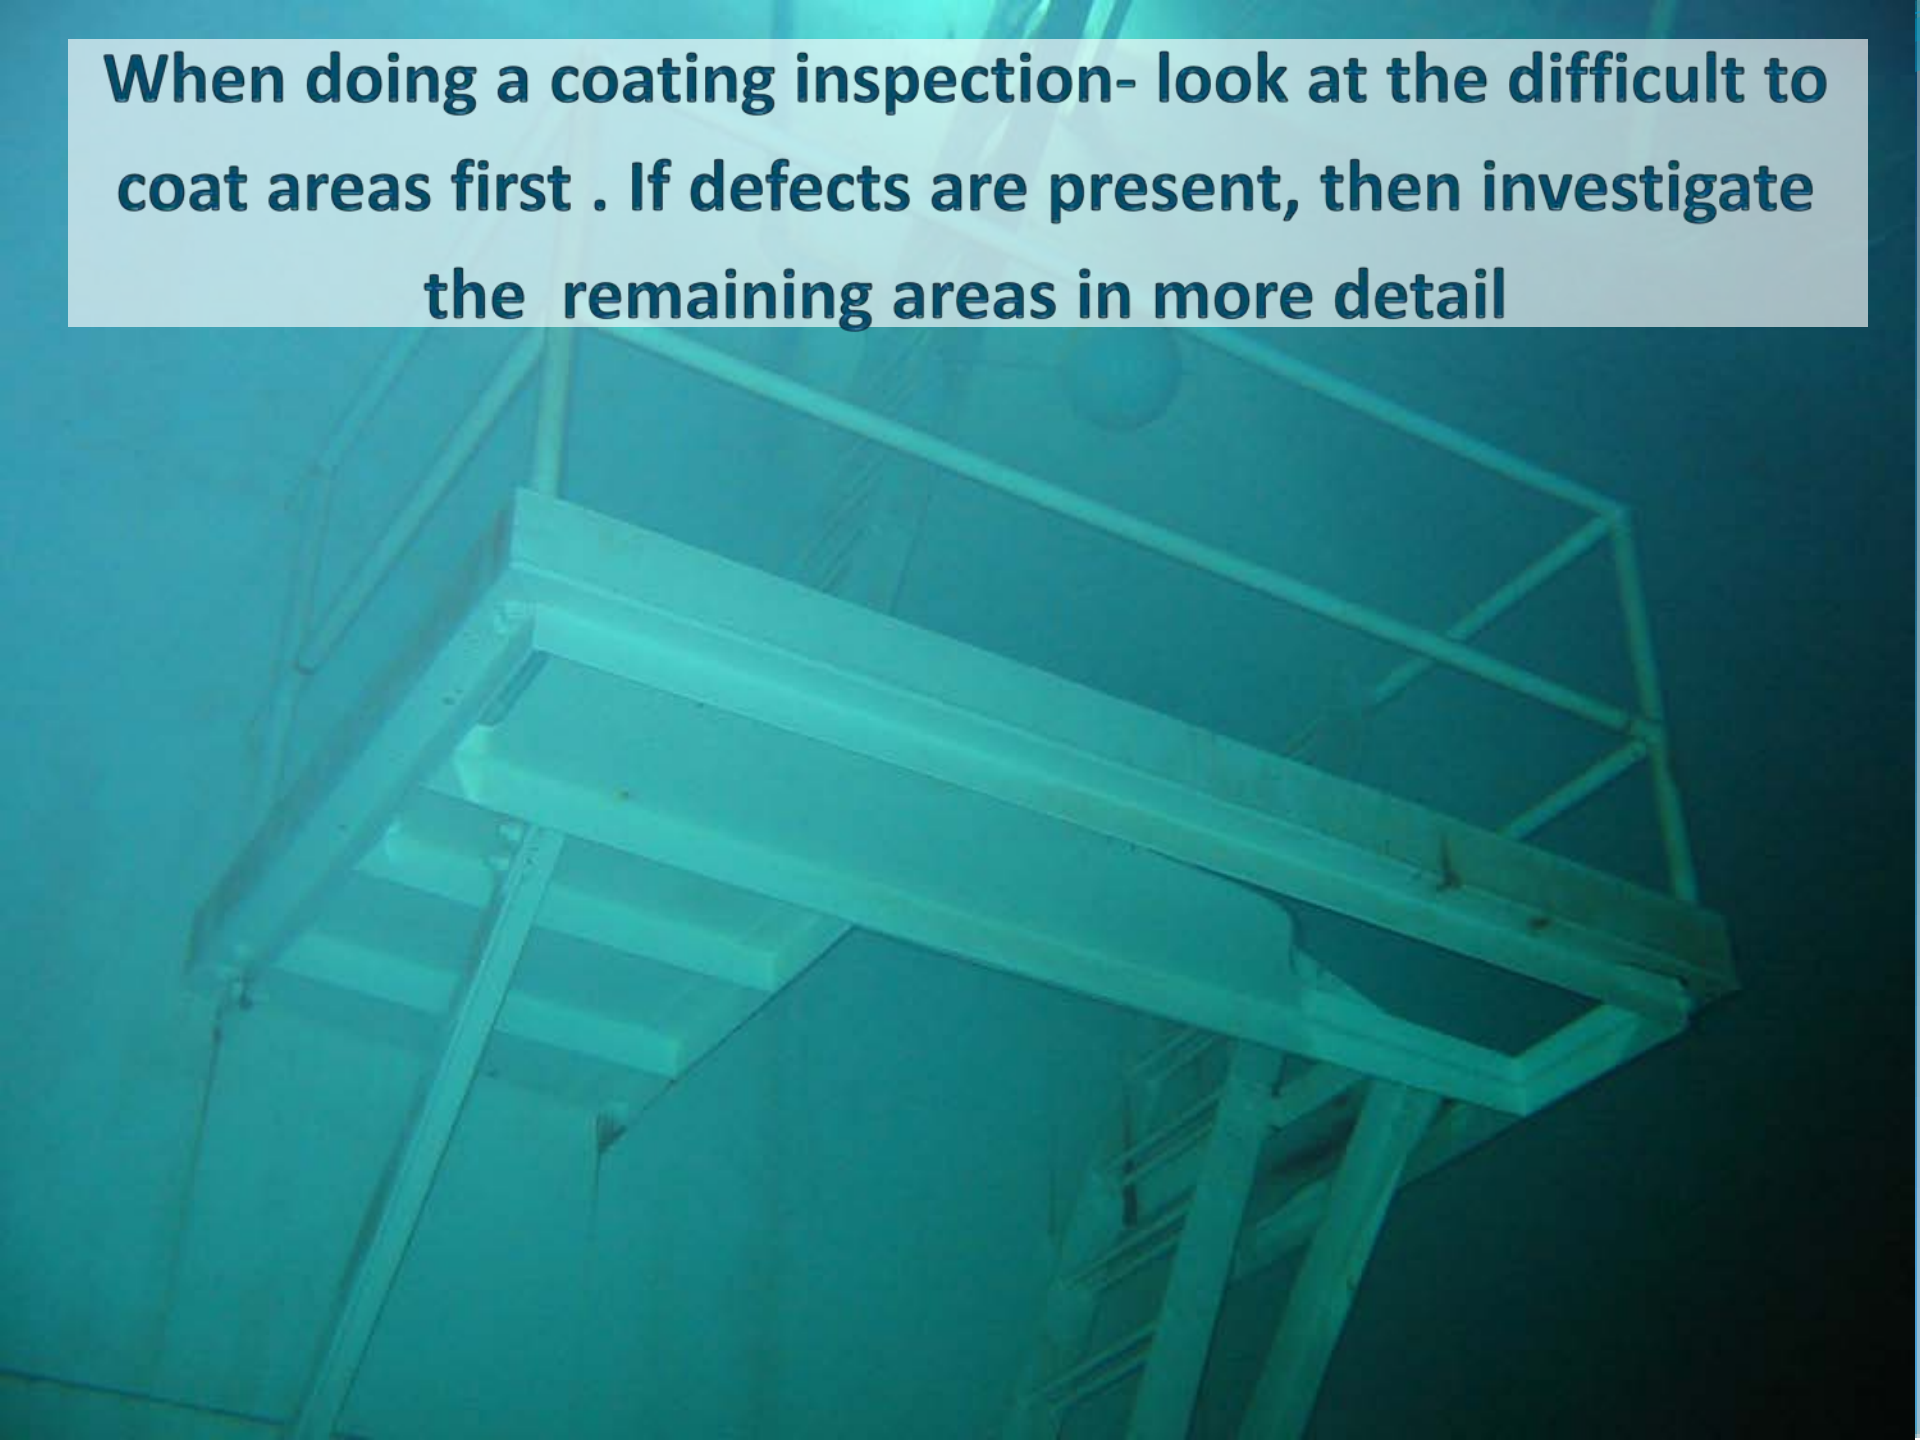
When doing a coating inspection- look at the difficult to coat areas first . If defects are present, then investigate the remaining areas in more detail

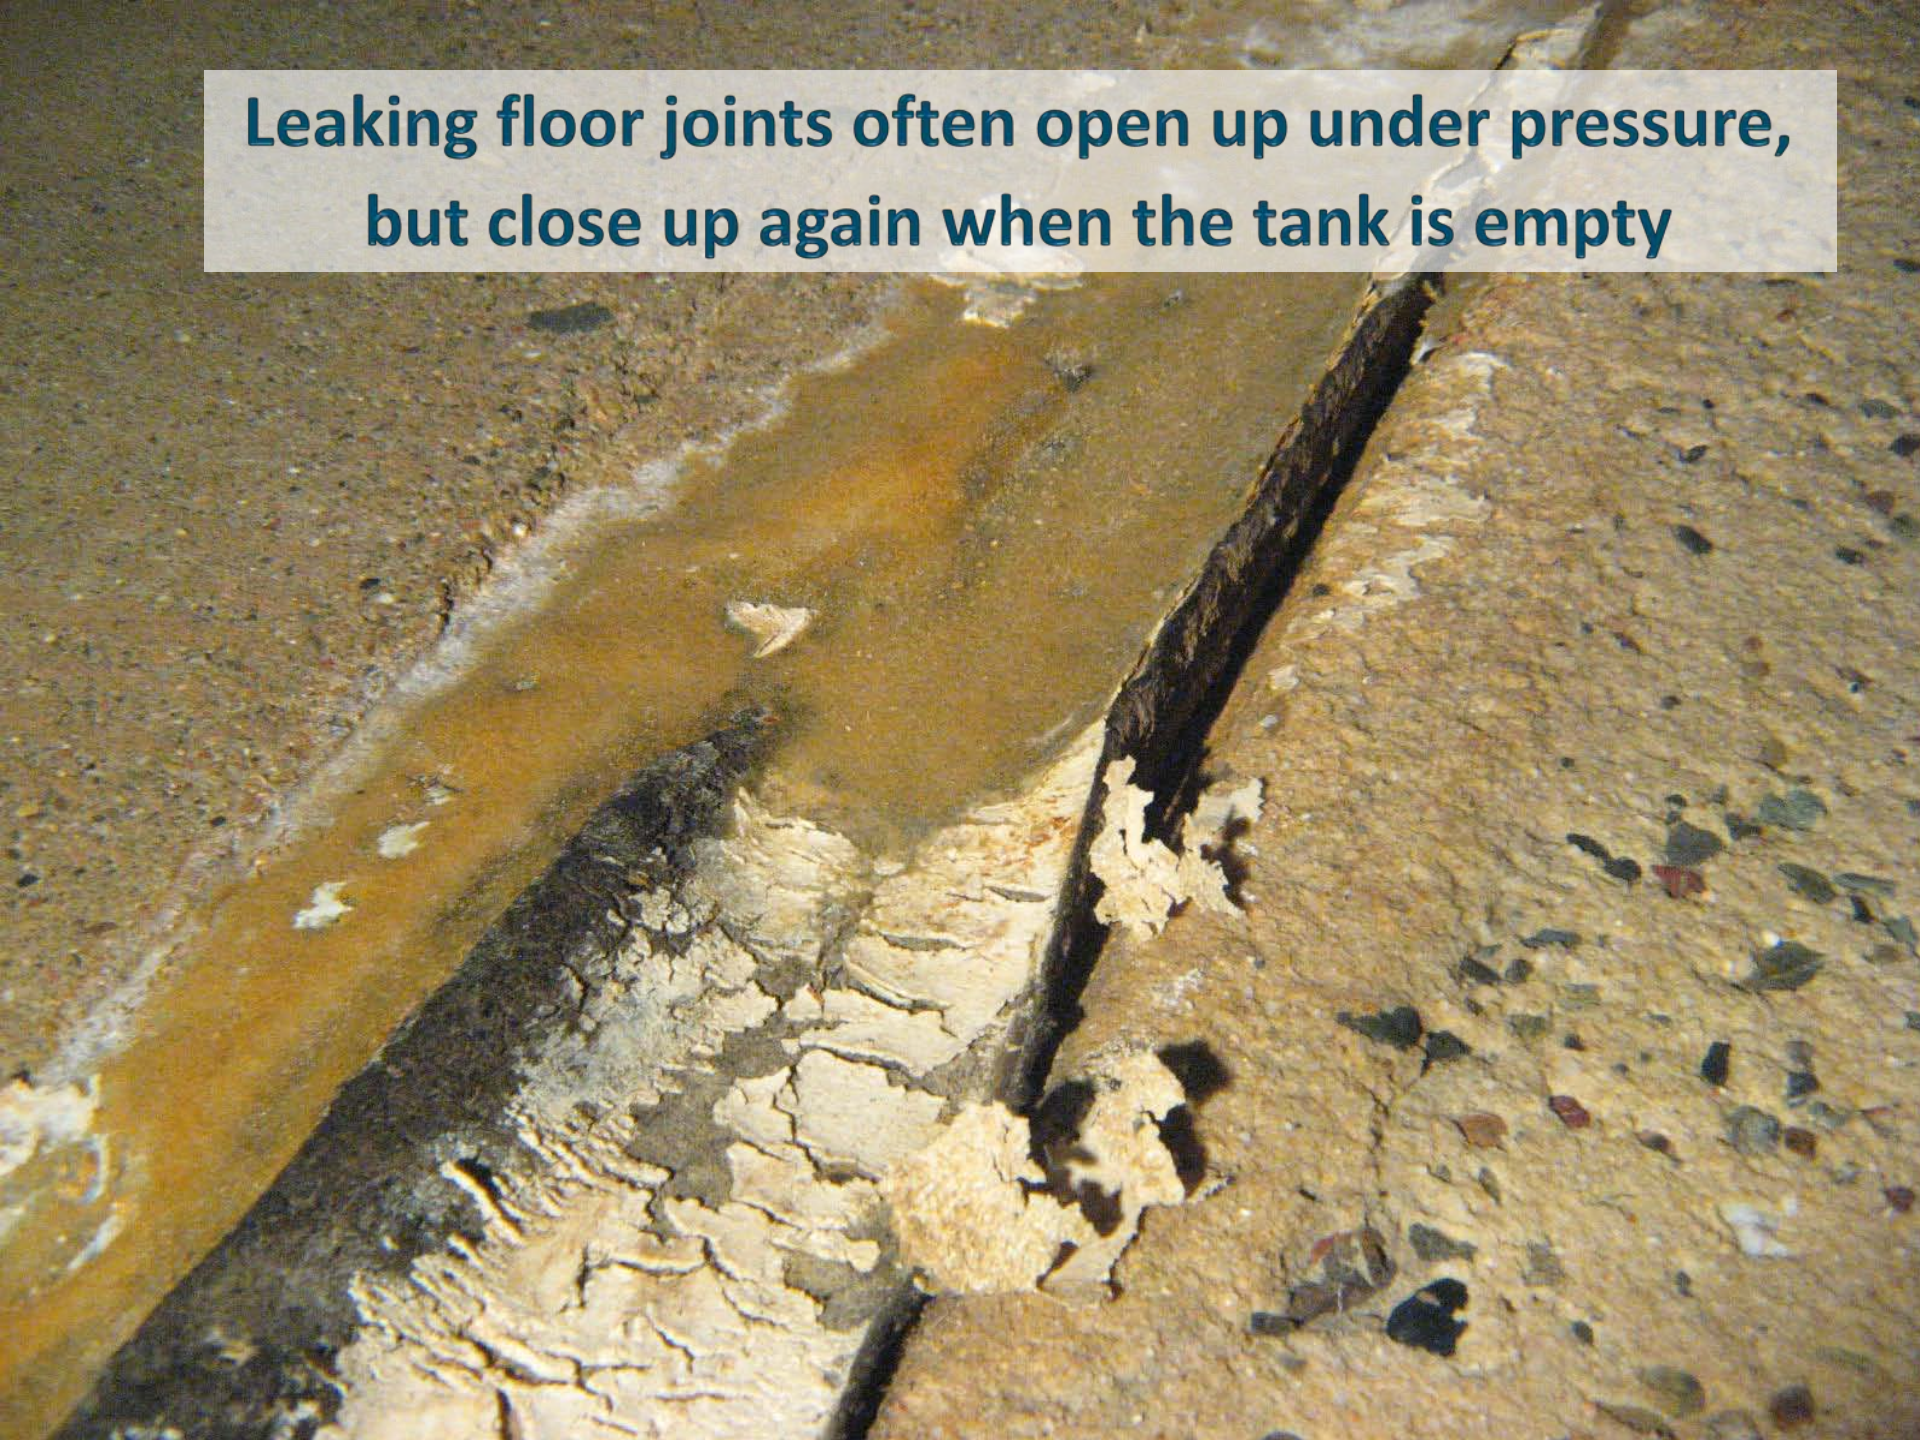
Leaks under pressure are often detected by an absence of local sediment – draining the tank will loose this evidence as the sediment will fall back into place

**Leaking floor joints often open up under pressure,
but close up again when the tank is empty**
