# Inspecting Service Reservoirs for Water Quality NOW

Jillian Busch and Dave Barry  
Aqualift Project Delivery Pty Ltd  
July 2015

# Inspection Program

82 Tanks inspected across western NSW

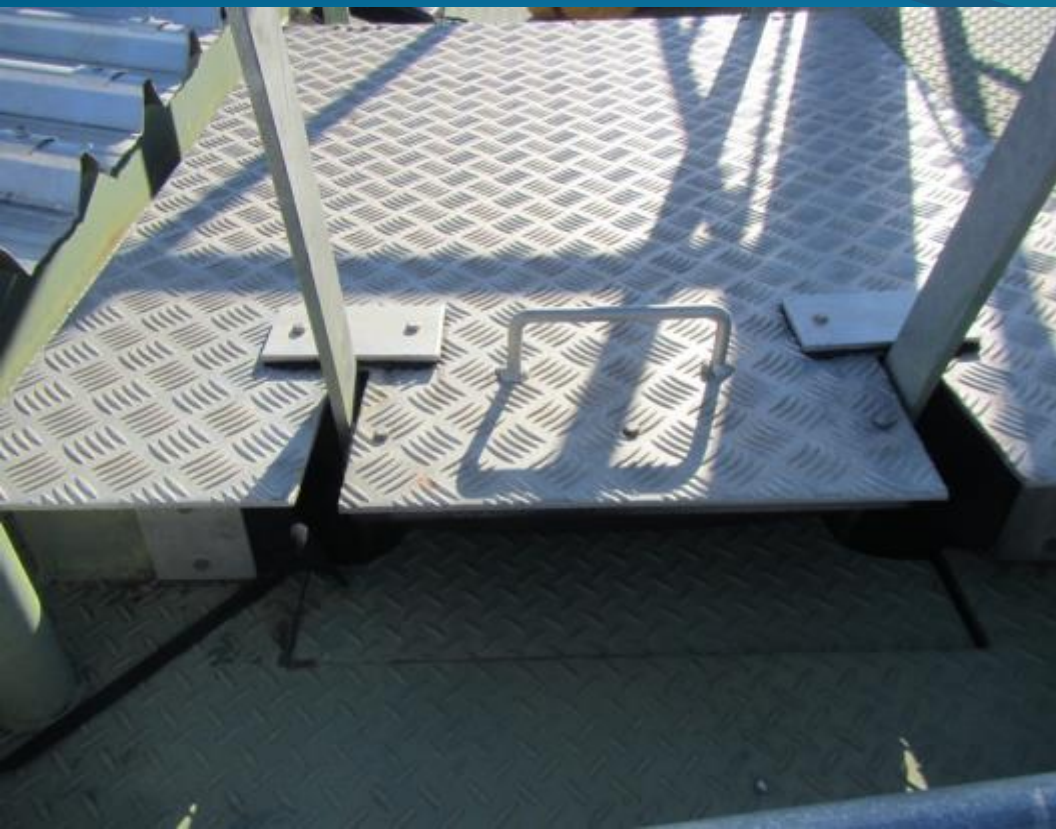
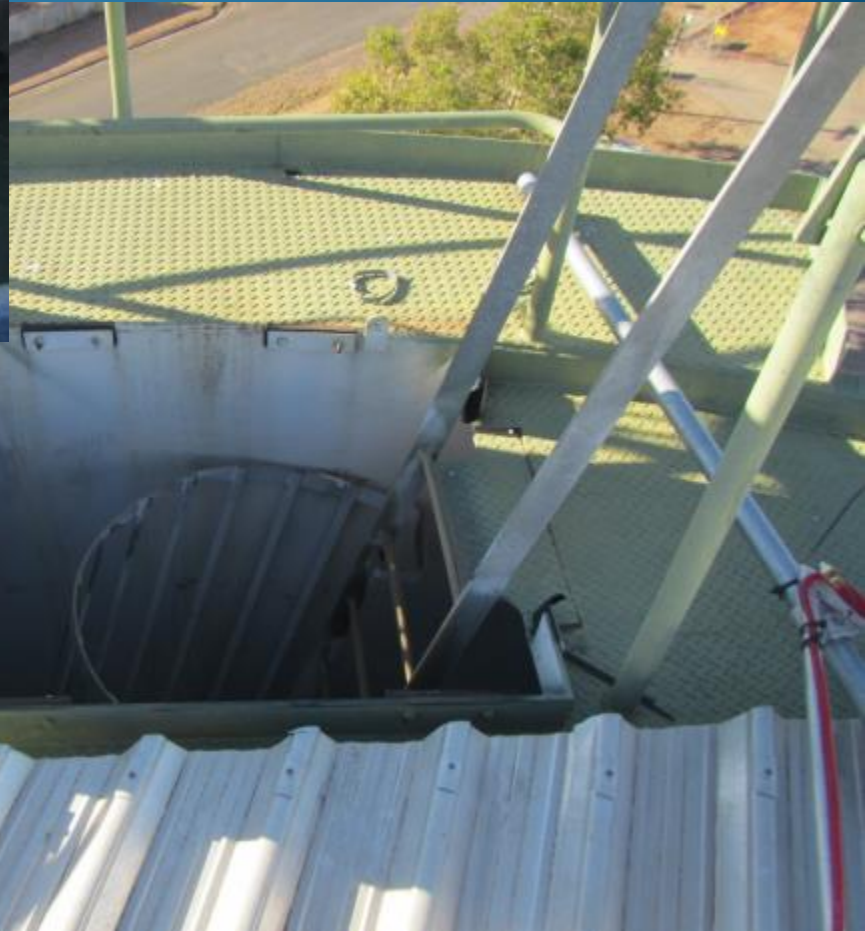
- Ladder stiles protruding
- No sealed front edge

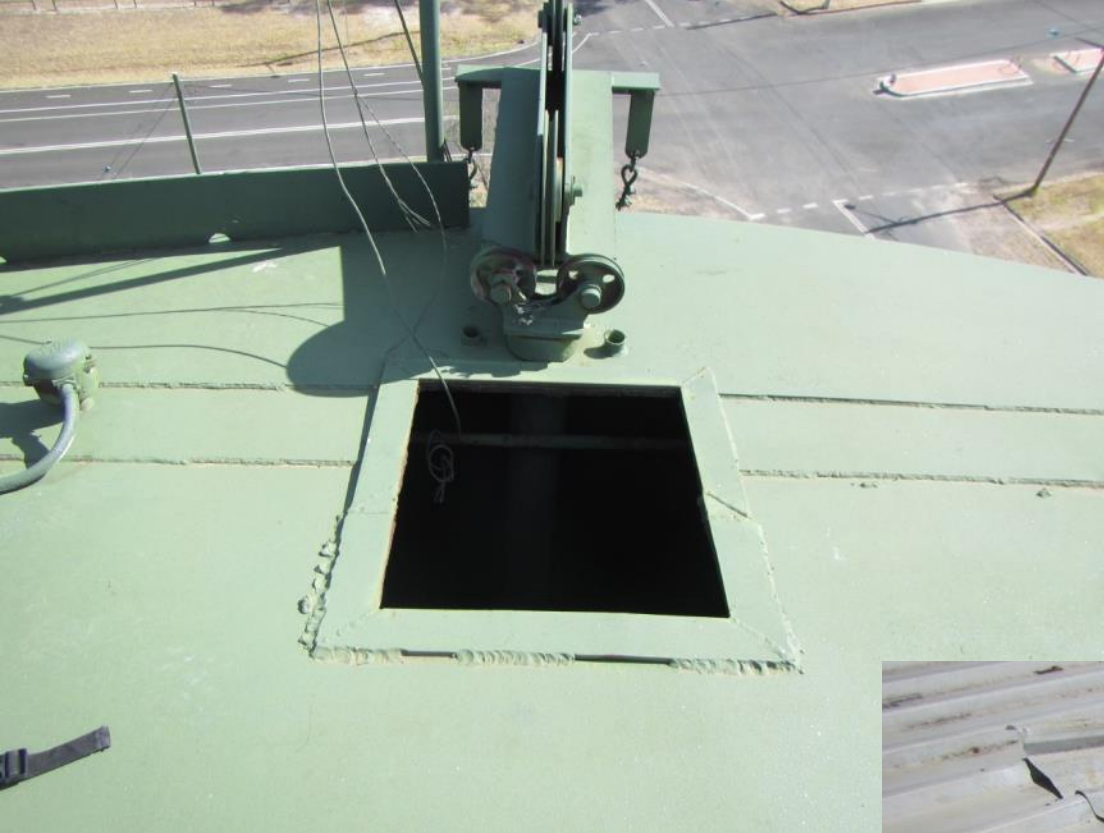
Sliding hatch cover with the same issues...

- protruding stiles
- no front edge
- faecal material entering the tank

Type 1 entry hatch frame and hinged cover required

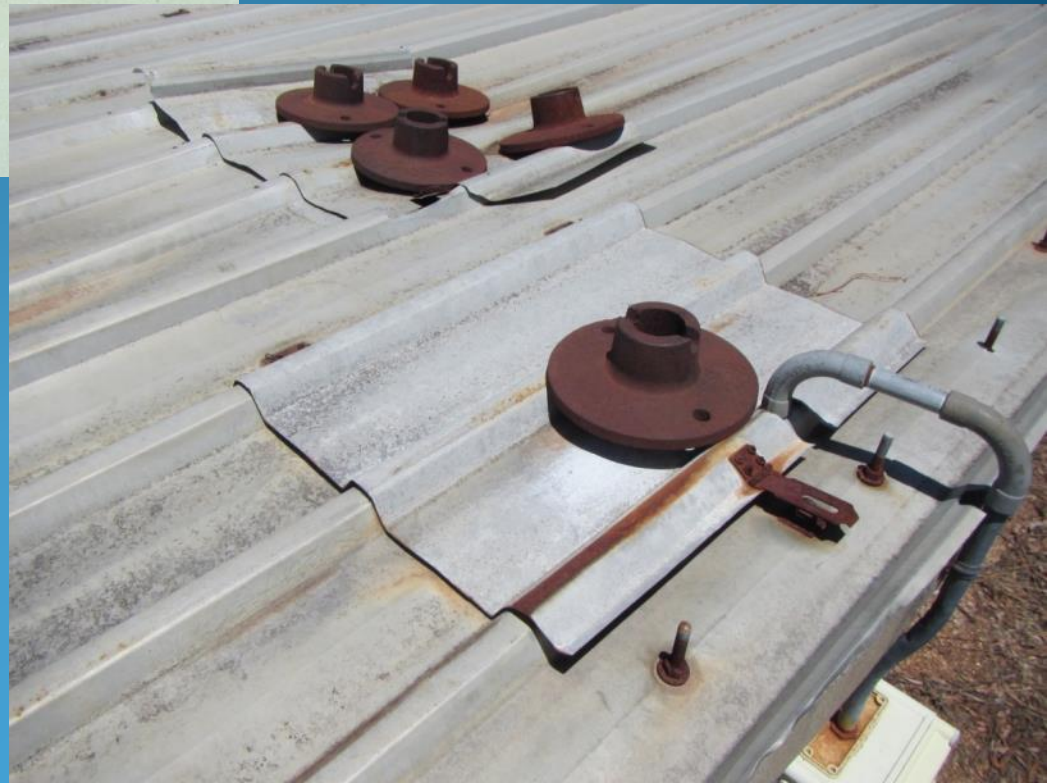
No hatch cover in place  
since the tank was  
painted...years ago!

Dead birds found inside

No effective sealing or  
security

A Type 1 Platform  
renovation suggested

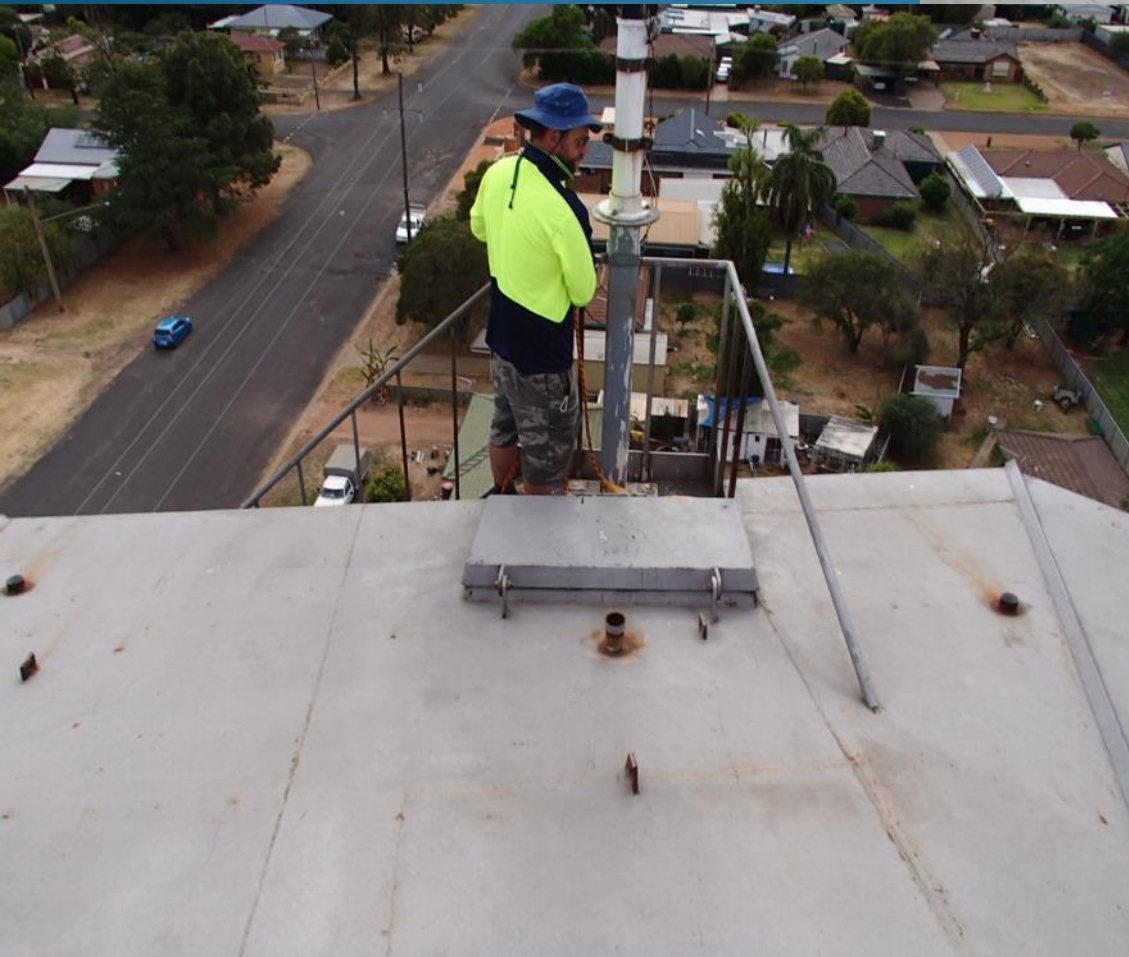
- Too small to work on or around
- No safety rails on roof edges

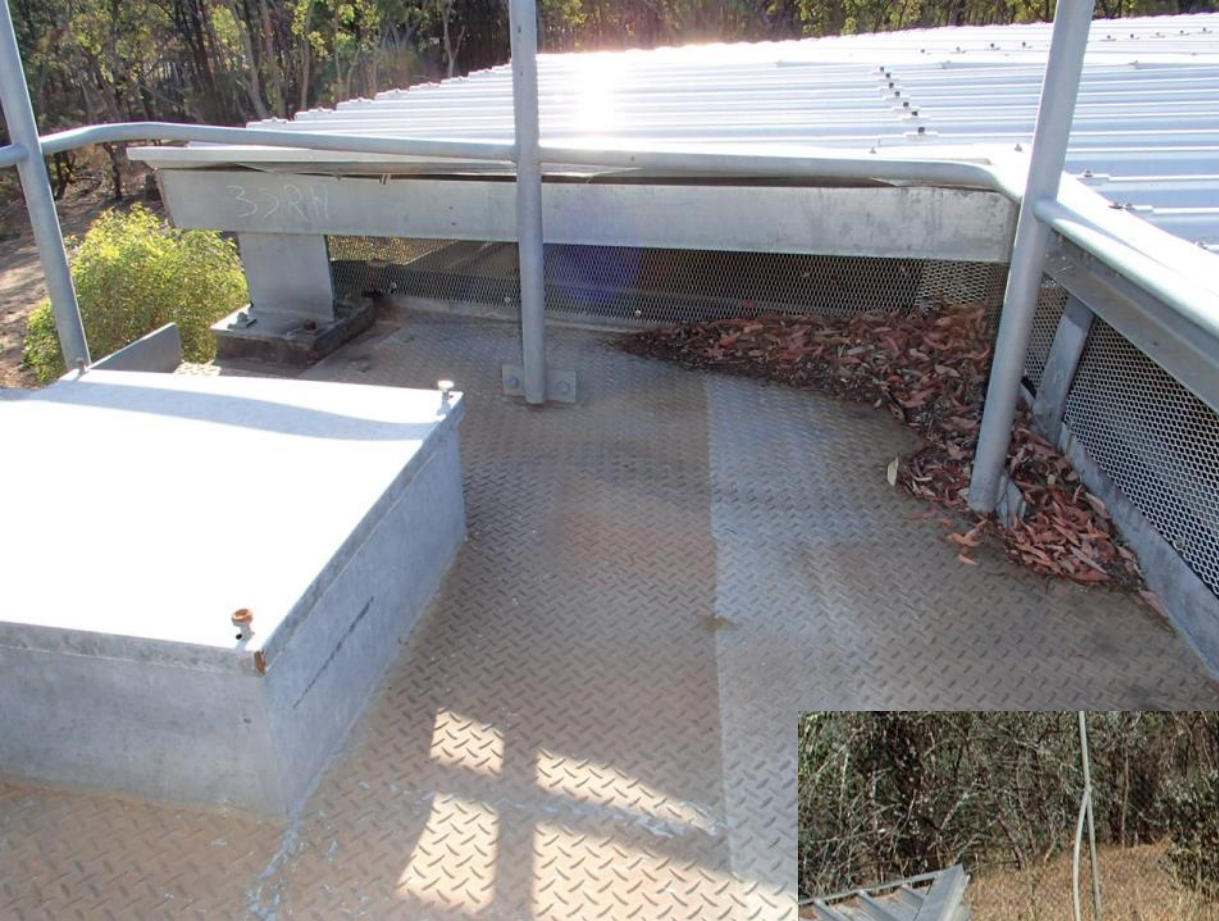
Negative fall  
allowing debris  
ponding  
- regular cleaning  
is required

Side flashings on  
roof sheet edges  
allow debris ponding

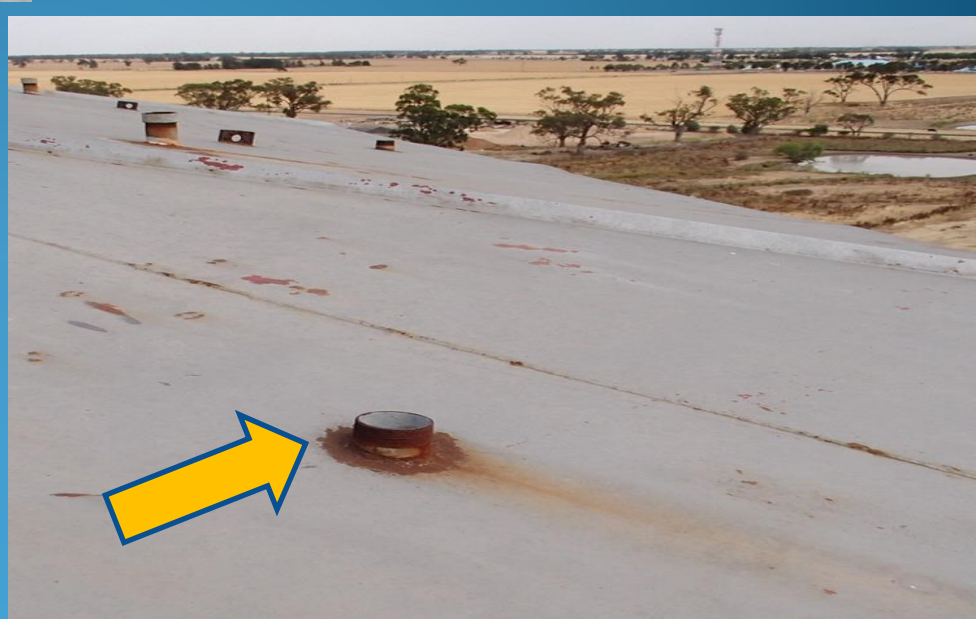
Birds and vermin can enter past these open areas

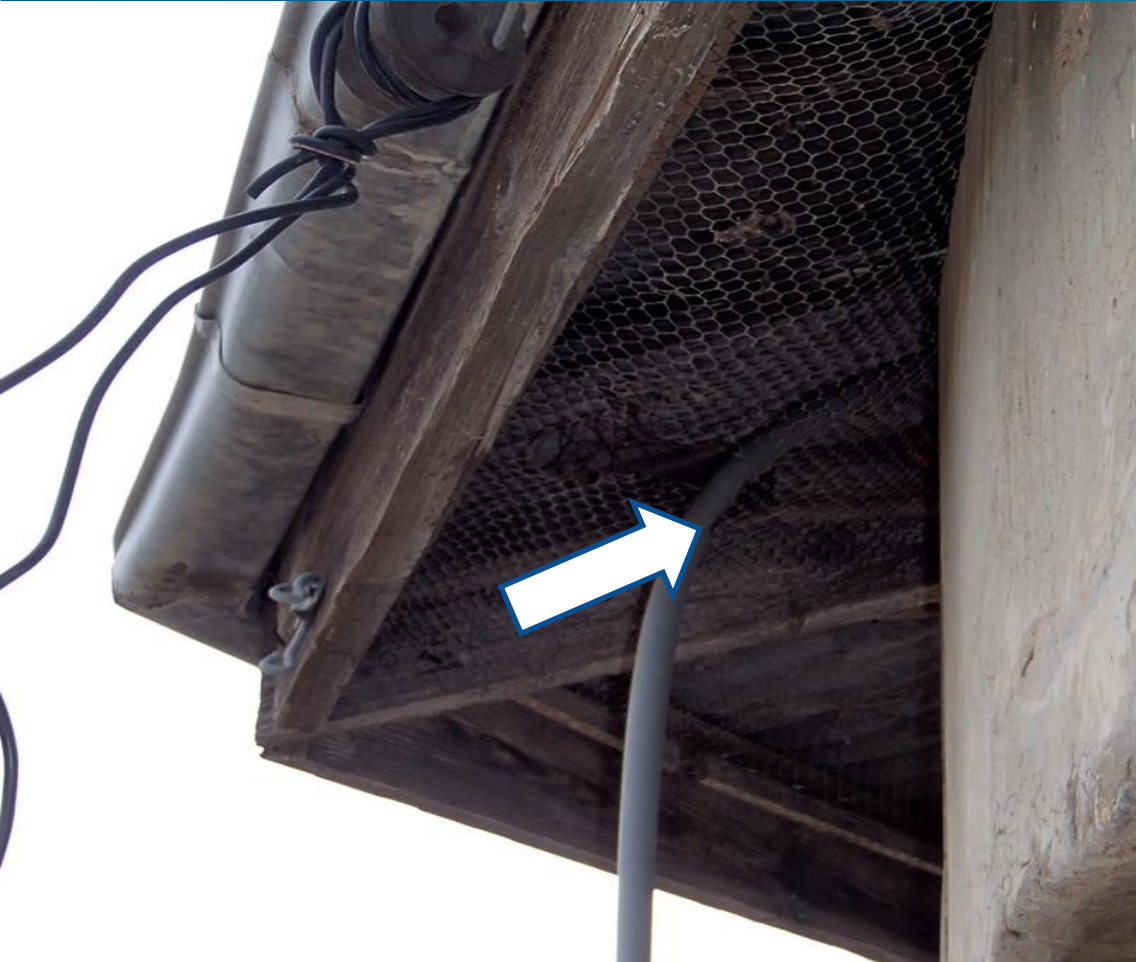
Conduits and cable entry points cause defects in vent mesh security

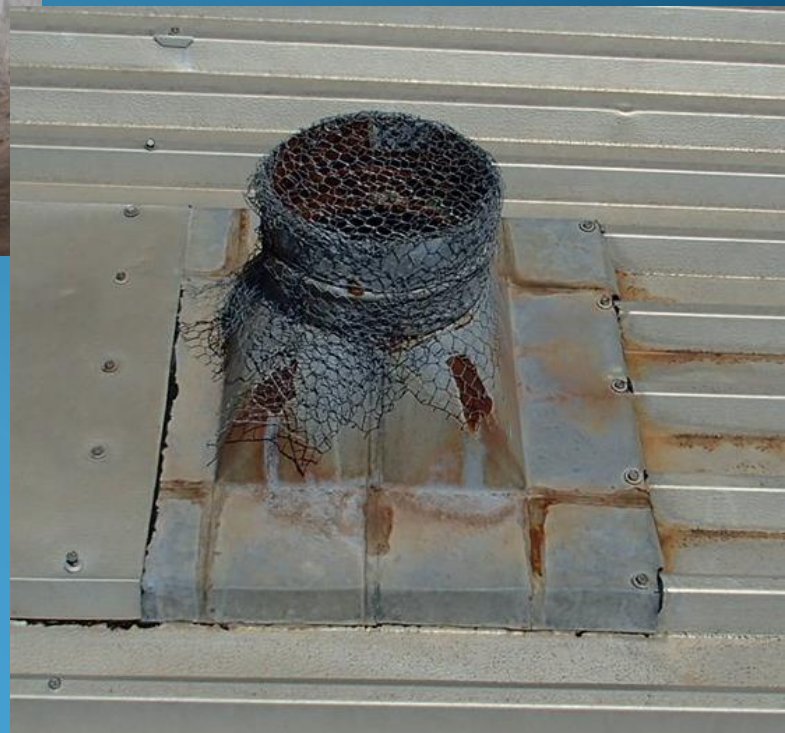
Vent turbine unit missing...  
Mesh top open to natural or  
deliberate contamination event

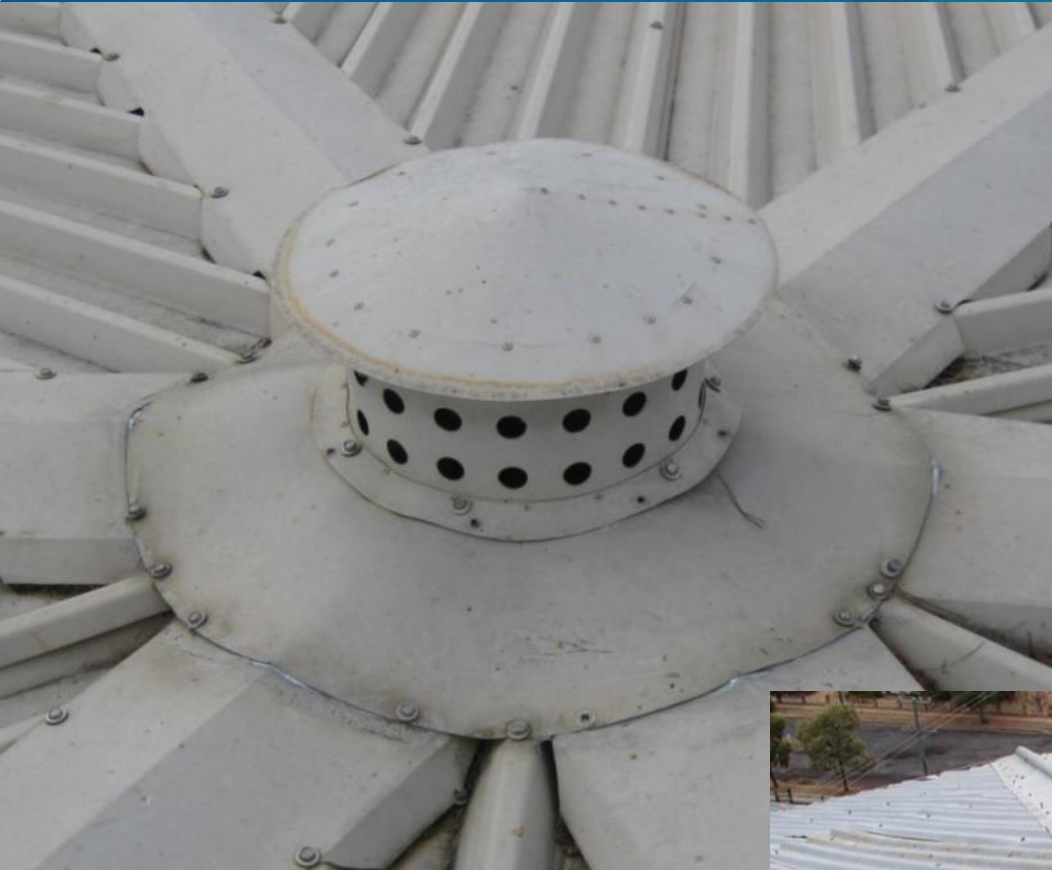
Vent holes too large  
– not vermin proof

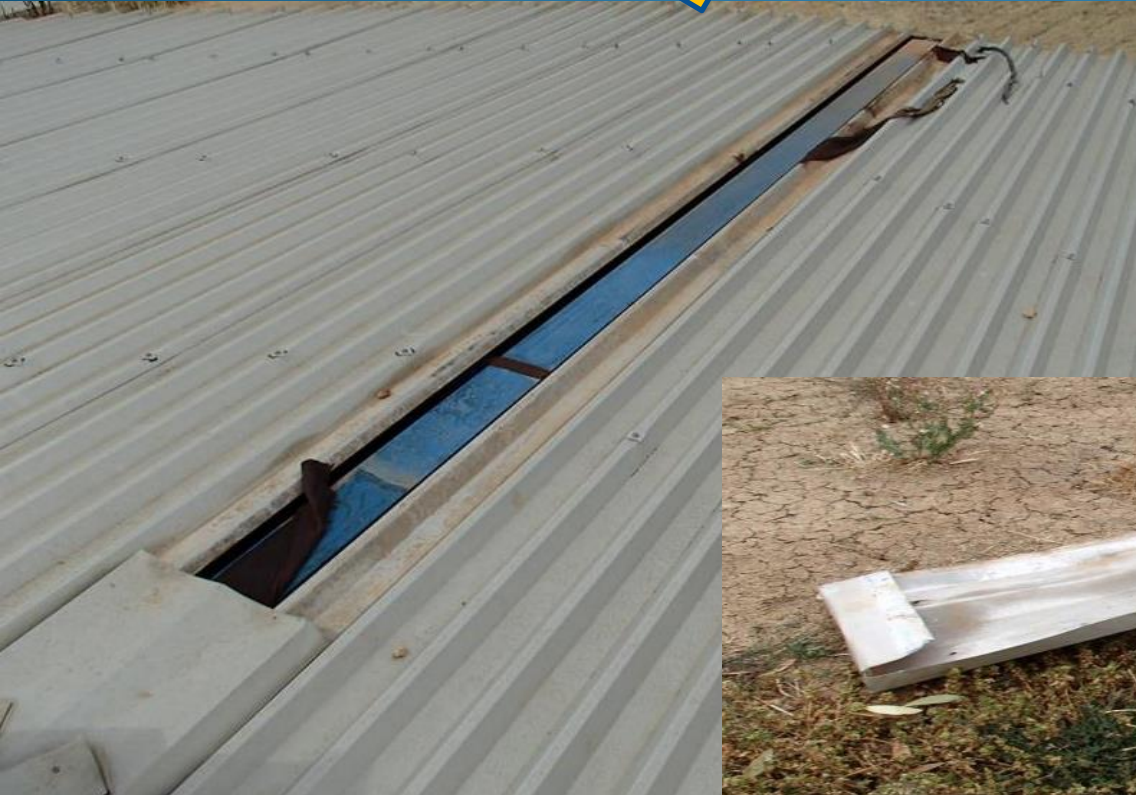
Flashings are unsecured  
and will become wind damaged  
in the future

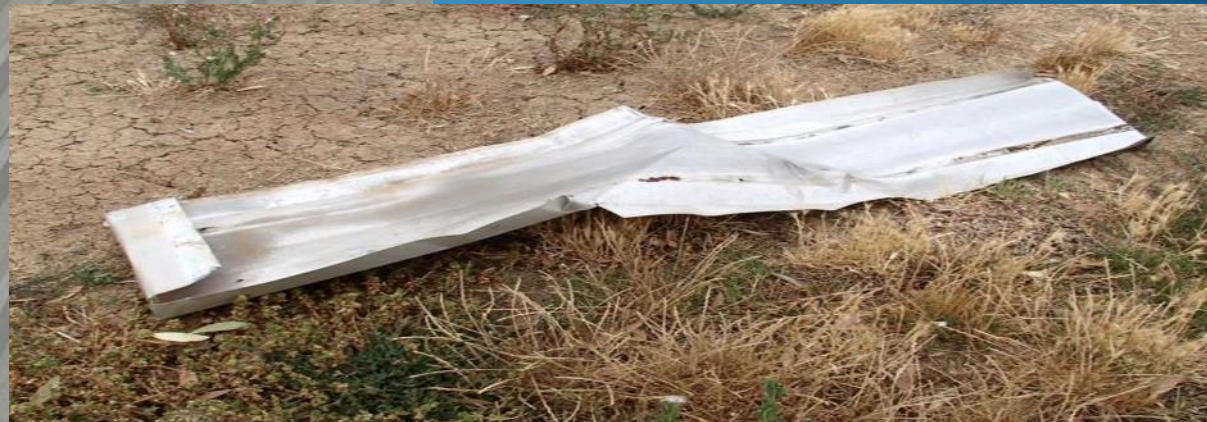
Flashings torn away  
due to wind damage

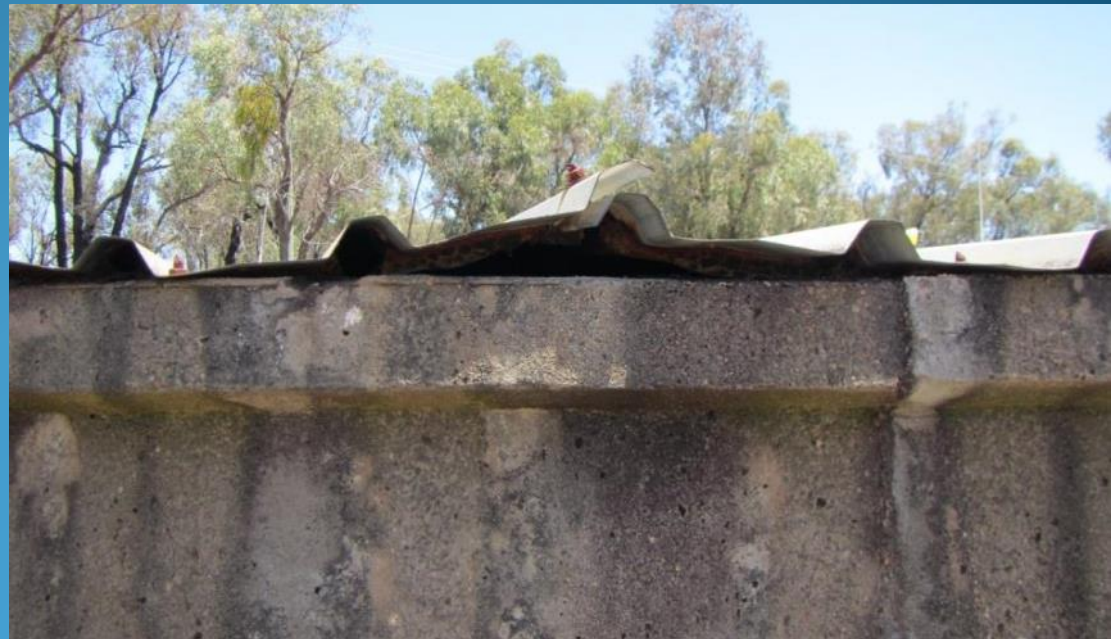
Roof sheets and flashings not secure...

- prone to wind damage

Roof sheet edges are not secured

- vermin can enter tank
- wind damage may occur

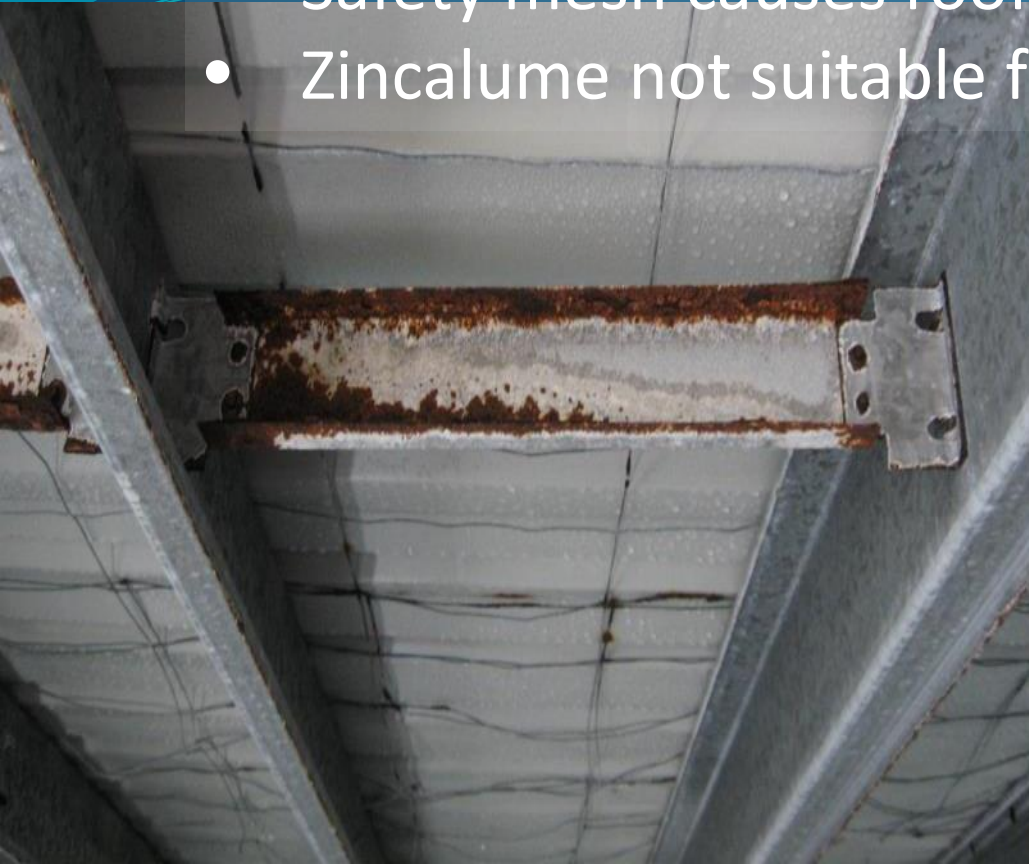
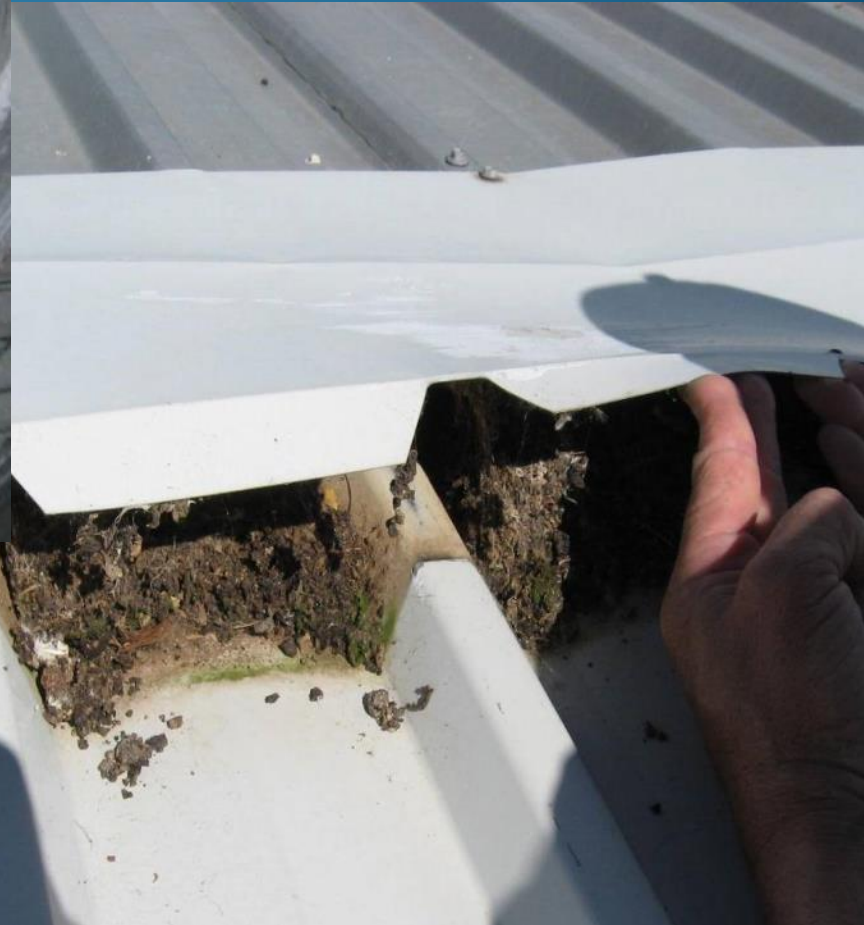
## Corrosion damage after 7 years!

- Safety mesh causes roof sheet damage
- Zincalume not suitable for humid & under roof areas

Debris collects under roof flashings

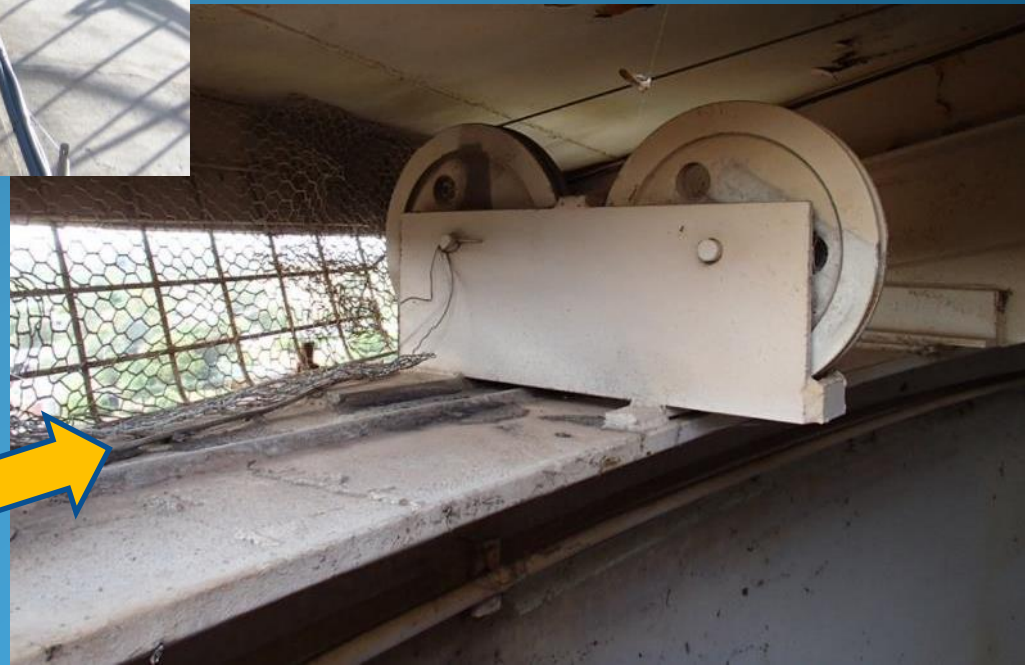
Pulley cover boxes are often open on the underside

Vent mesh is often damaged where cables pass through

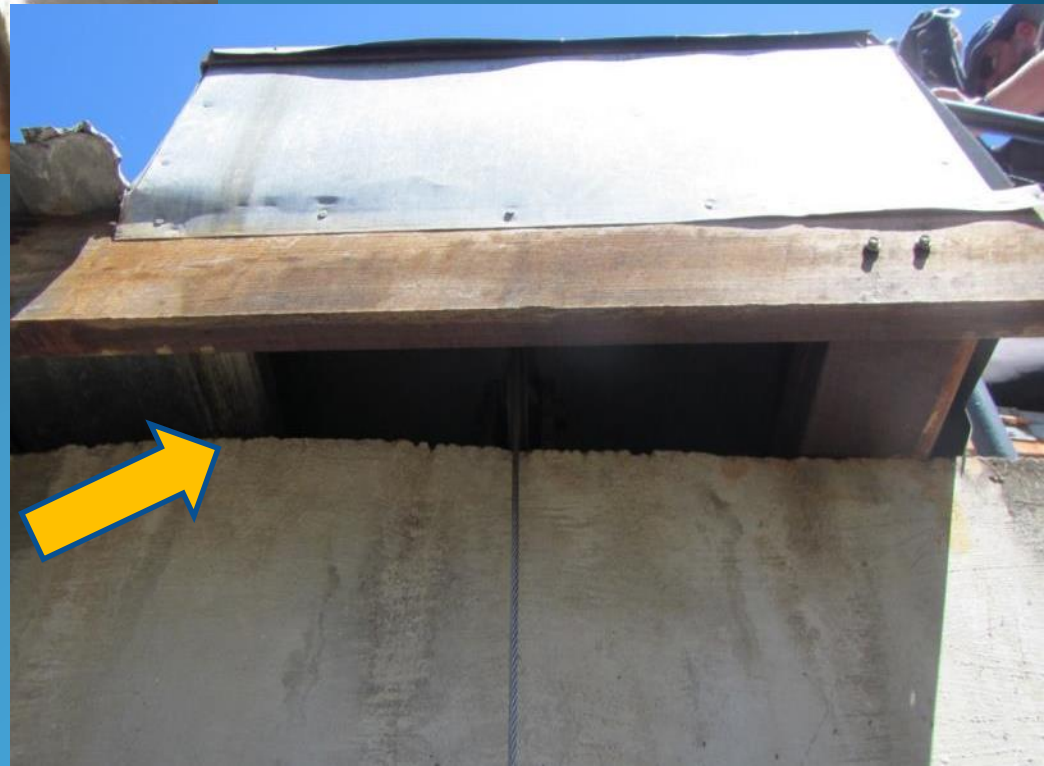
Level pulley systems  
often create bird and  
vermin entry areas

- Remove level indicators & remove the problem
- Learn to rely on telemetry instead

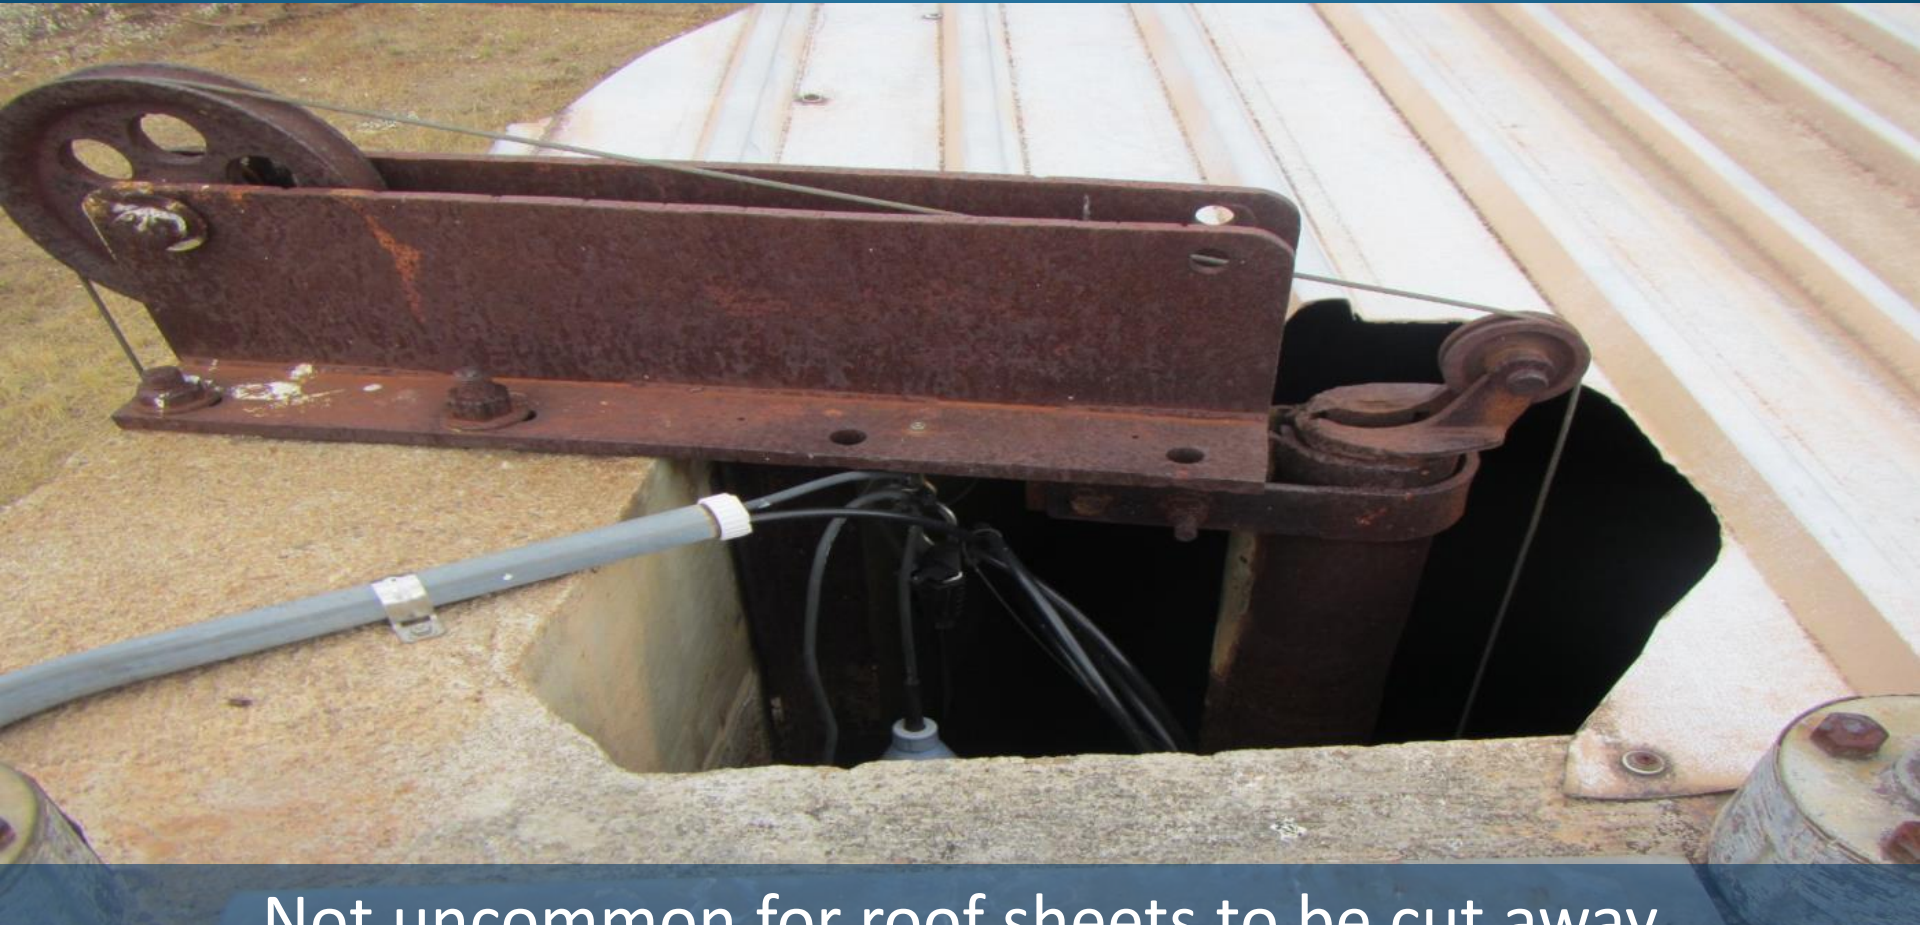
Not uncommon for roof sheets to be cut away to accommodate level pulley systems

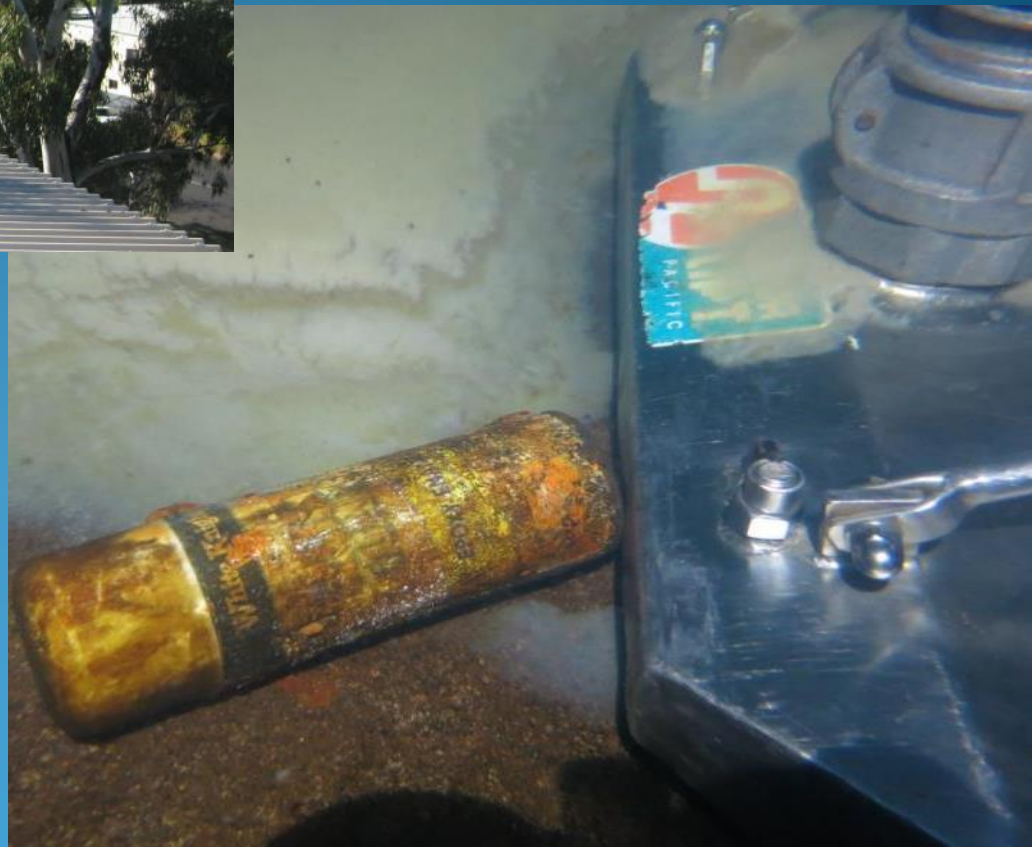
Overhanging trees allow vermin entry to roof area

Excessive sediments & vandal debris

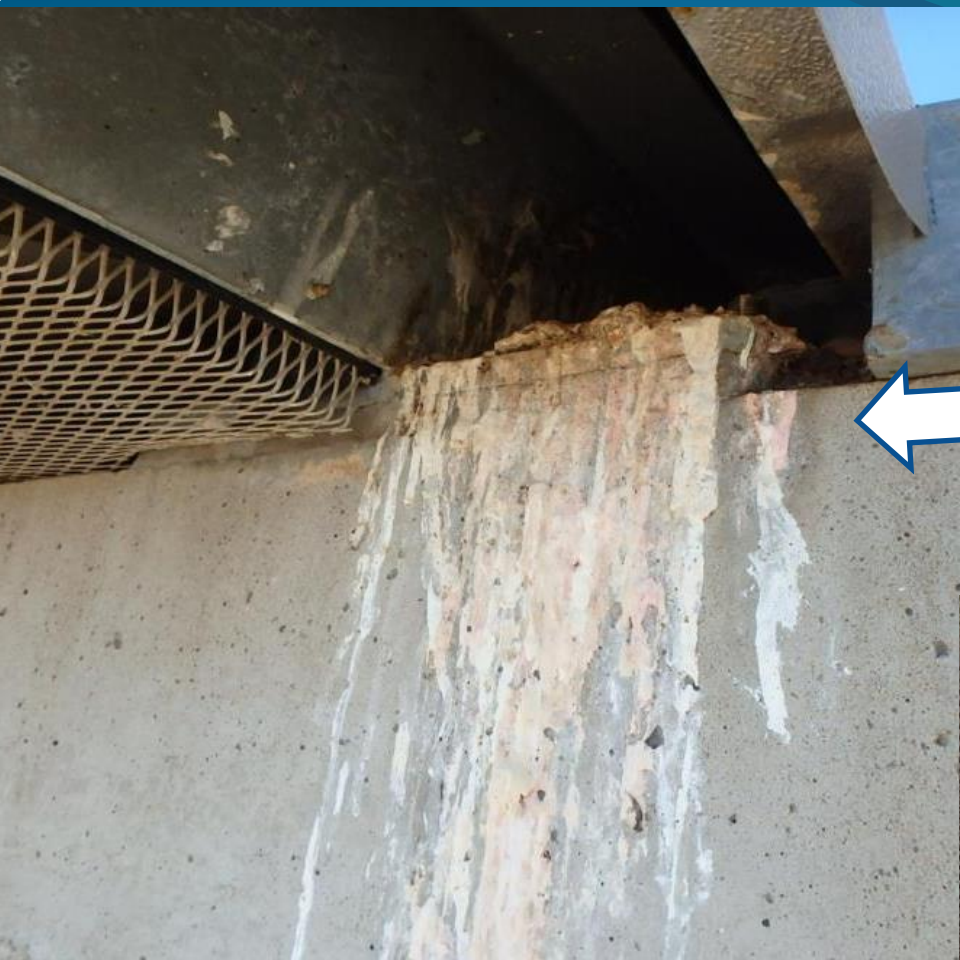
Obvious bird entry area –  
note the faecal evidence of  
birds roosting (and drowning)  
for a considerable time

Quickly fixed with mesh and  
an EWP!

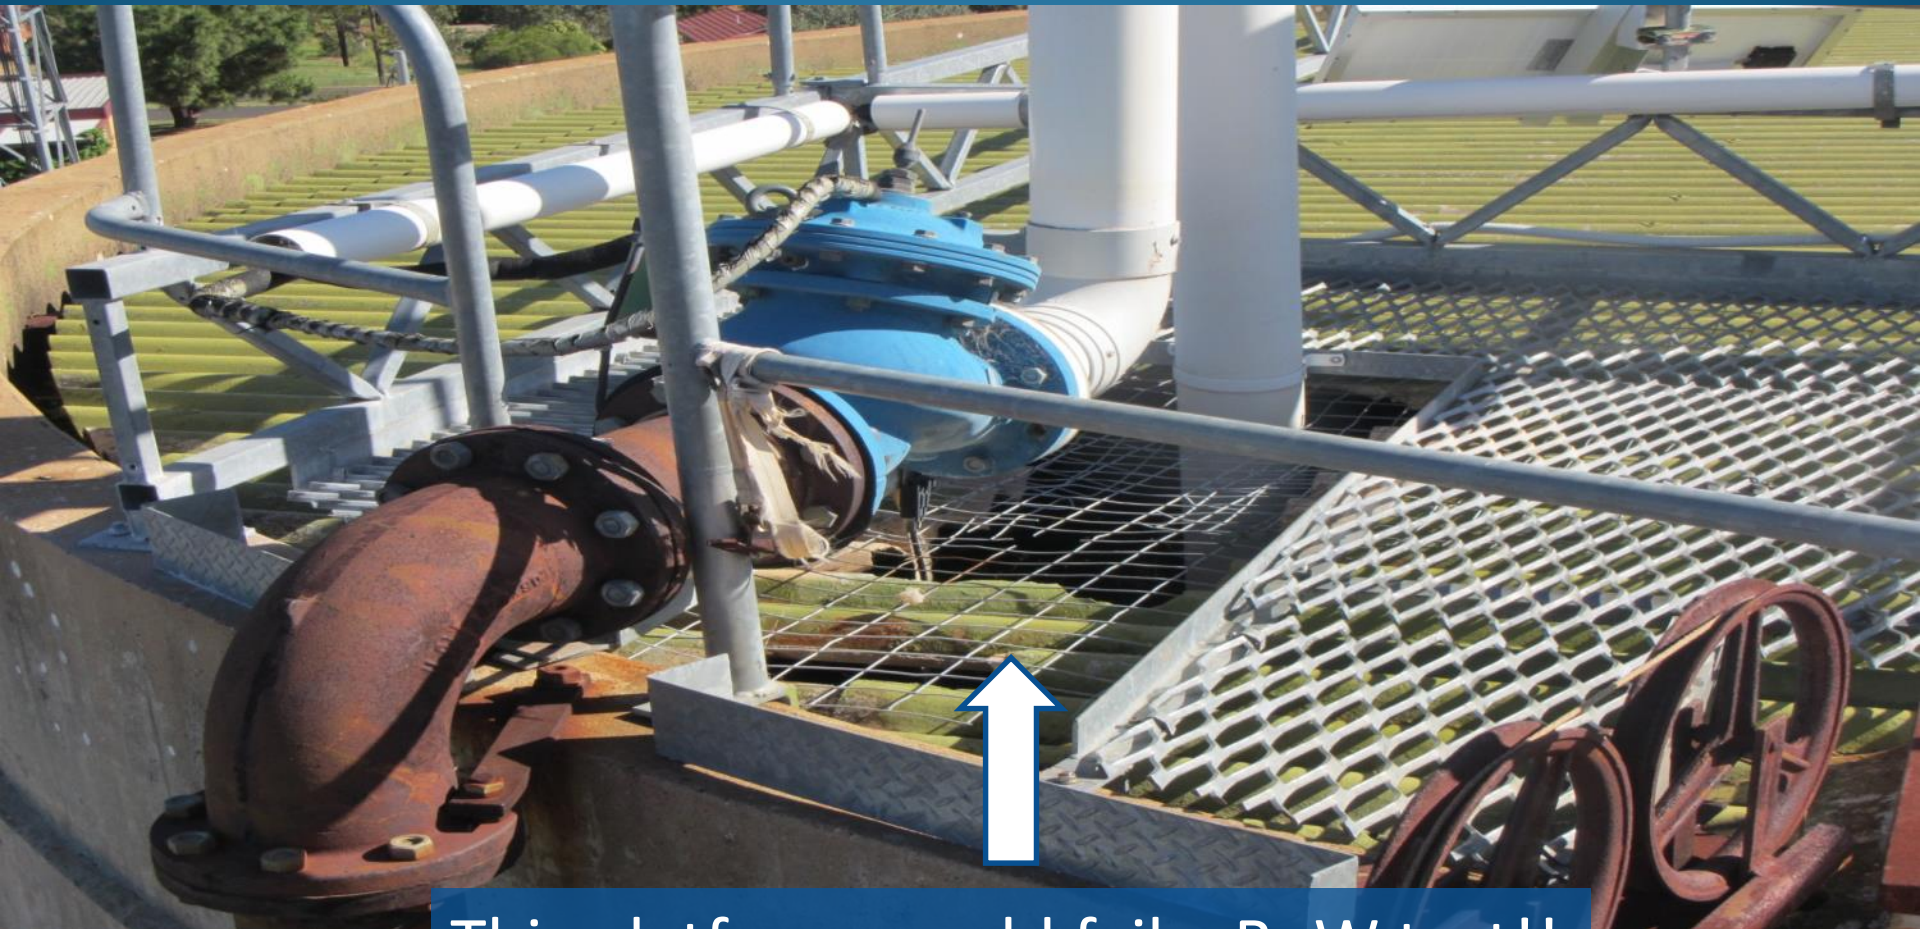
This platform would fail a BoW test!!

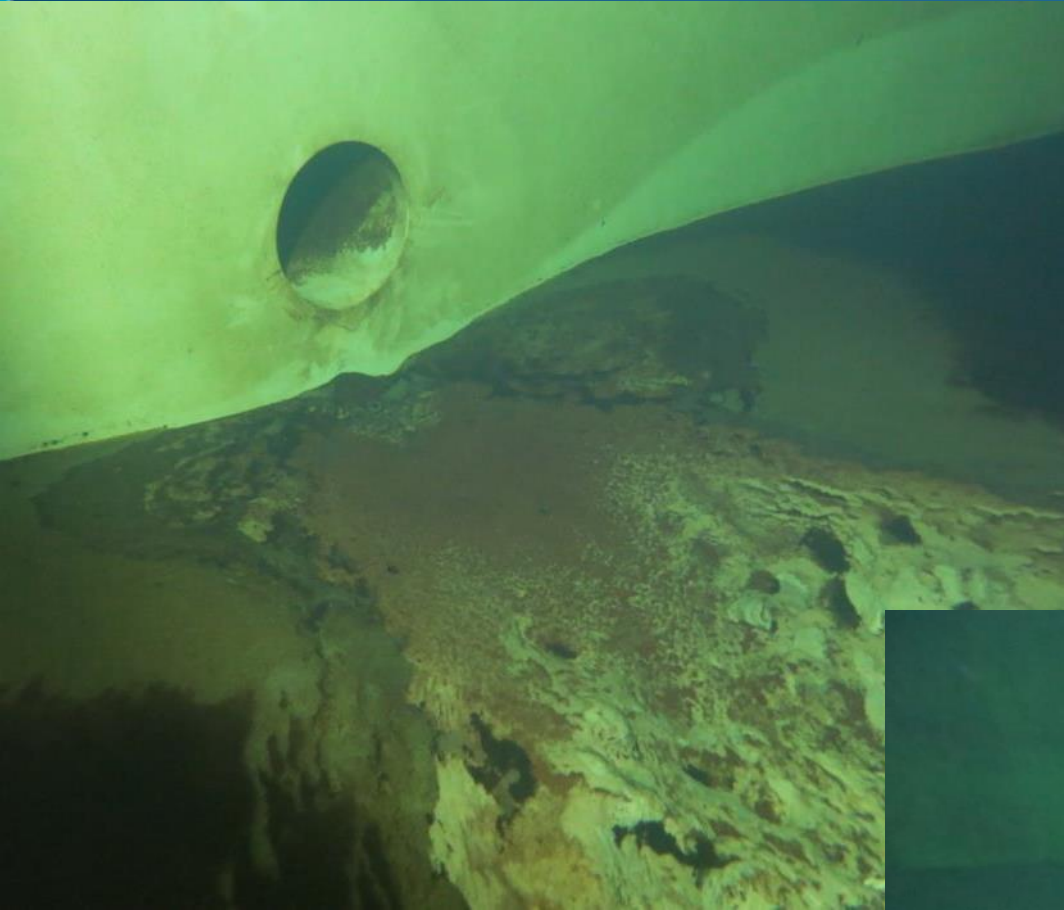
The penetration is 200mm diam, so.... sediment is 300mm deep at least!

Sediments are being displaced & stirred up during filling cycle  
- a directional nozzle is required

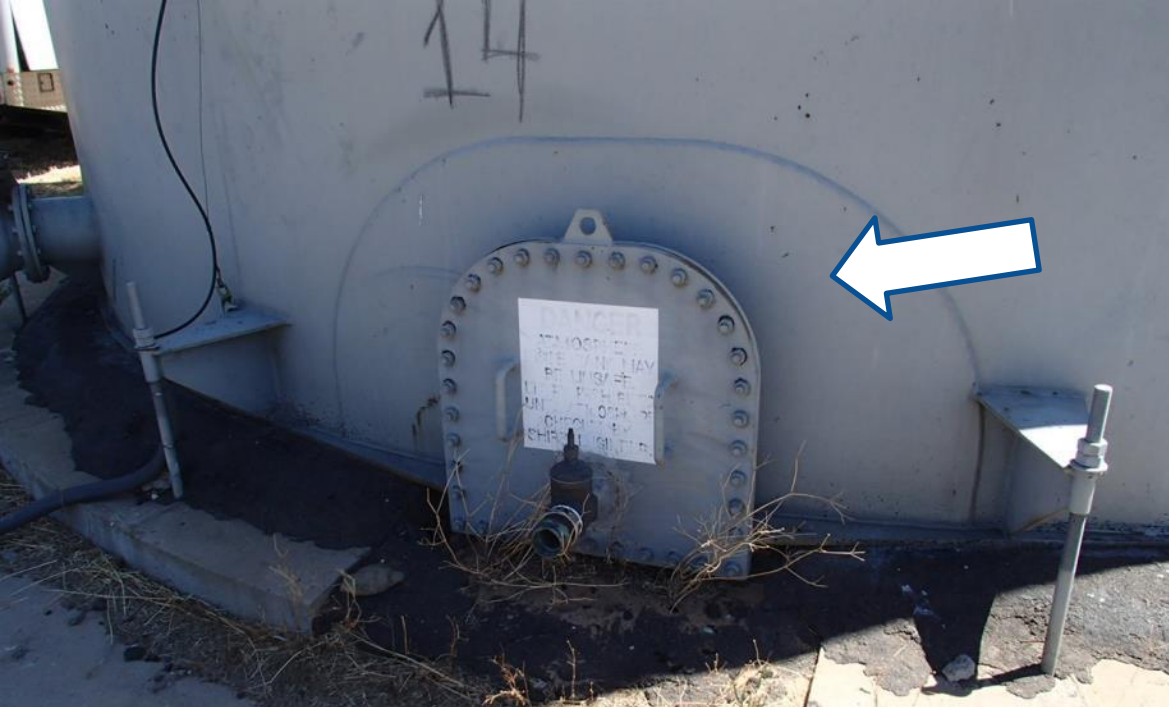
Wall hatch height  
from the outside

The same wall hatch on  
the inside....  
400mm + of sediment!

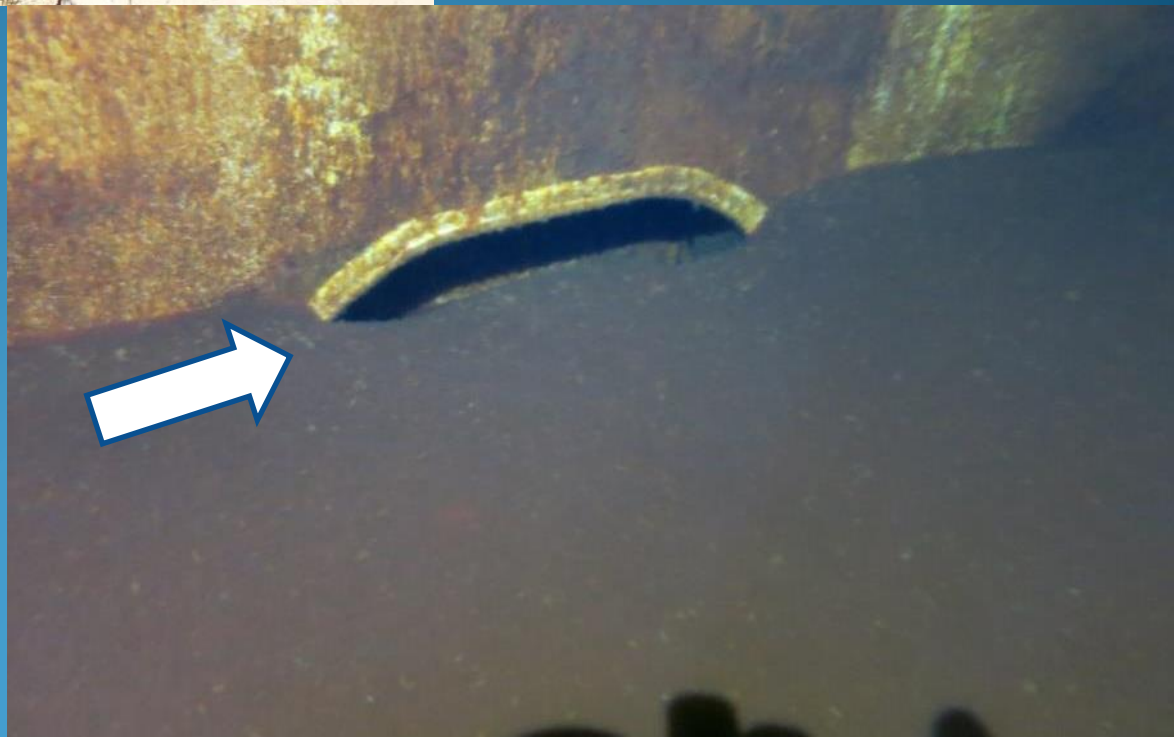
Foot prints –  
supposedly cleaned  
6 months previous

Wall step not cleaned

Cut line obvious –  
uncleaned area remaining
