# Inspecting Service Reservoirs for Water Quality NOW

Jillian Busch and Dave Barry  
Aqualift Project Delivery Pty Ltd  
July 2015

# Inspection Program

82 Tanks inspected across western NSW

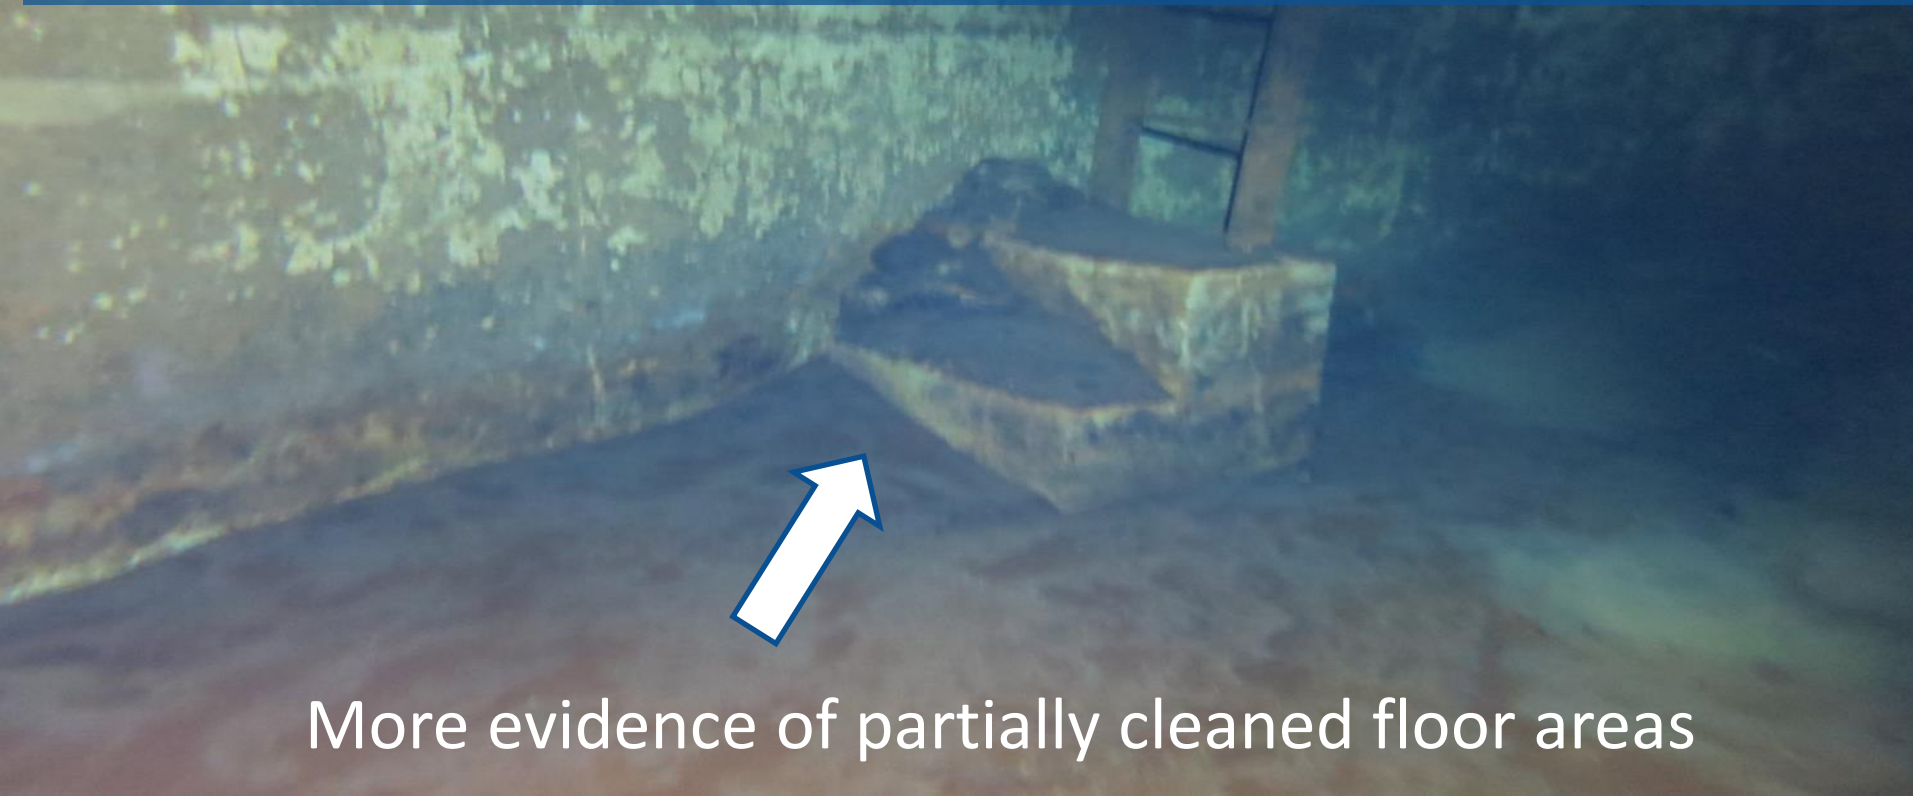
More evidence of partially cleaned floor areas

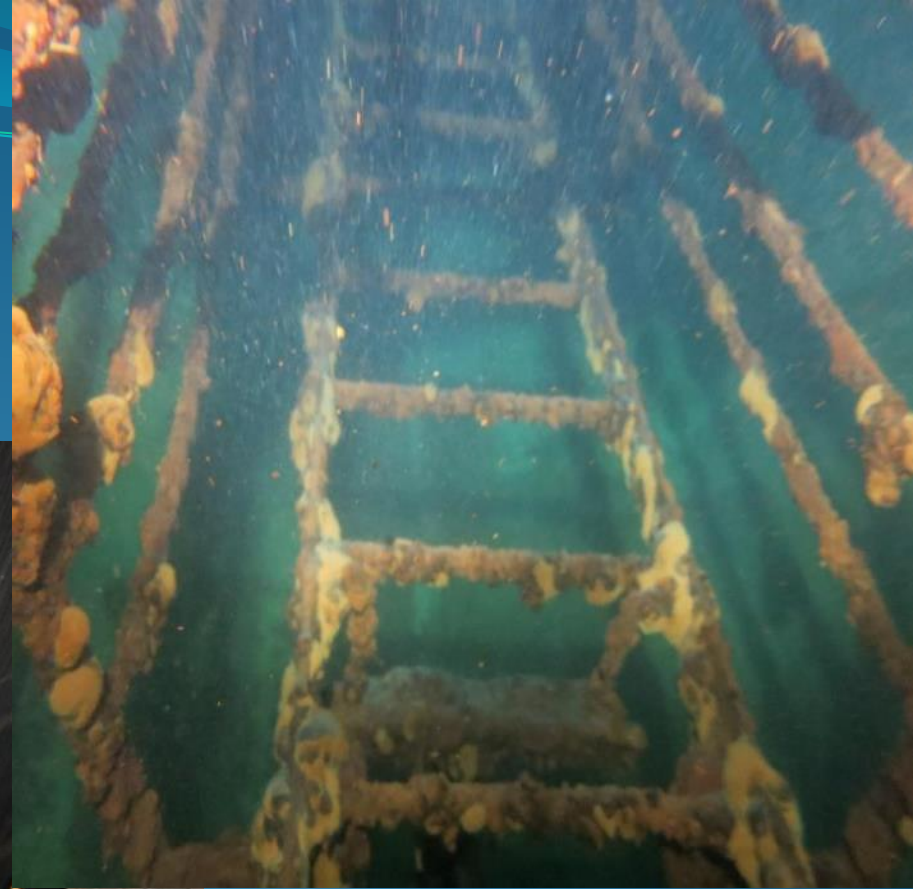
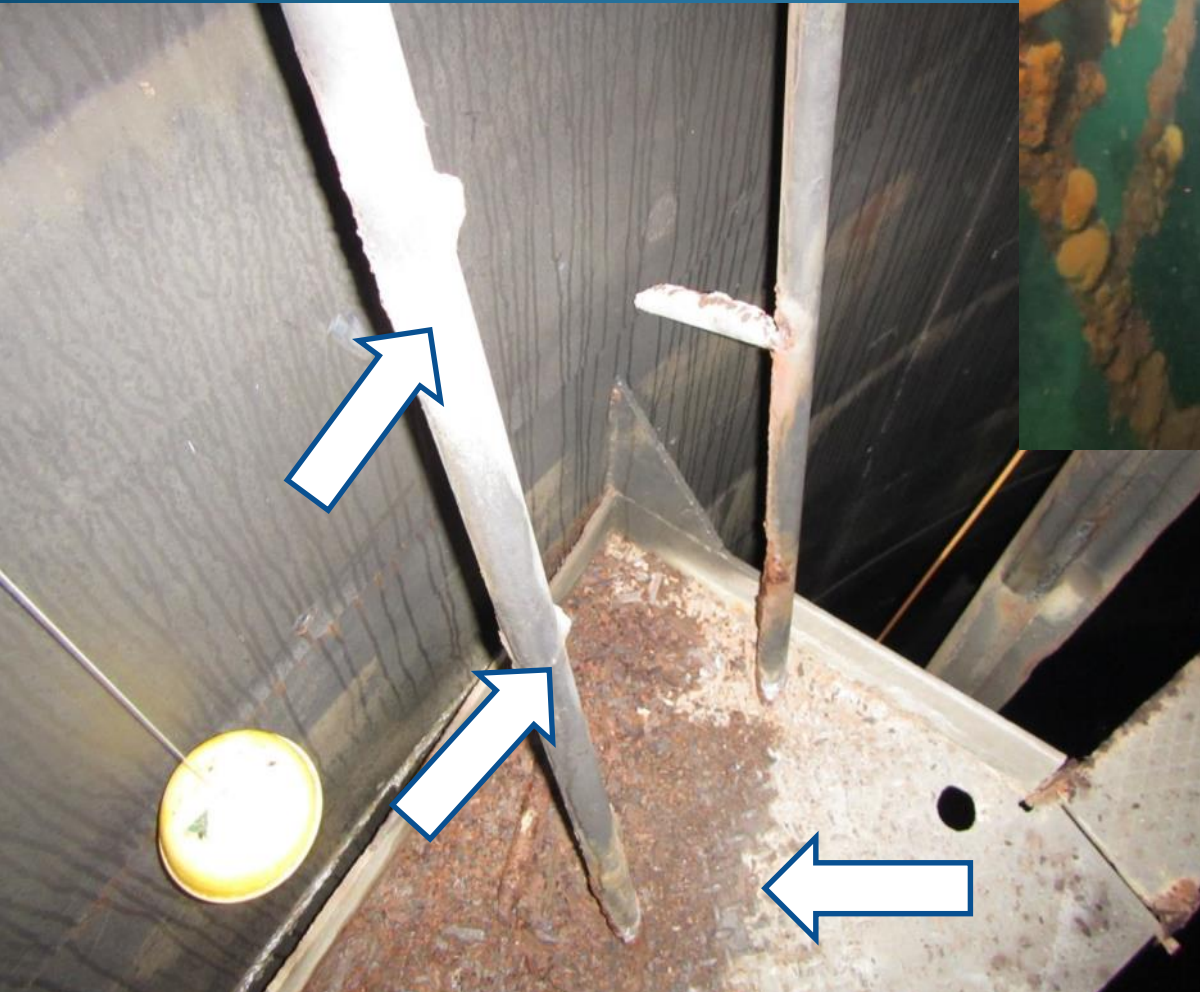
The rungs are now rust!!

Not safe to use..  
wet or dry!

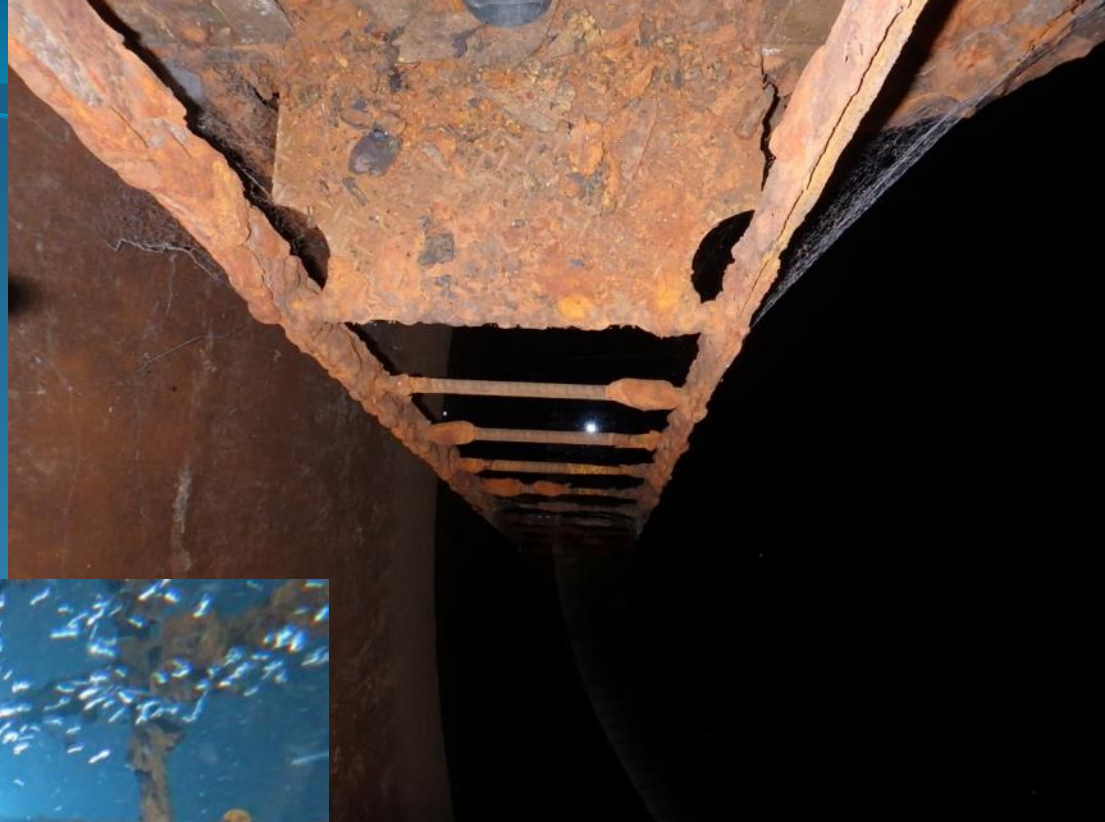
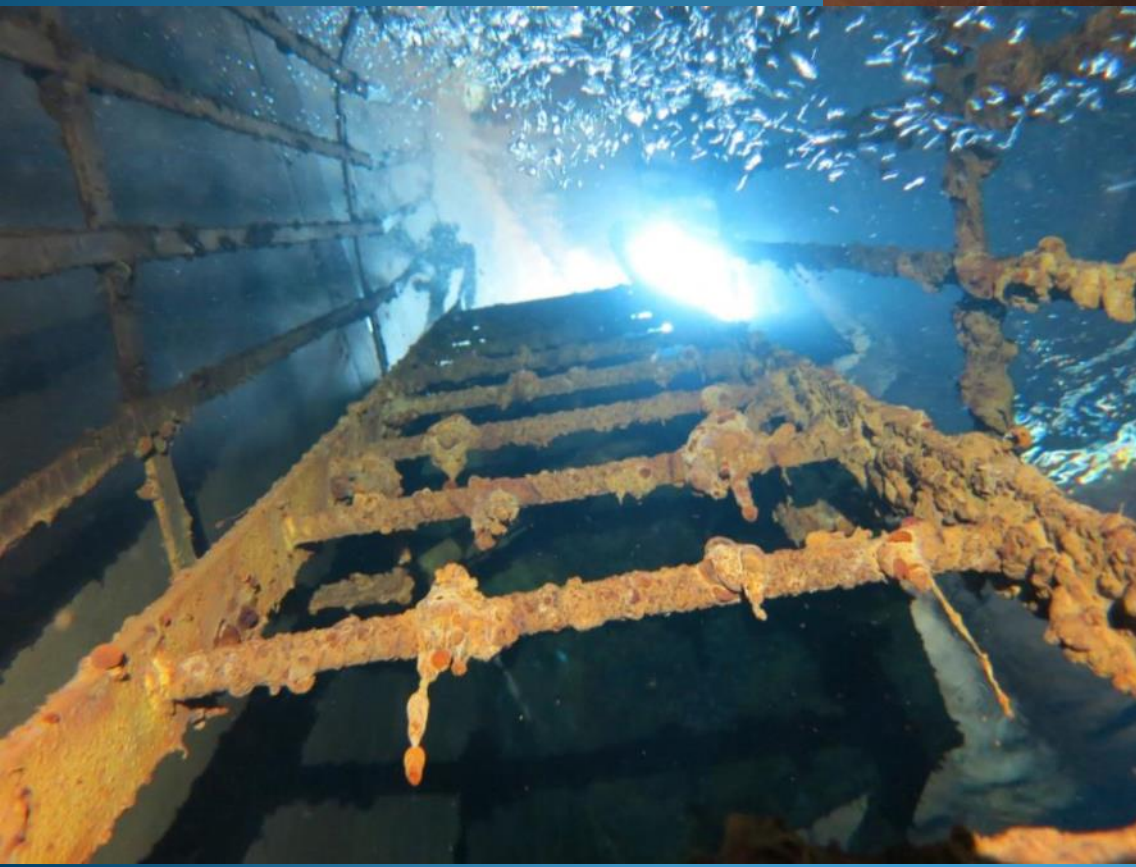
Corroded products  
create chlorine  
demand

- Remove heavily corroded ladders & platforms
- Simplify new ladder design to vertical, no platforms or cages
- Not all FRP units are approved or suitable
- Use Nextep FRP - WSAA approved product

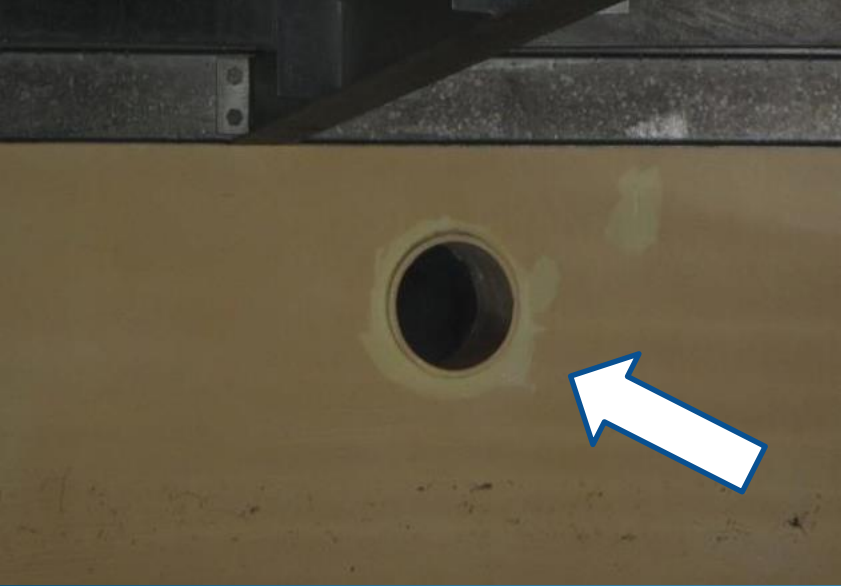
The internal overflow is  
now a simple hole  
in the wall

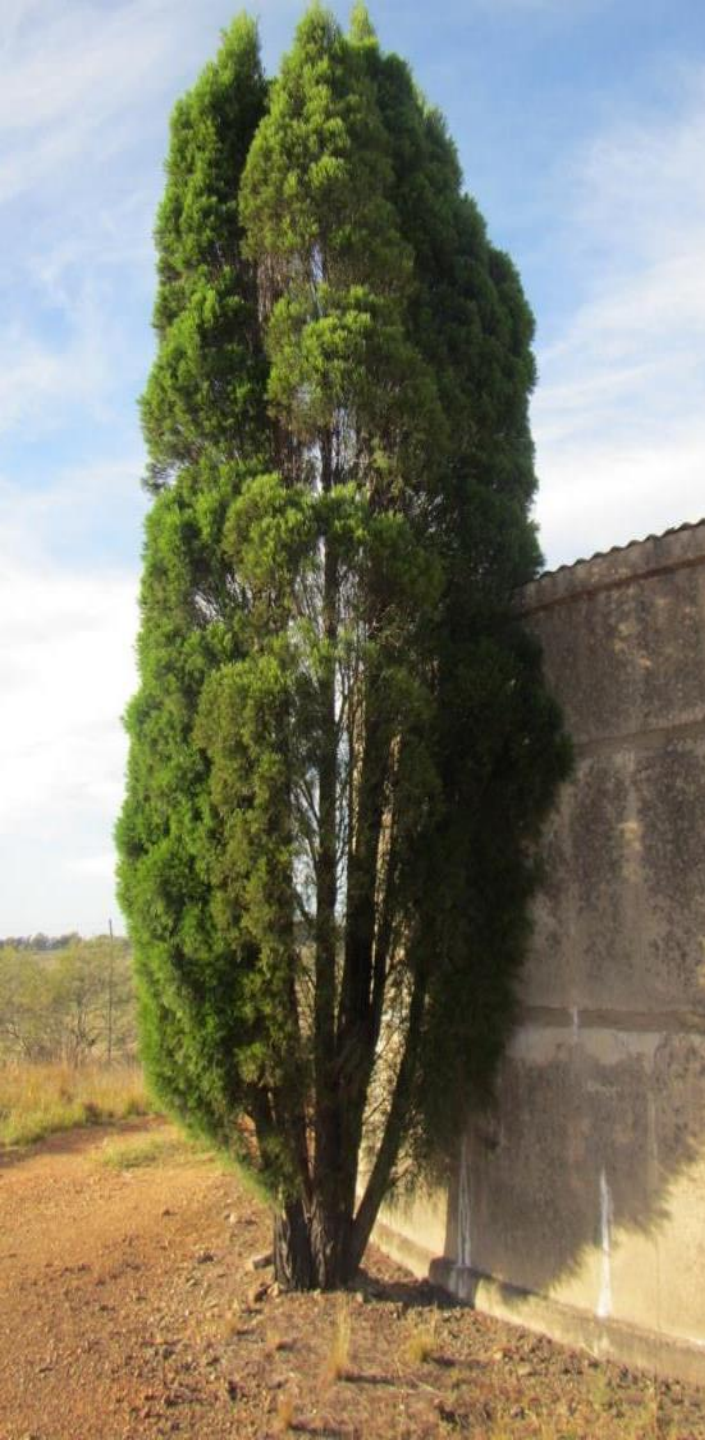
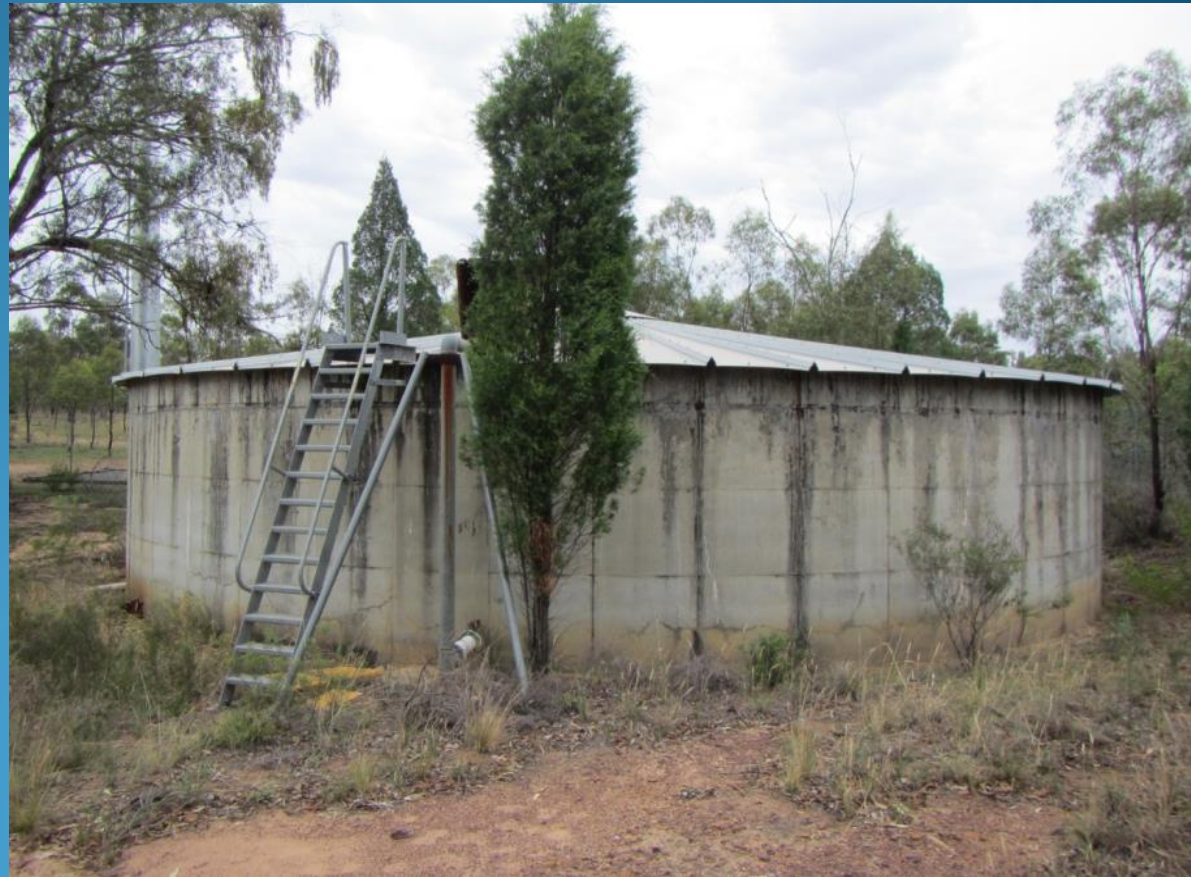
Tree roots will undermine floor  
& cause cracking and leakage

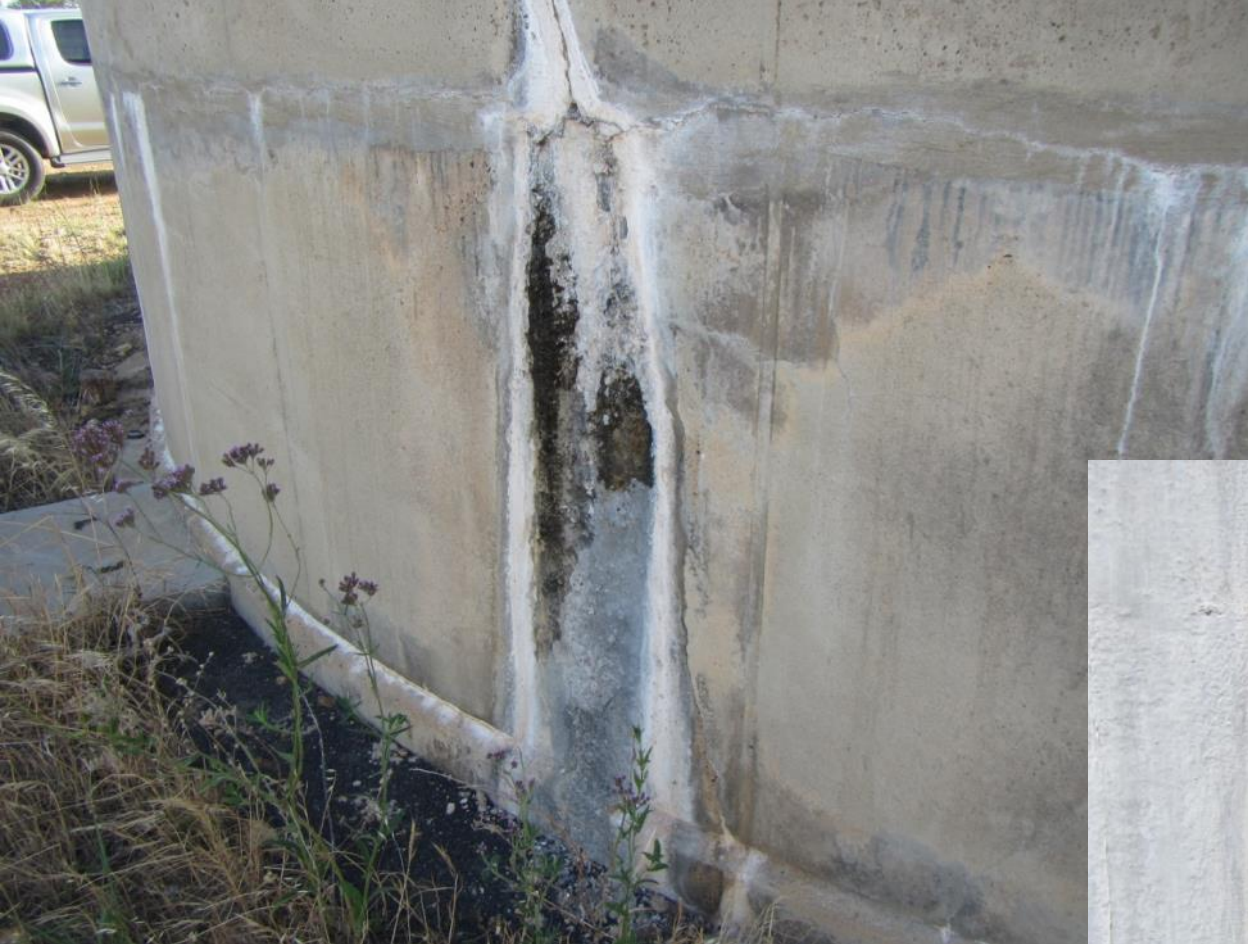
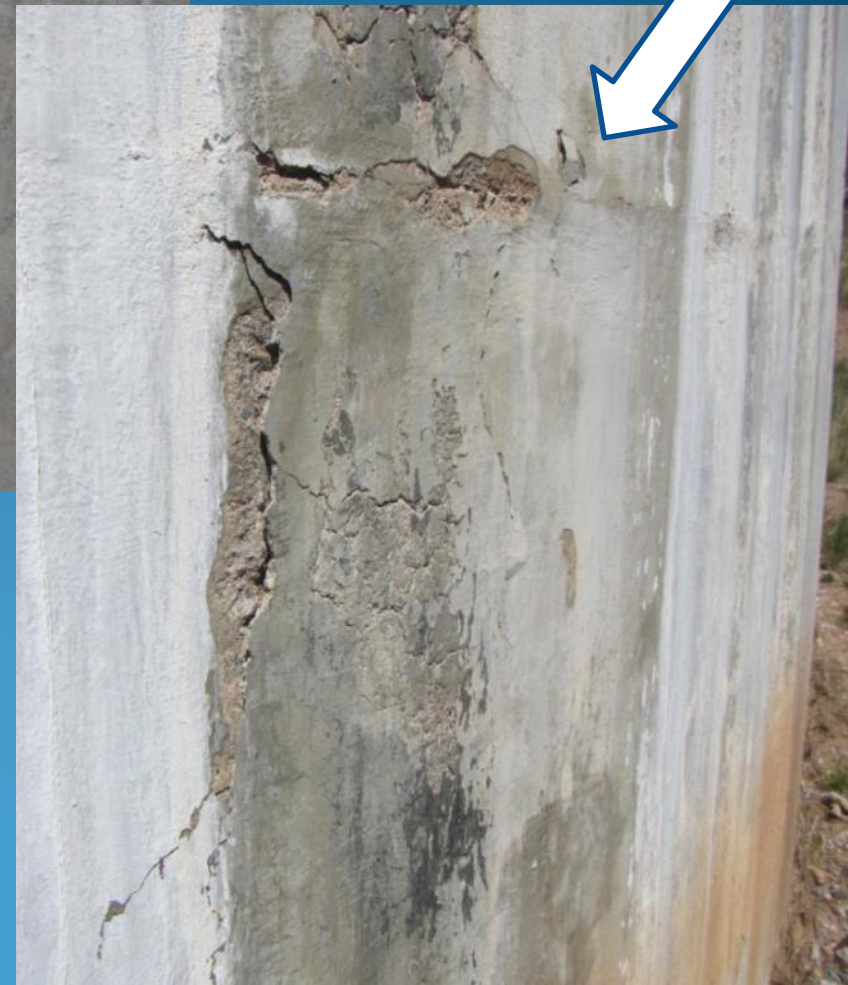
Poor construction & inferior materials may lead to significant structural defects developing

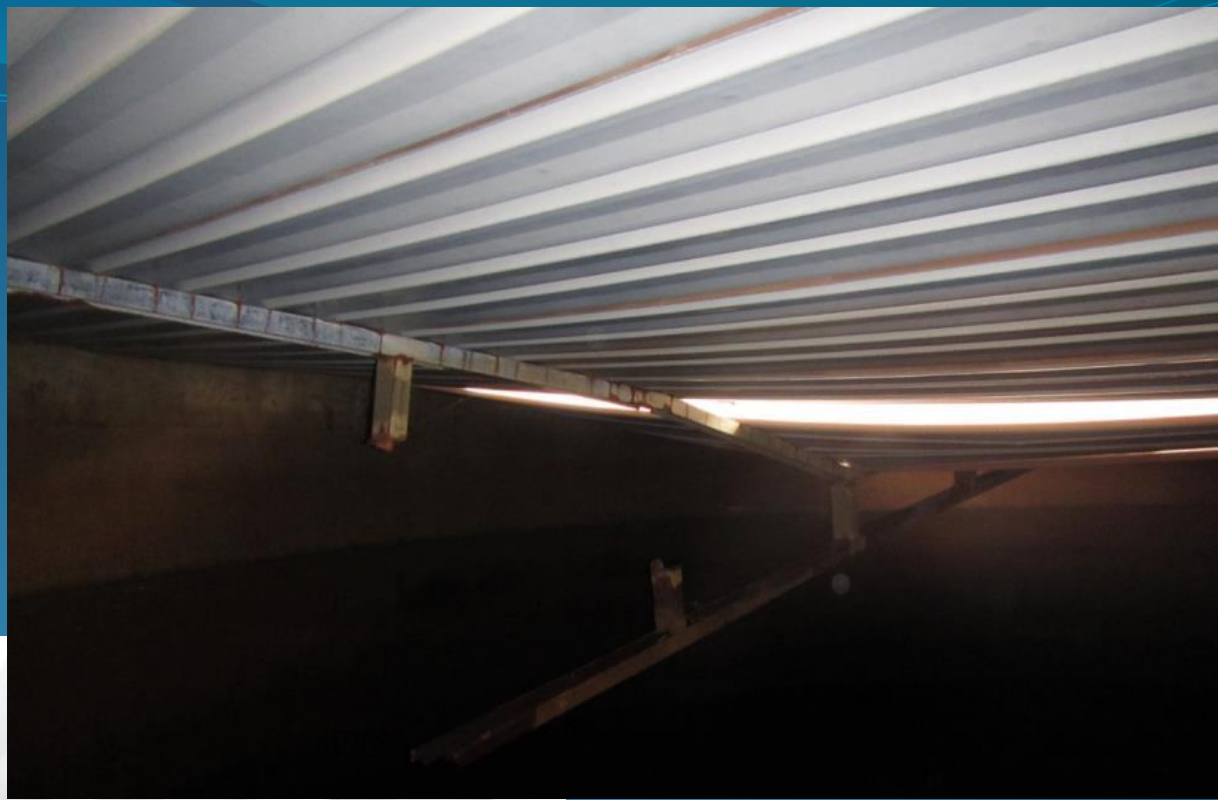
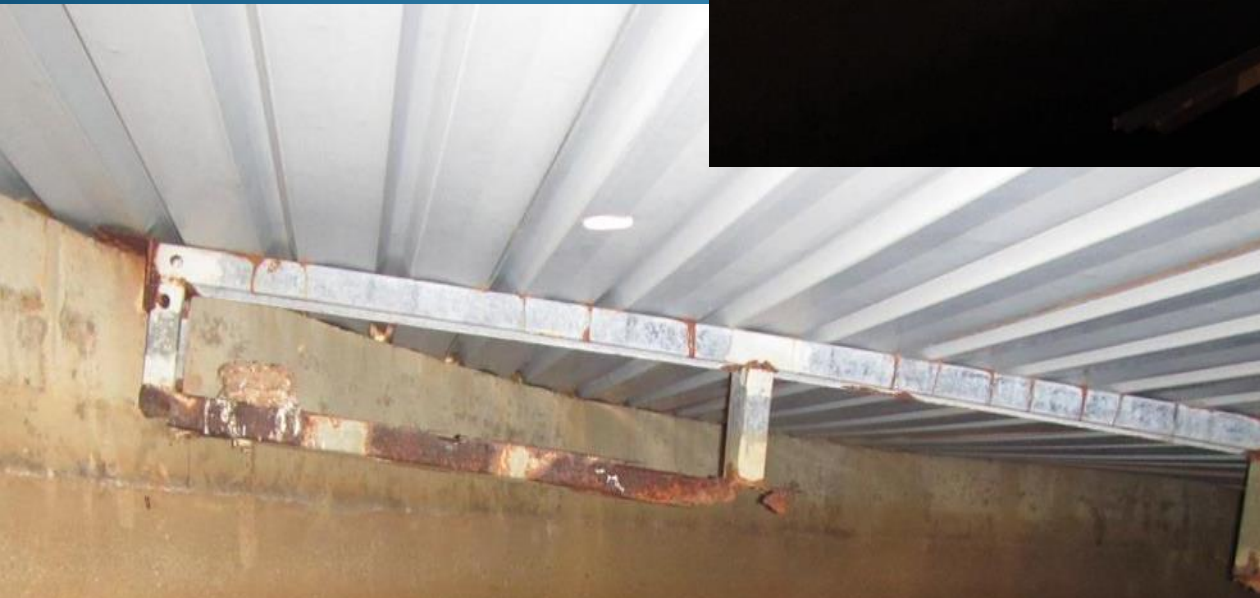
Inferior roof framing  
materials have  
corroded and  
collapsed

Regular inspections would have identified the problem....  
before it caused a complete structural failure

- Inspect roof framing condition and connections
- Be aware of materials that are prone to failure
- Act before it is too late

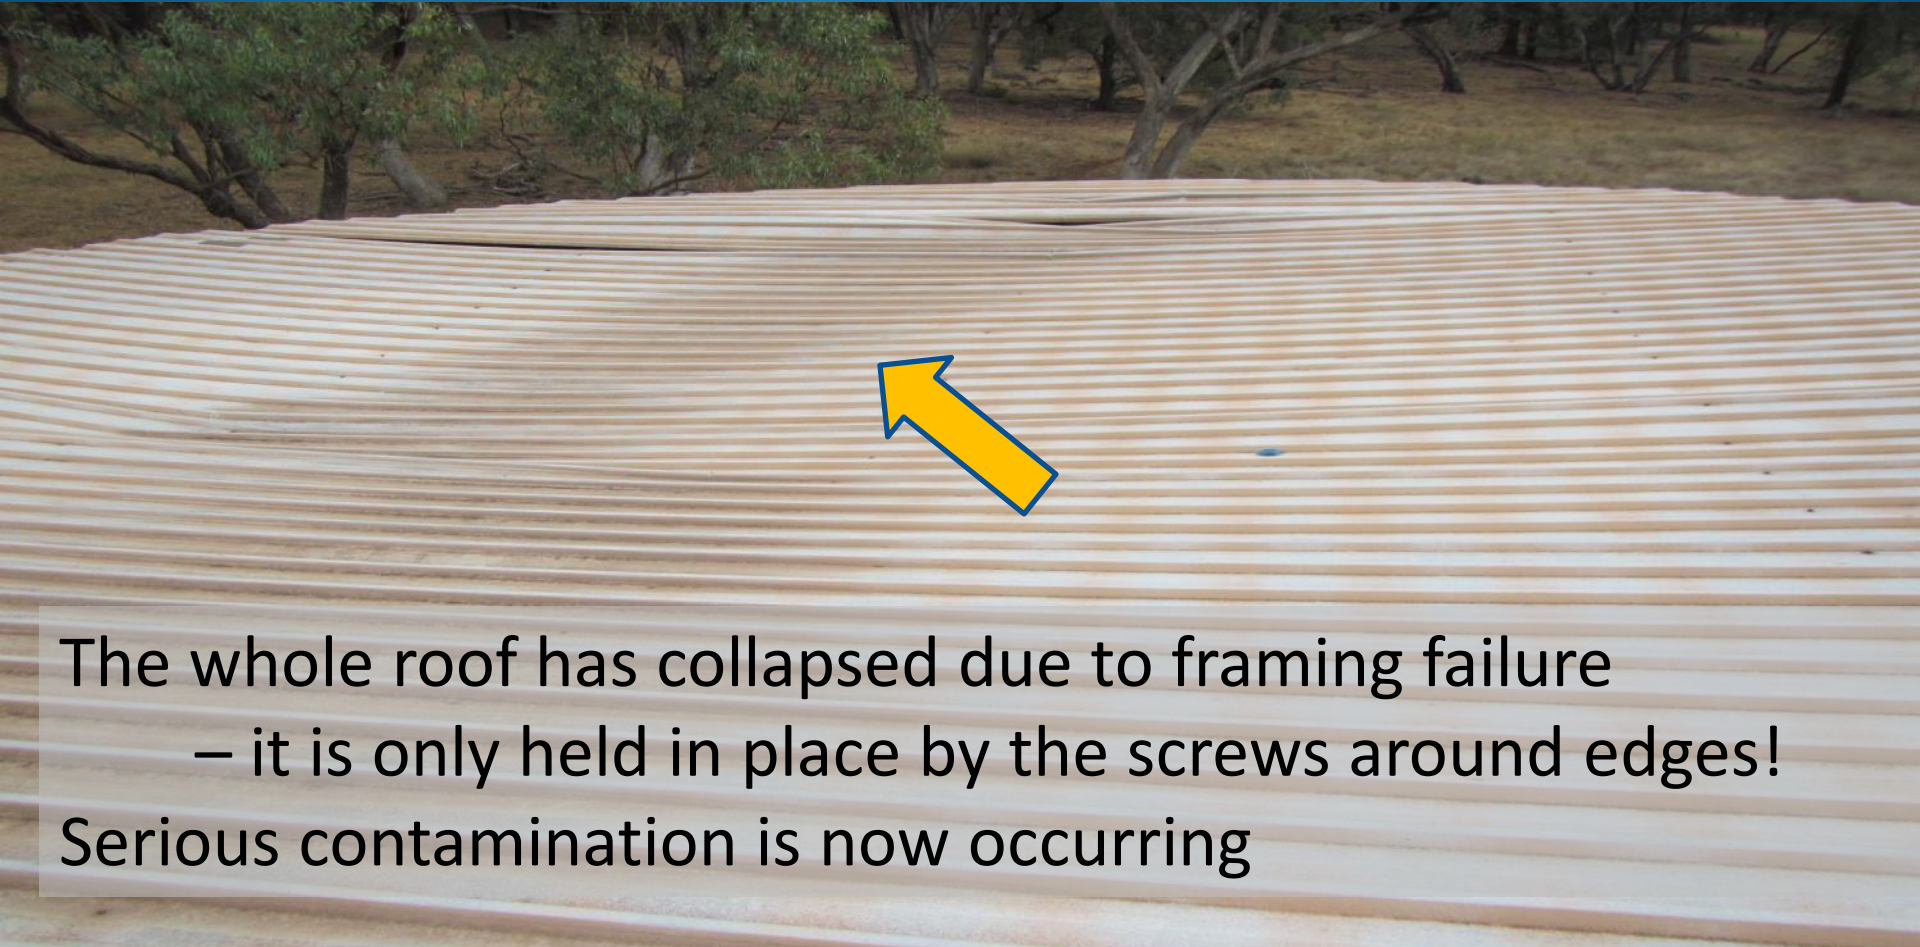
The whole roof has collapsed due to framing failure  
– it is only held in place by the screws around edges!  
Serious contamination is now occurring
