Renovating for Improved Water Quality

Renovation and Water Quality

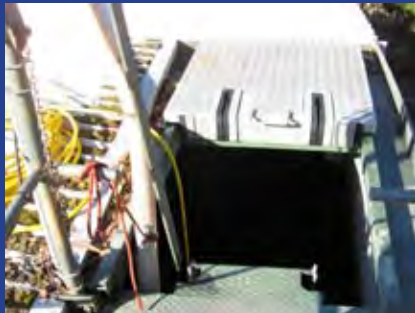
Entry hatch before

Access hatches into storage tanks are the most common area where contaminants can enter into our drinking water.

There are four simple things that can be done to improve entry hatches.

- 1. Cut off any protruding ladder stiles**
- 2. Install a sealed front edge**
- 3. Change sliding covers over to a hinged, overlapping type**
- 4. Improve the sealing capabilities around the hatch frame area**

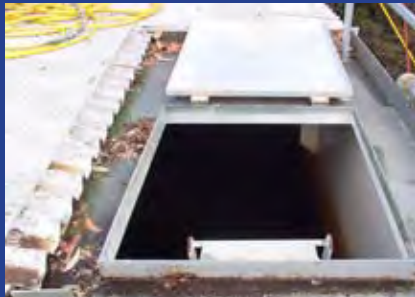
Entry hatch after

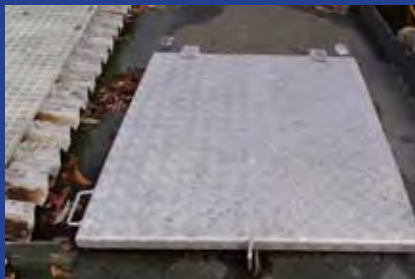
New entry hatch closed

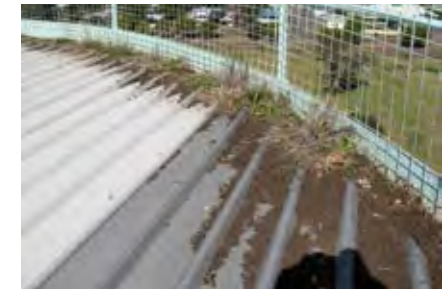
Many are not sealed where the roof sheets join up against the platform frame, allowing roof water to drain directly into the tank during rain fall events. Platforms also attract bird activity due to safety rails and aerials mounted close by. Faecal contamination then accumulates and drains or blows into the stored water supply.

Kick rail ponding

1. Platforms need to be 'tucked under' the roof sheets or have good upstream drainage fitted.
2. Kick rails can be lifted higher to reduce leaf debris blockages and subsequent back flow events.
3. Poned areas can have an 'underdrain' system fitted that delivers accumulated water out through the wall area of the tank.
4. Hand rails can be simplified and aerials can be relocated to reduce the attraction to roosting birds.

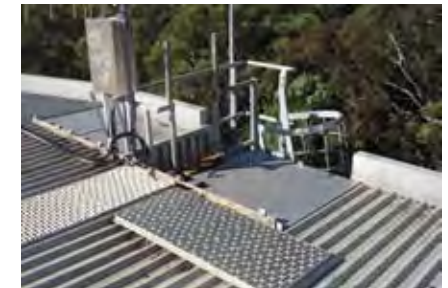
Before platform renovation

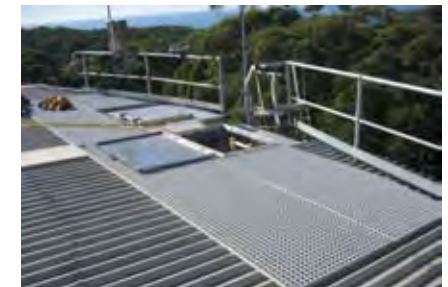
After platform renovation

Many platform designs were a compromise to the existing structure, when older tanks were roofed, so a complete re-design is the only effective method of overcoming the contamination issues. Good design is the cornerstone of this process and simply adding on 'bits and pieces' to existing poor designs will not solve the water security issues present on most of our tanks today.
