RESERVOIR RENOVATIONS – BEST CHANCE OR LOST CHANCE

This paper will highlight the key areas where old designs were deficient and it will also offer solutions to improve the safety of both operations personnel and the stored water.

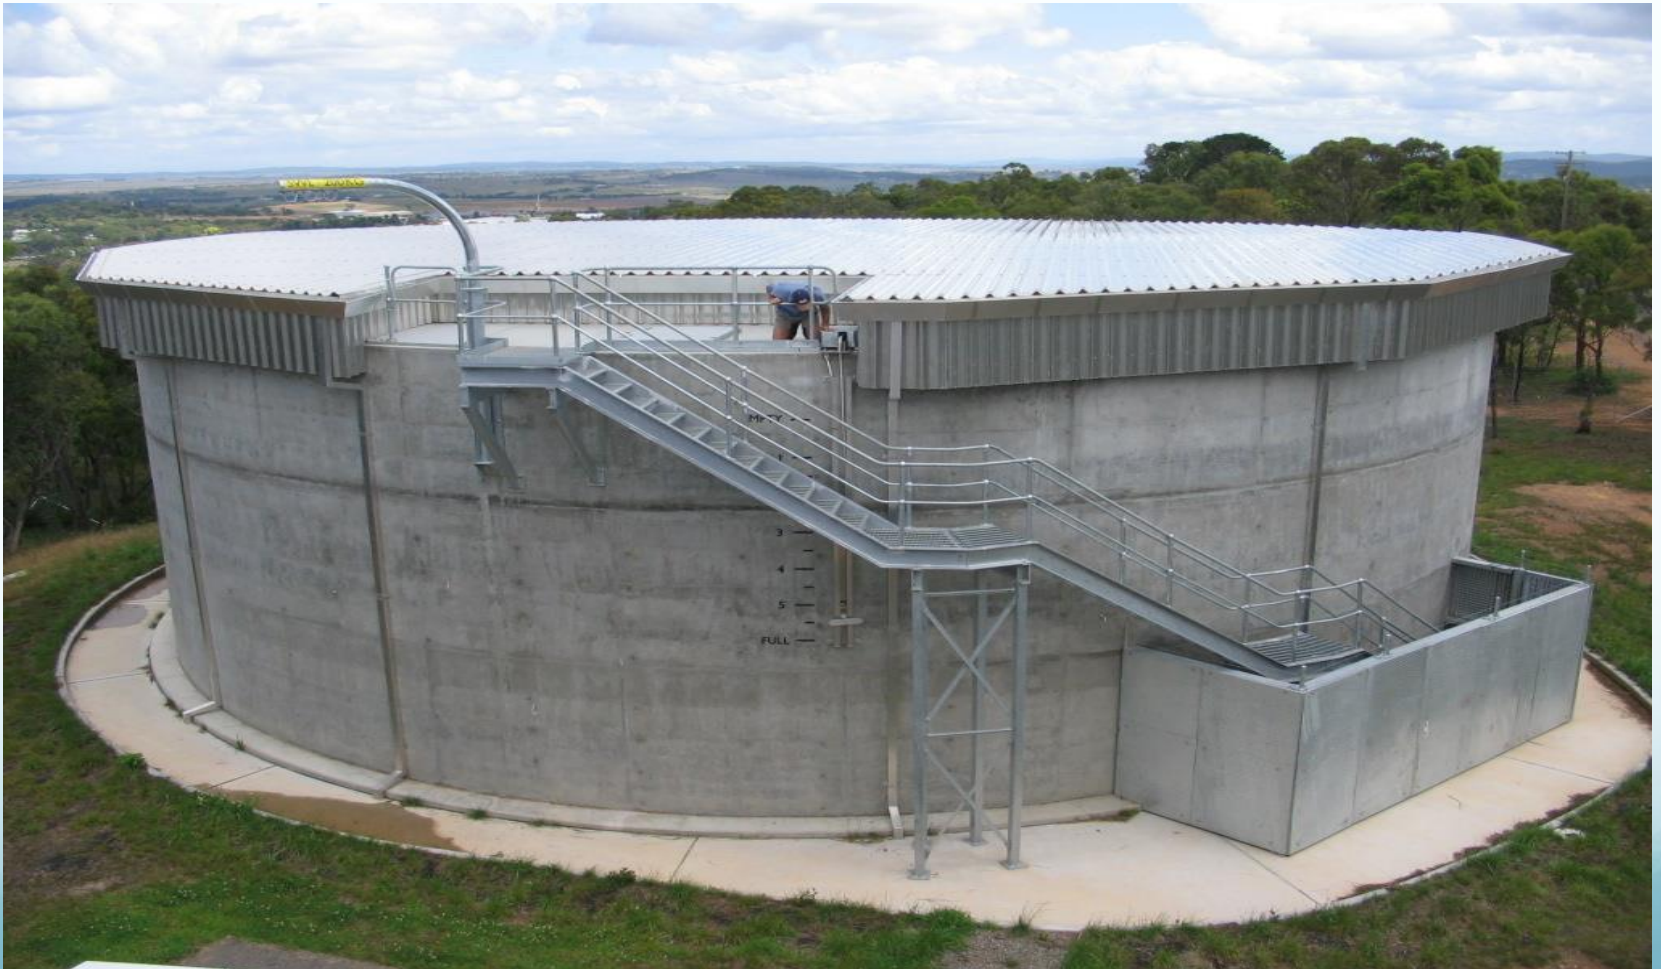
This new tank has an impressive external stairway system, but the entry hatch and platform areas remain unsealed against natural or deliberate contamination.

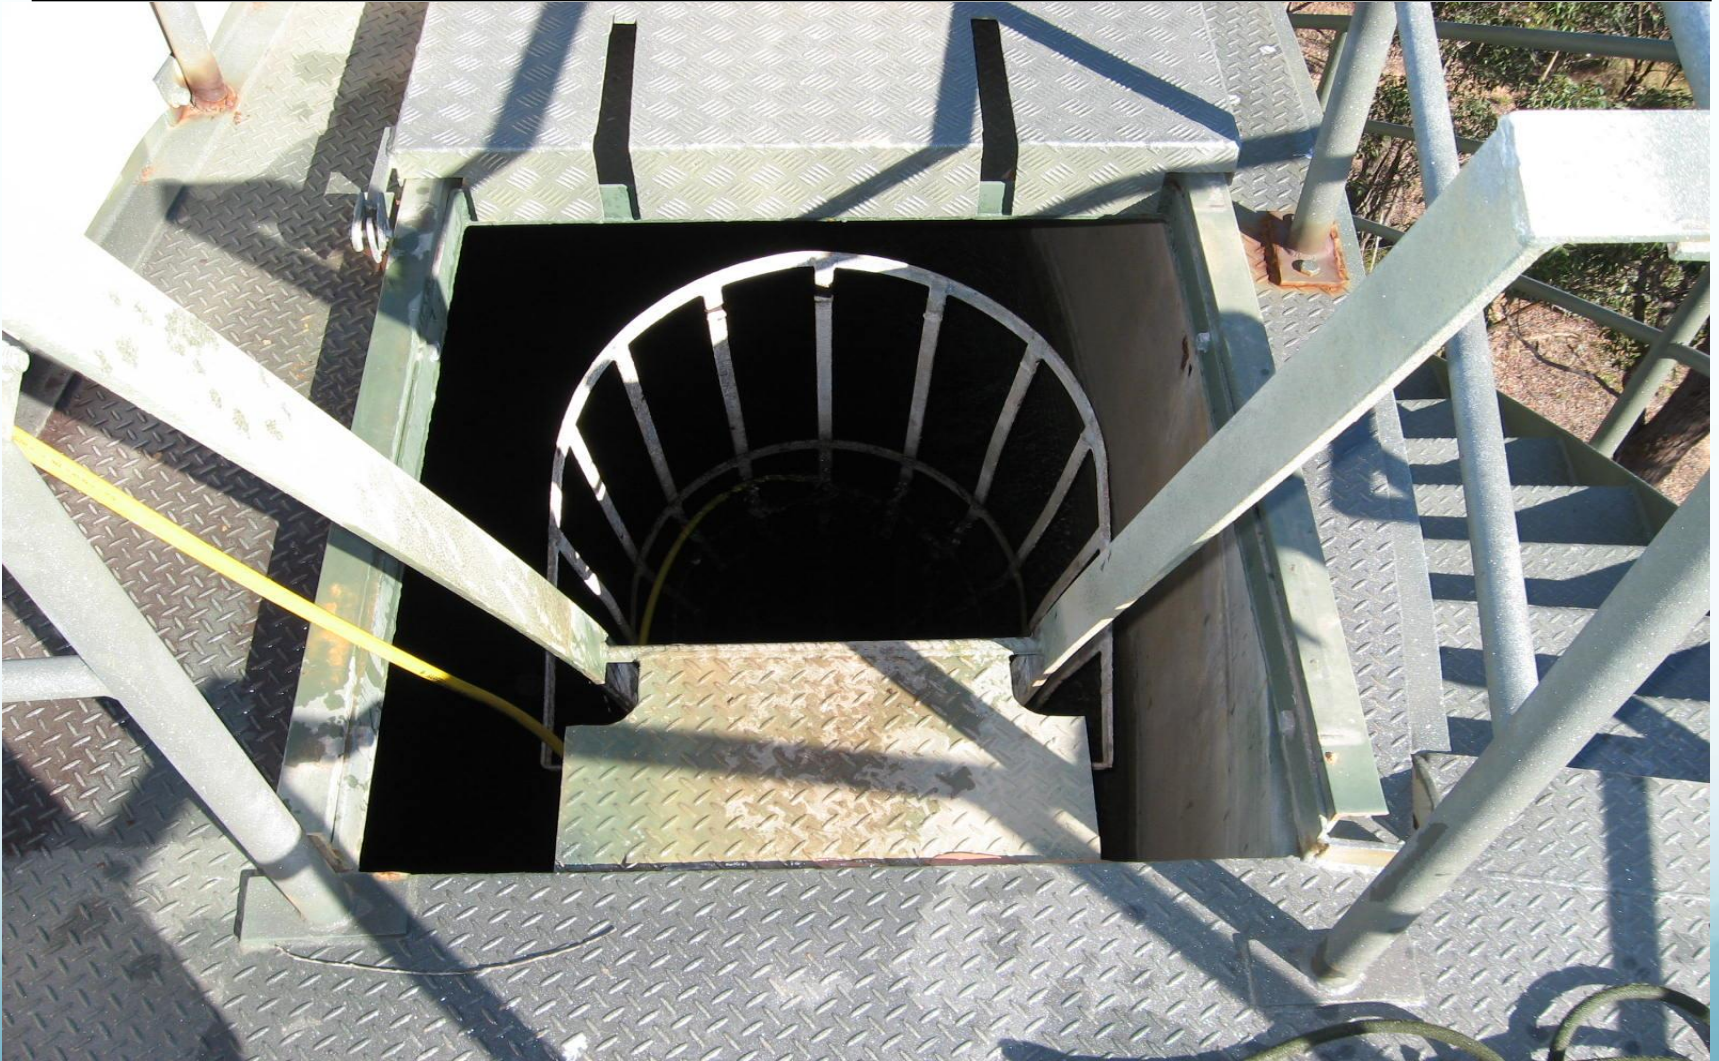
The ladder takes up available hatch space and is caged, making a confined space rescue difficult. The stiles extend out through the hatch cover, which cannot be sealed.

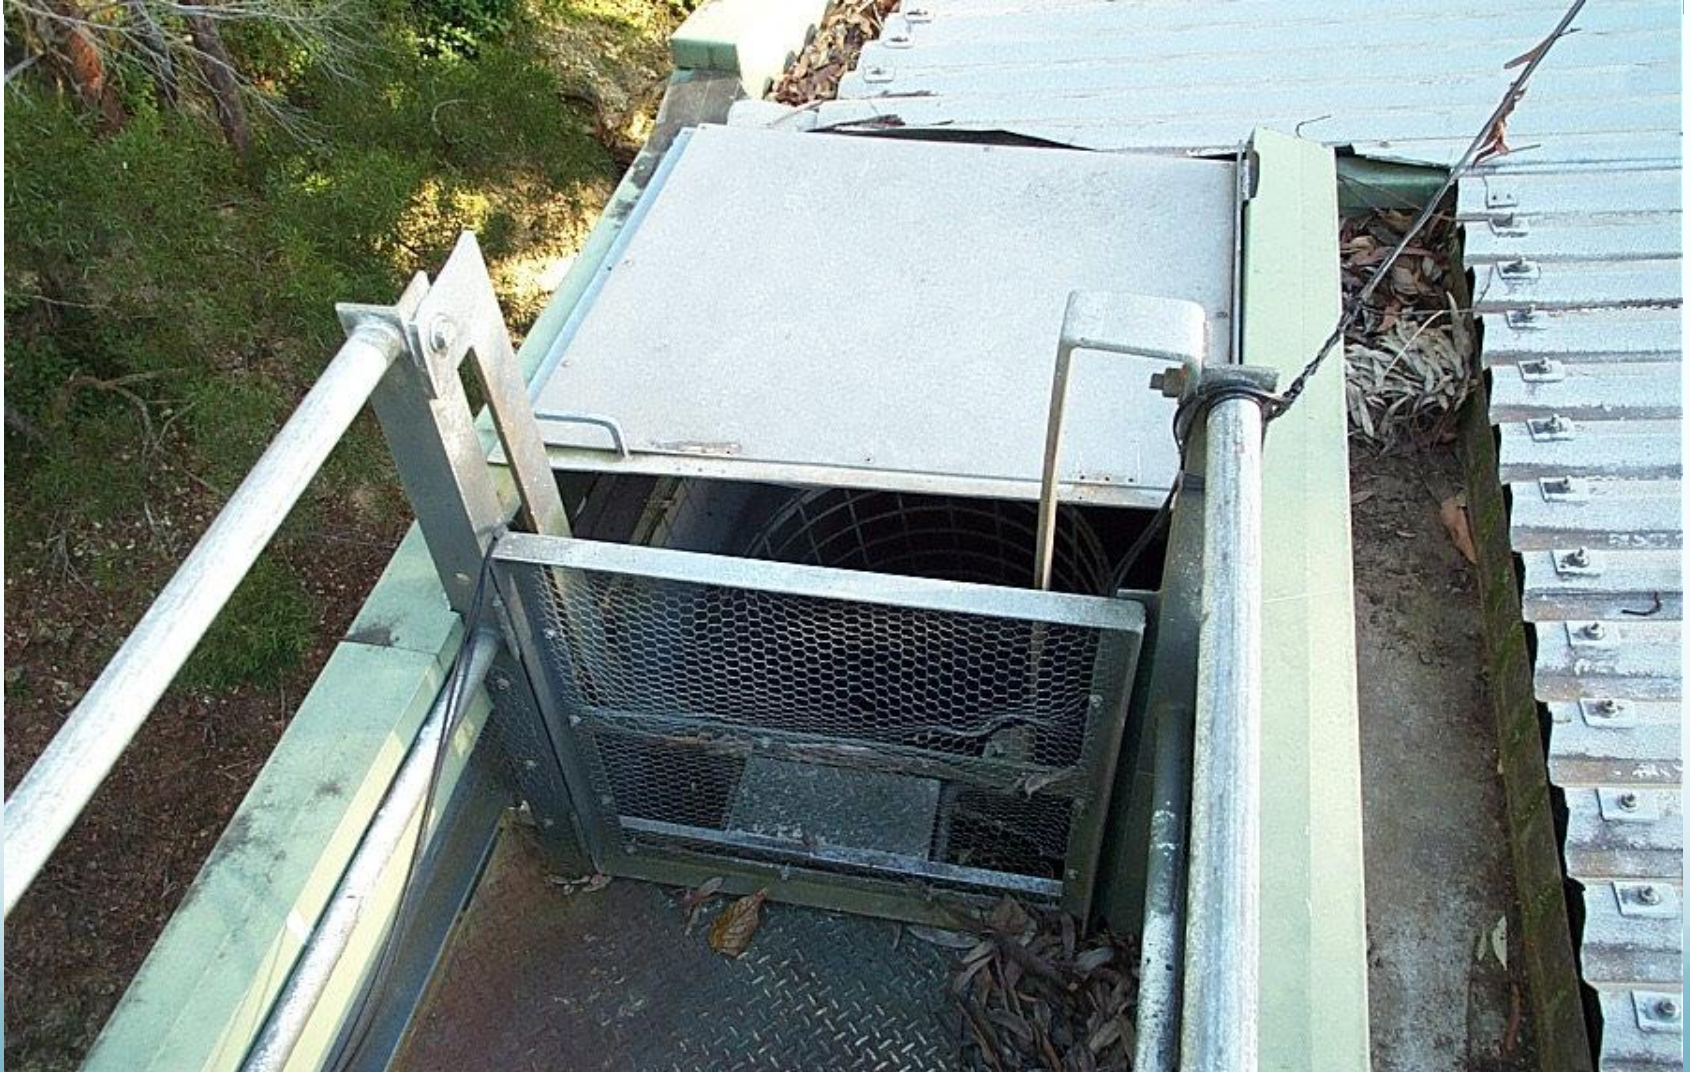
The ladder stiles extend out through the opening and the hatch cover is not sealed or secured

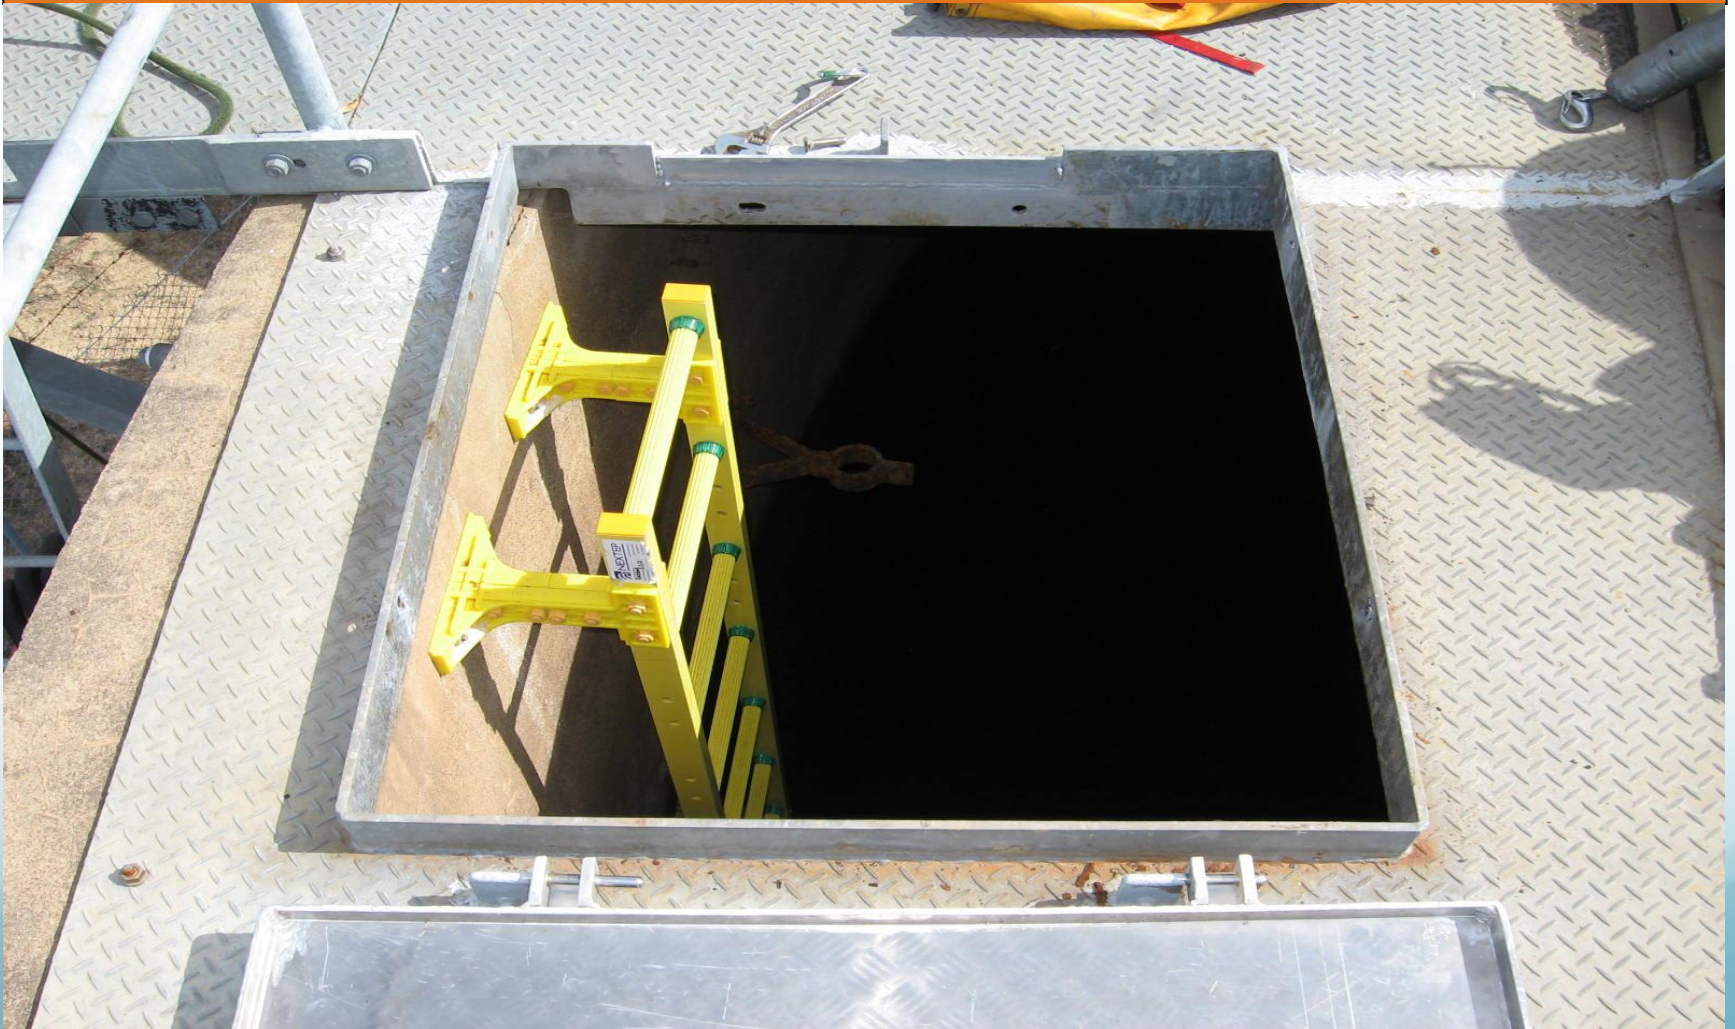
The original sloping steel ladder has been replaced with a vertical FRP unit, making more hatch space available for safe access or a rescue scenario. The hatch cover can now be sealed and secured against contamination.

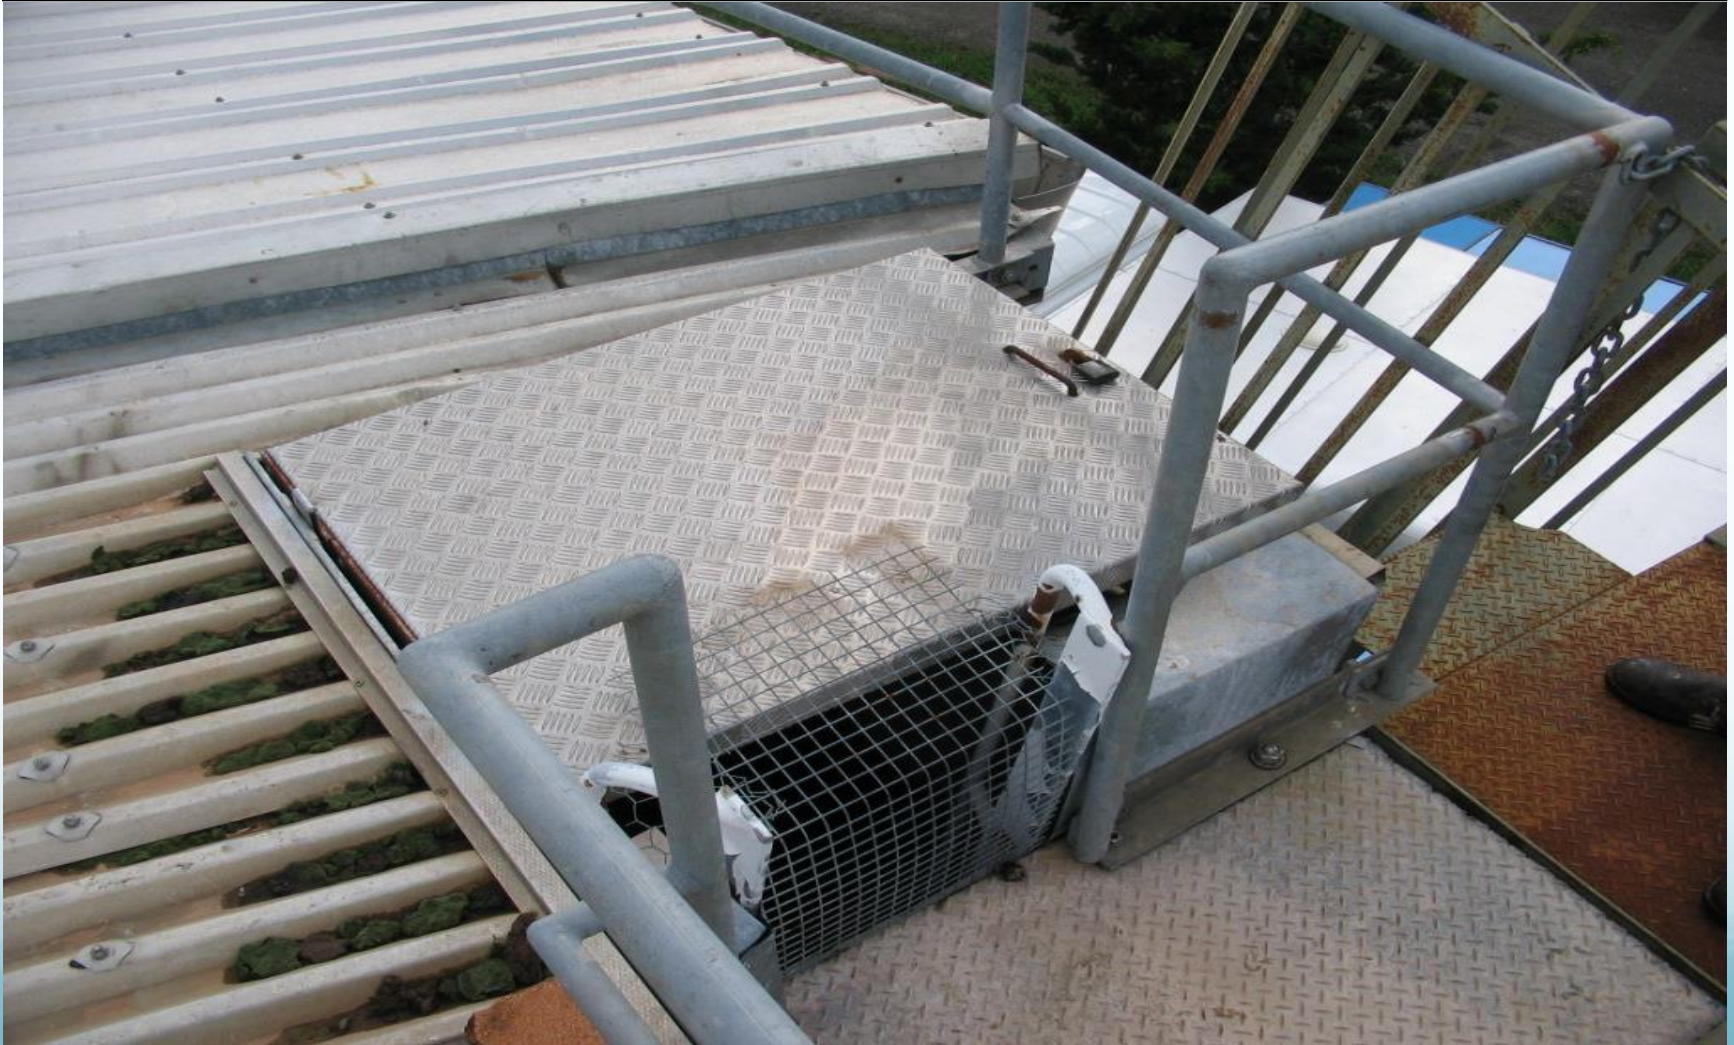
The front edge is missing from the hatch frame area and the hatch cover security has been compromised by trying to accommodate the protruding ladder stiles.

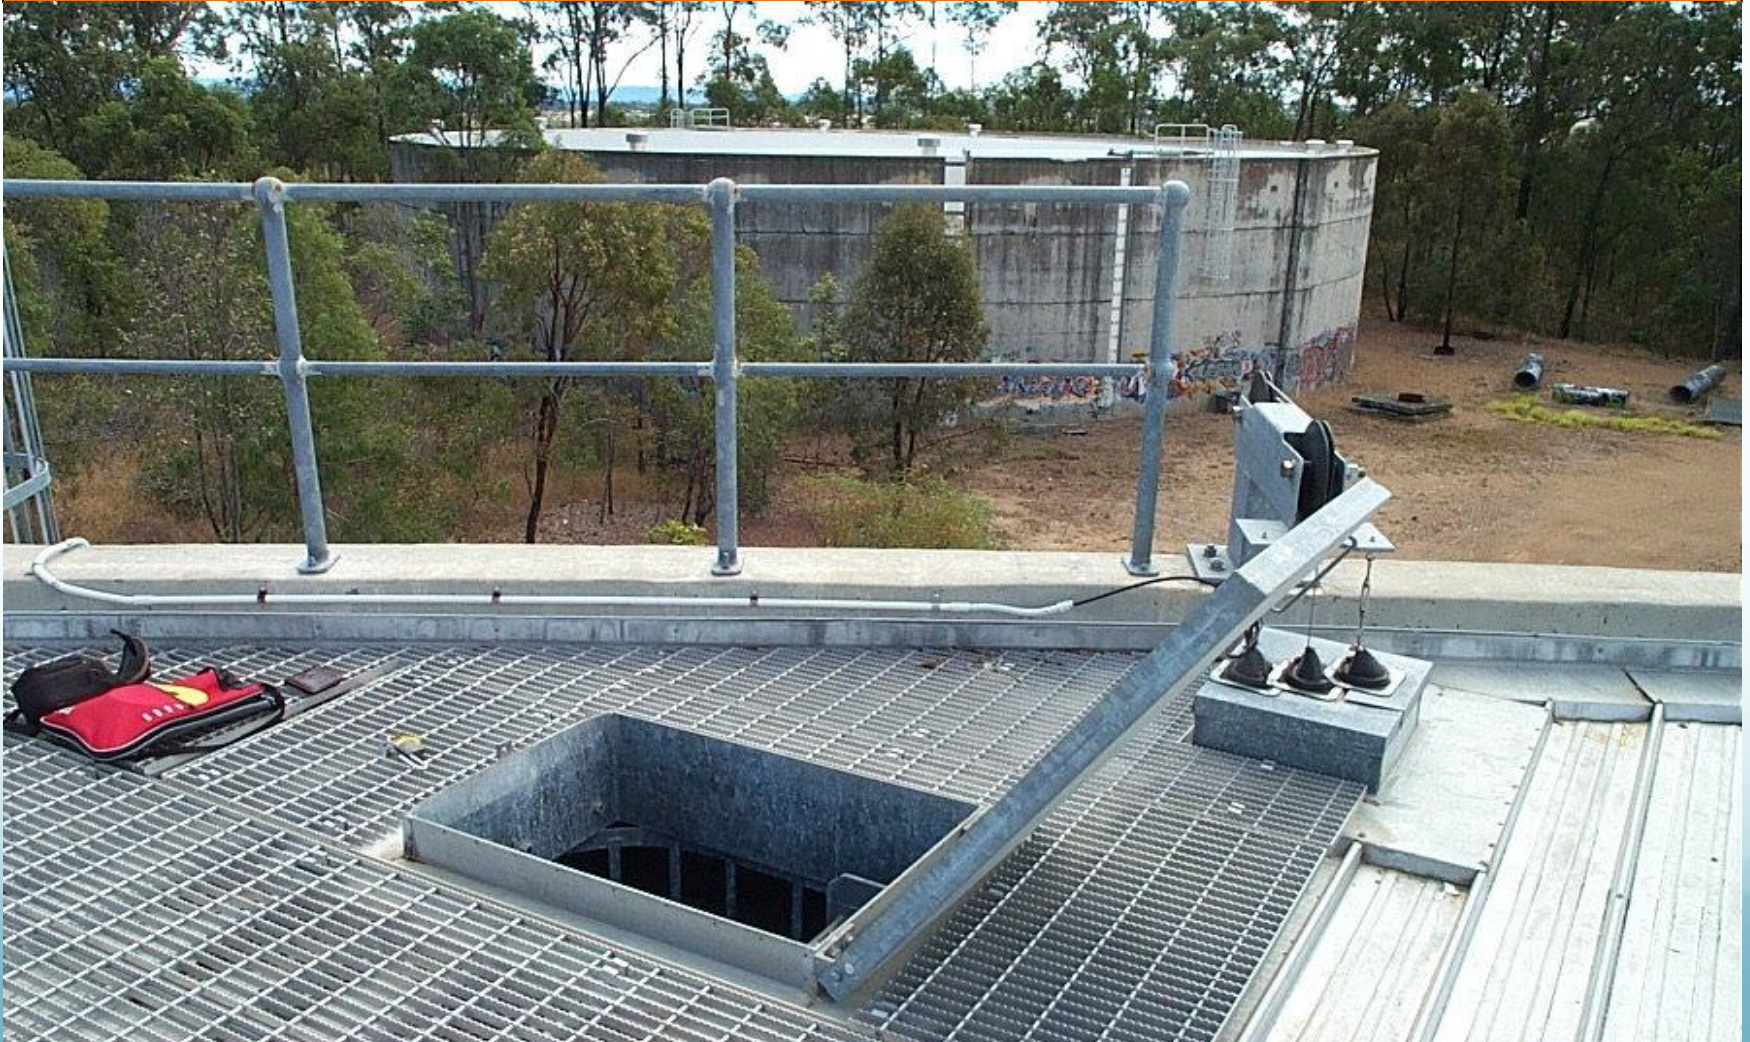
This entry hatch is too small for a confined space entry and it is poorly positioned on the platform. It should be parallel to and close to the wall area to allow for a more ergonomic placement of the ladder.

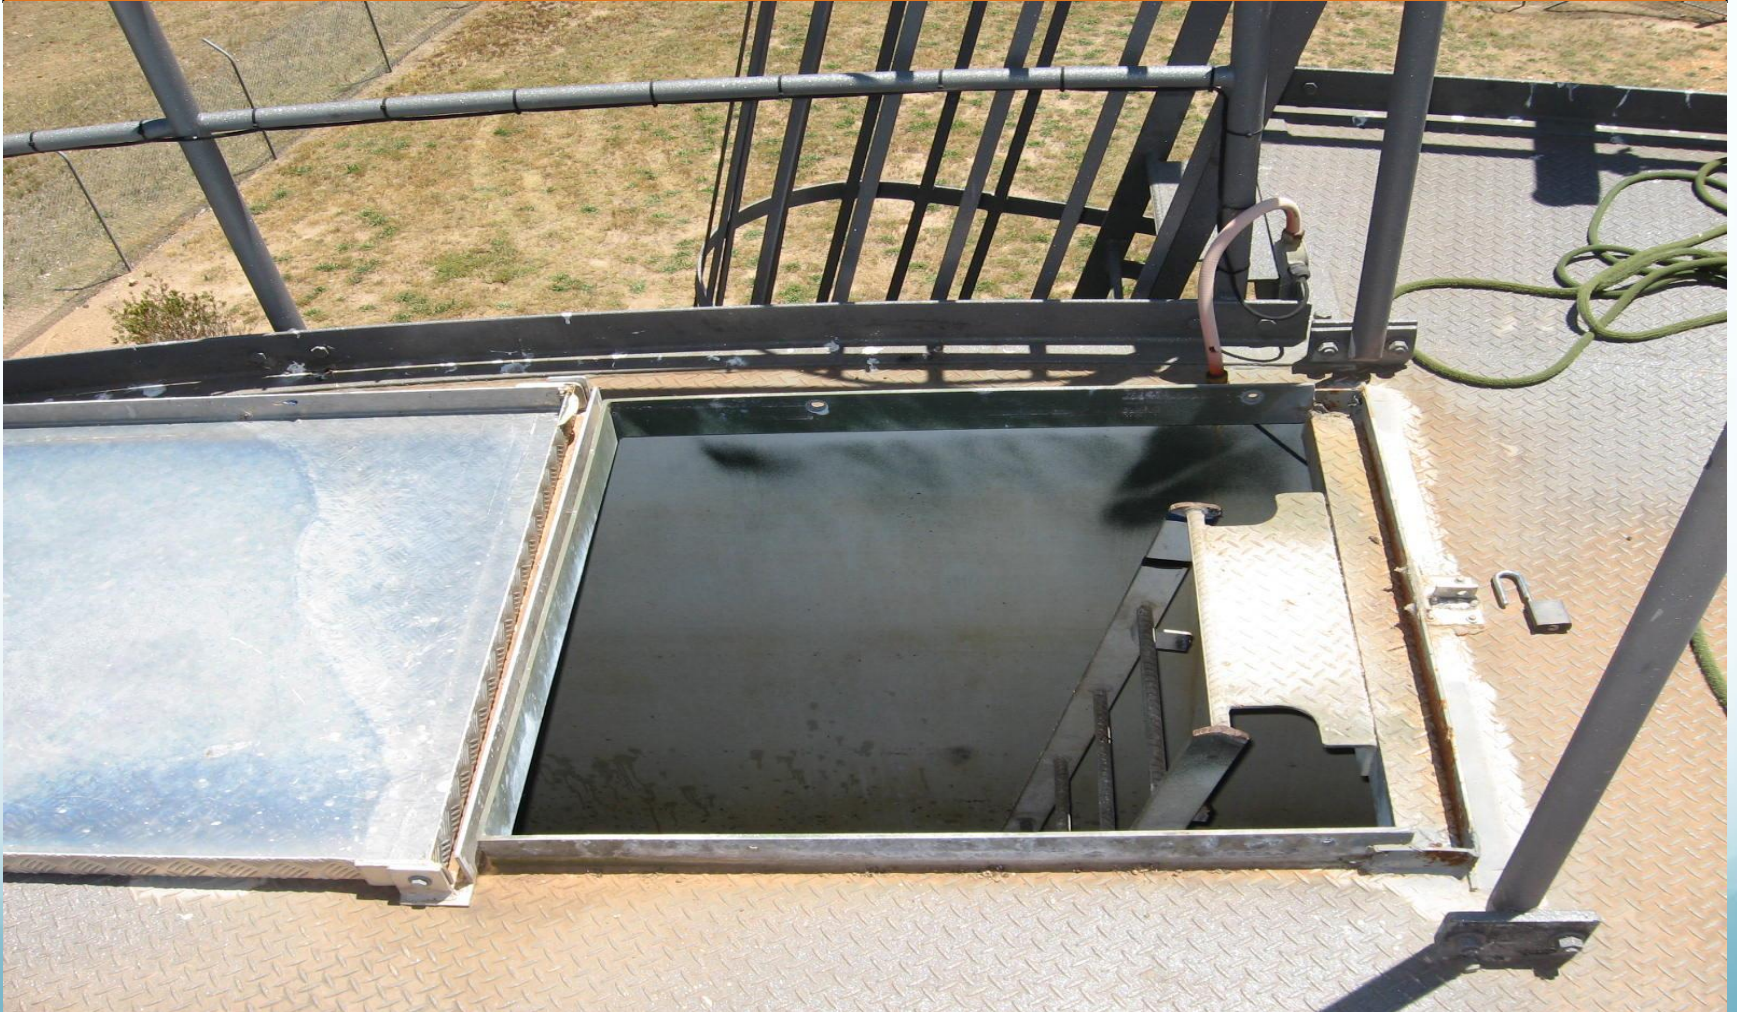
A simple and inexpensive hatch upgrade – the ladder stiles have been trimmed off, the front edge has been sealed and the sliding hatch replaced with a hinged, overlapping type cover that increases security and prevents contamination entry.

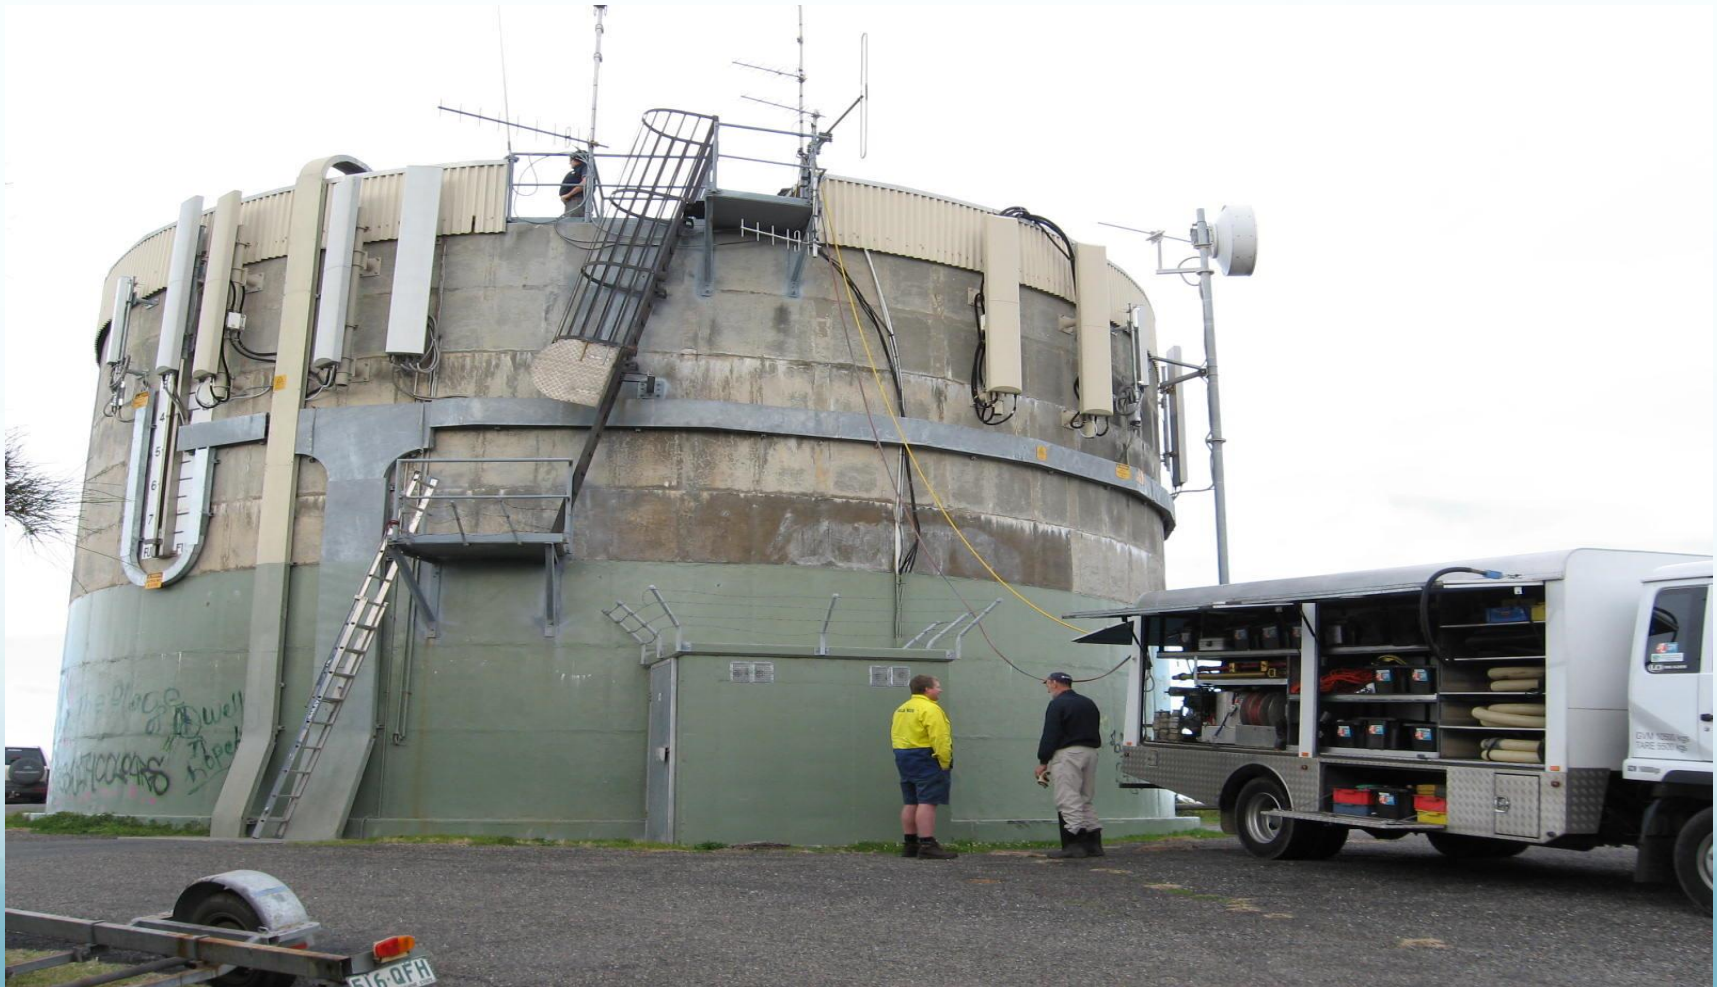
This tank is also used as a 'Broadcasting facility' – the platform area is littered with aerials and there are safety concerns for personnel with the associated EMF hazards.

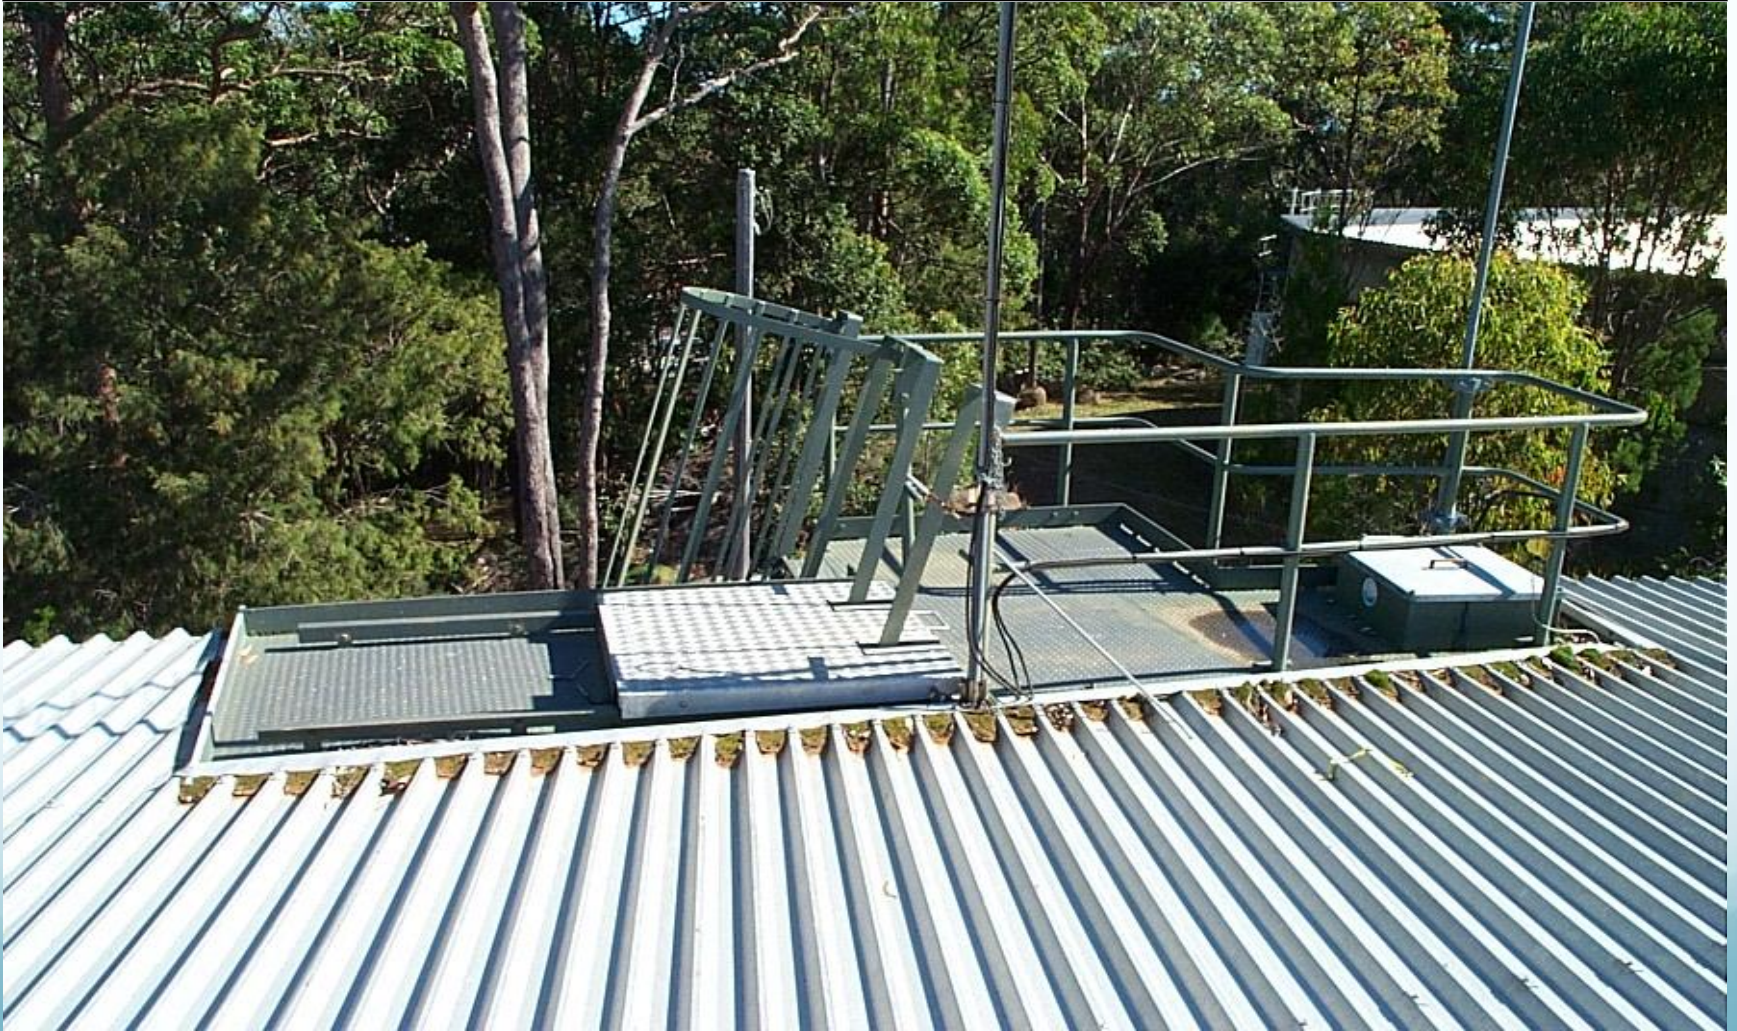
This platform requires guard rails on the LHS and the entry hatch area is unsealed. The adjacent roof sheets are ponded with debris and cannot drain away effectively .

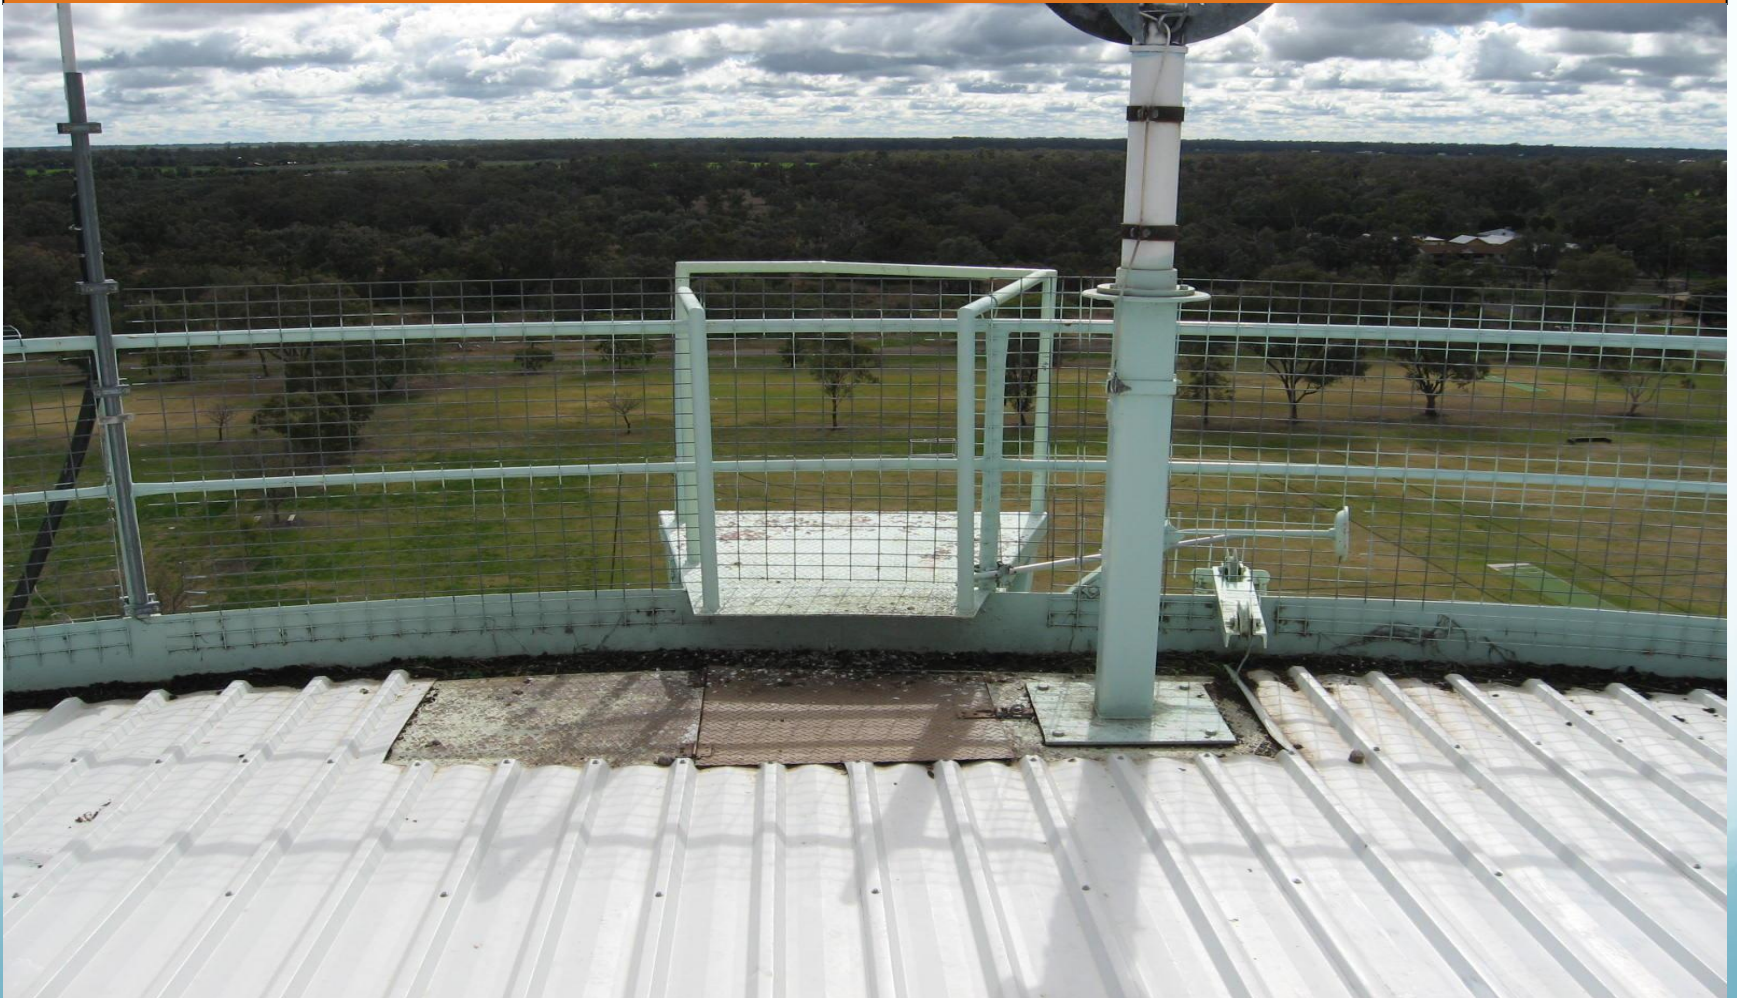
The working space is too small, the entry hatch is unsealed and the whole area is covered in bird faeces and debris. The adjacent trig tower is encouraging birds to roost in this particular area.

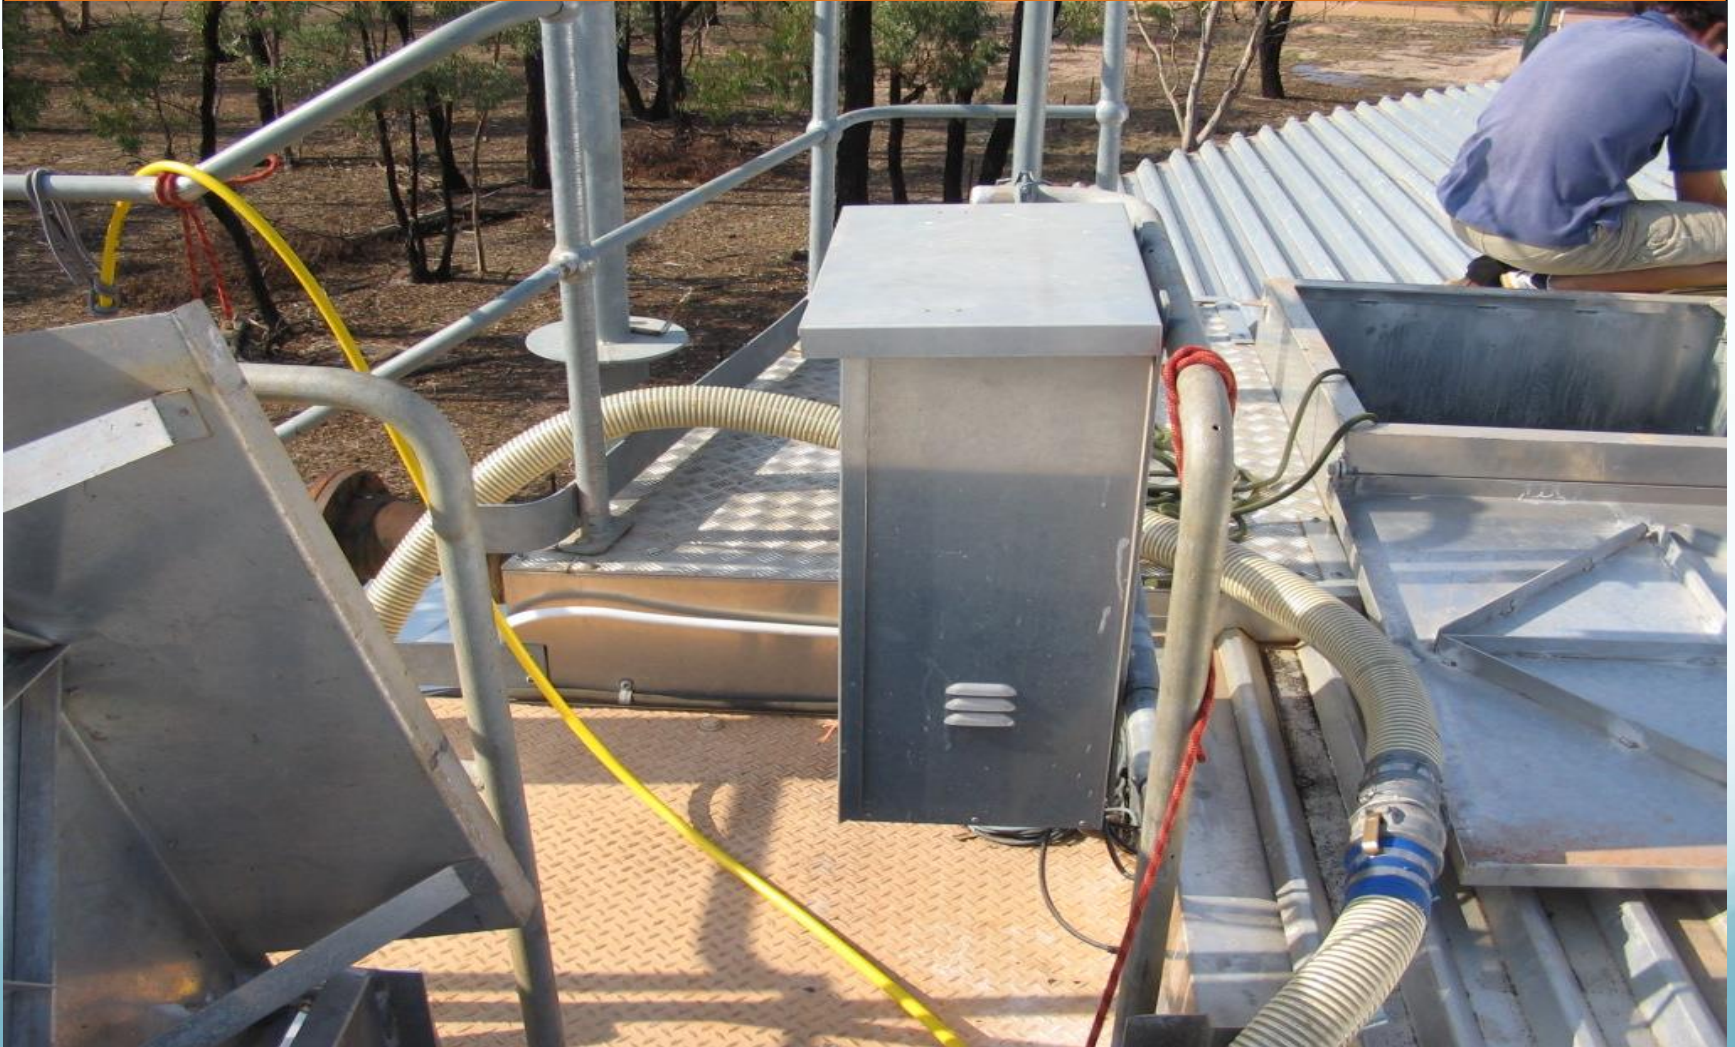
The working area is overcrowded with control boxes and other accessories, that could have been located further away to make room around the immediate access area.

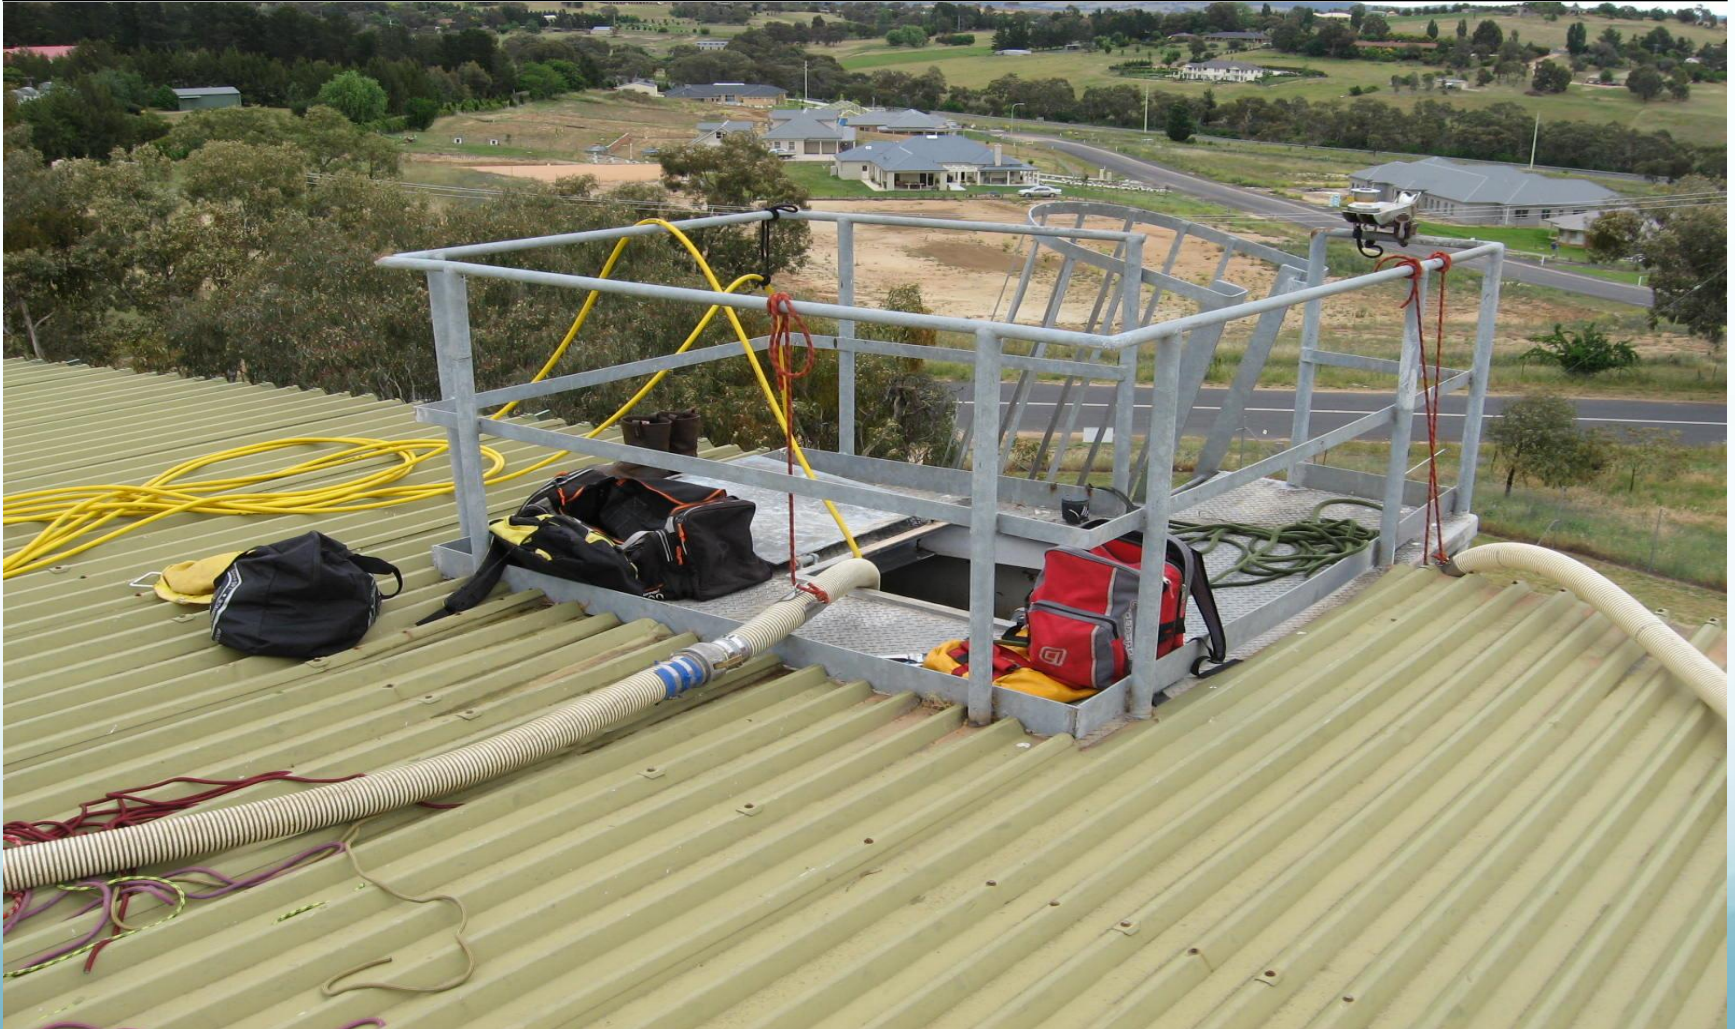
Personnel are 'fenced into' a small working section and have to continually climb over the rails to access the roof area - more guard rails are required on either side of the roof.
