RESERVOIR RENOVATIONS – BEST CHANCE OR LOST CHANCE

This paper will highlight the key areas where old designs were deficient and it will also offer solutions to improve the safety of both operations personnel and the stored water.

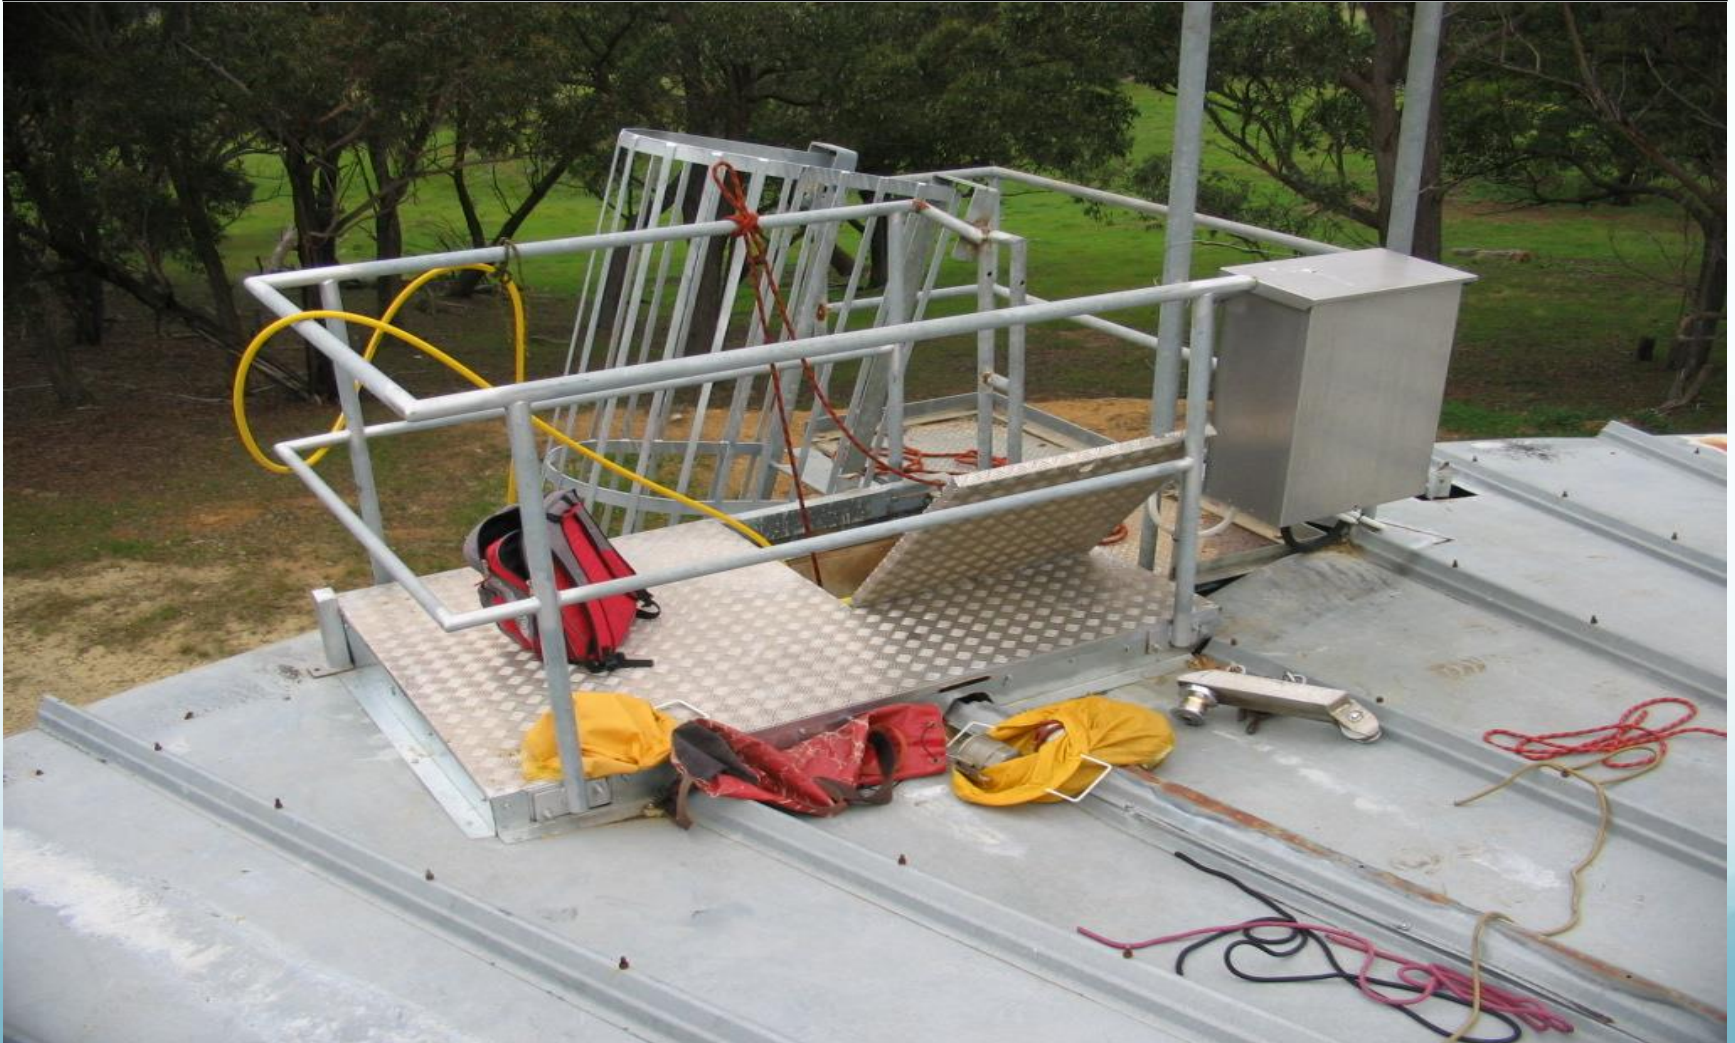
A platform upgrade with poor outcomes – personnel are 'fenced into' a small working area and the roof sheets are not sealed where the platform module was cut in.

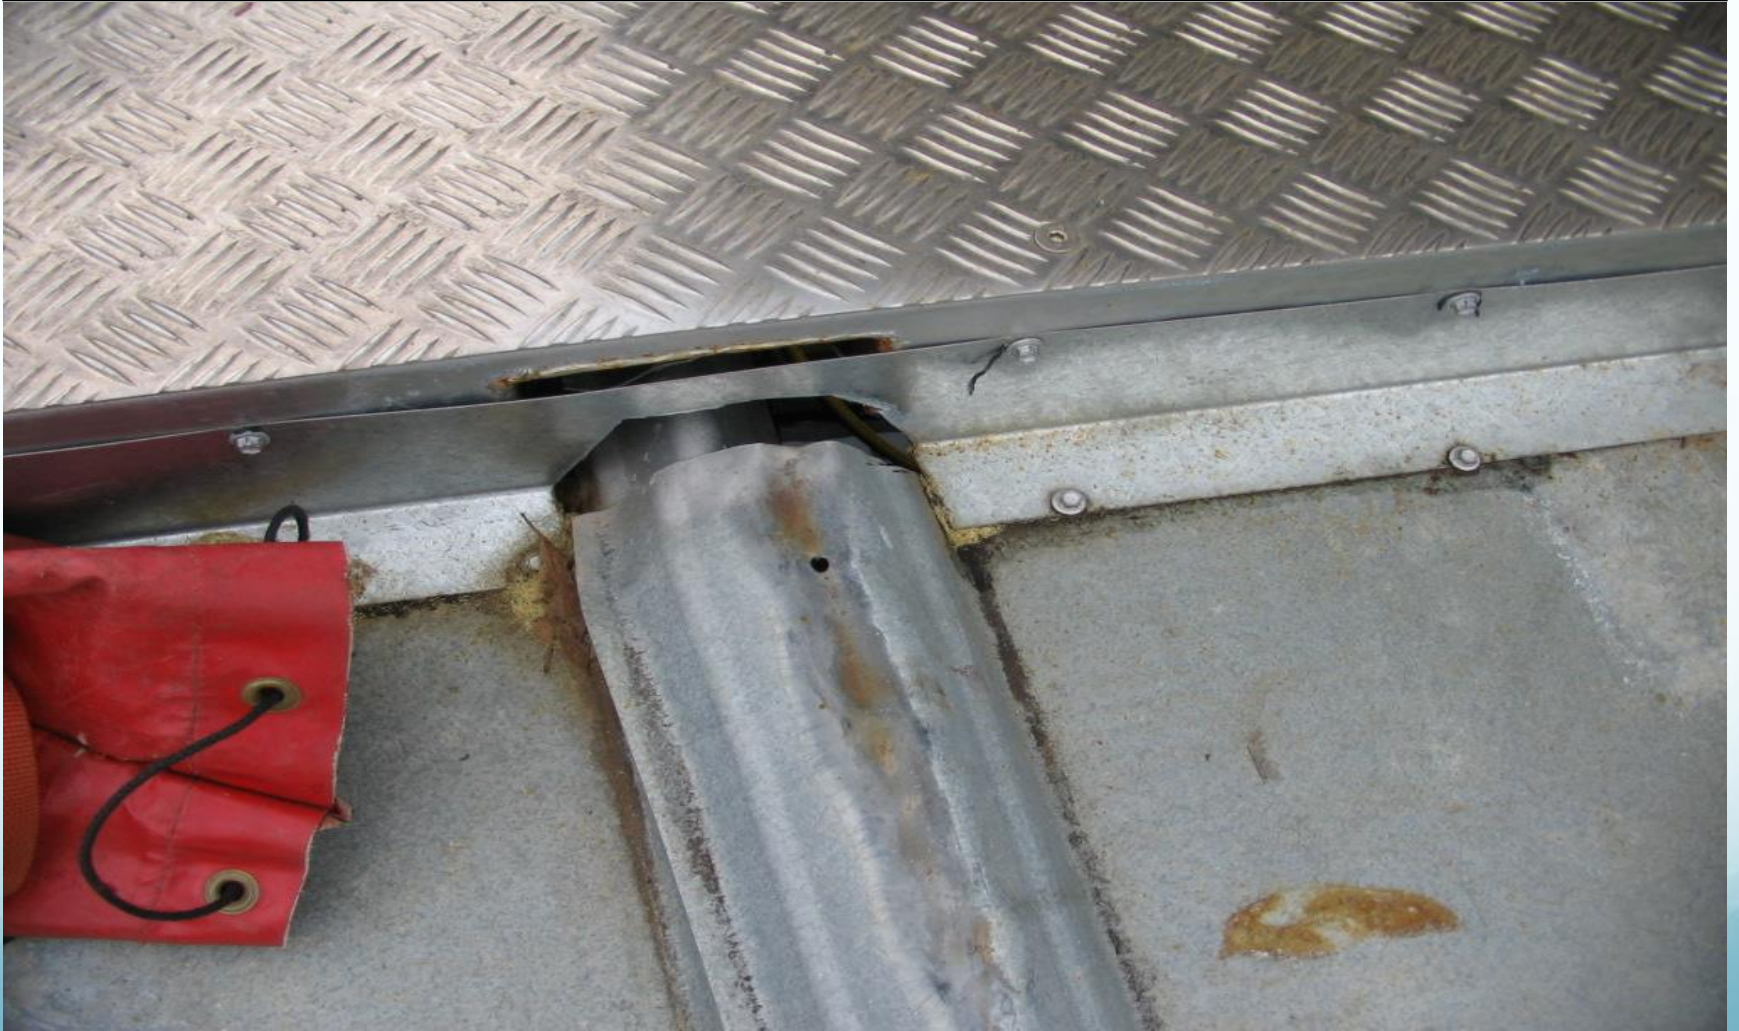
A close up of the platform to roof sheet sealing and a lack of understanding regarding the upgrade process and what it was supposed to achieve.

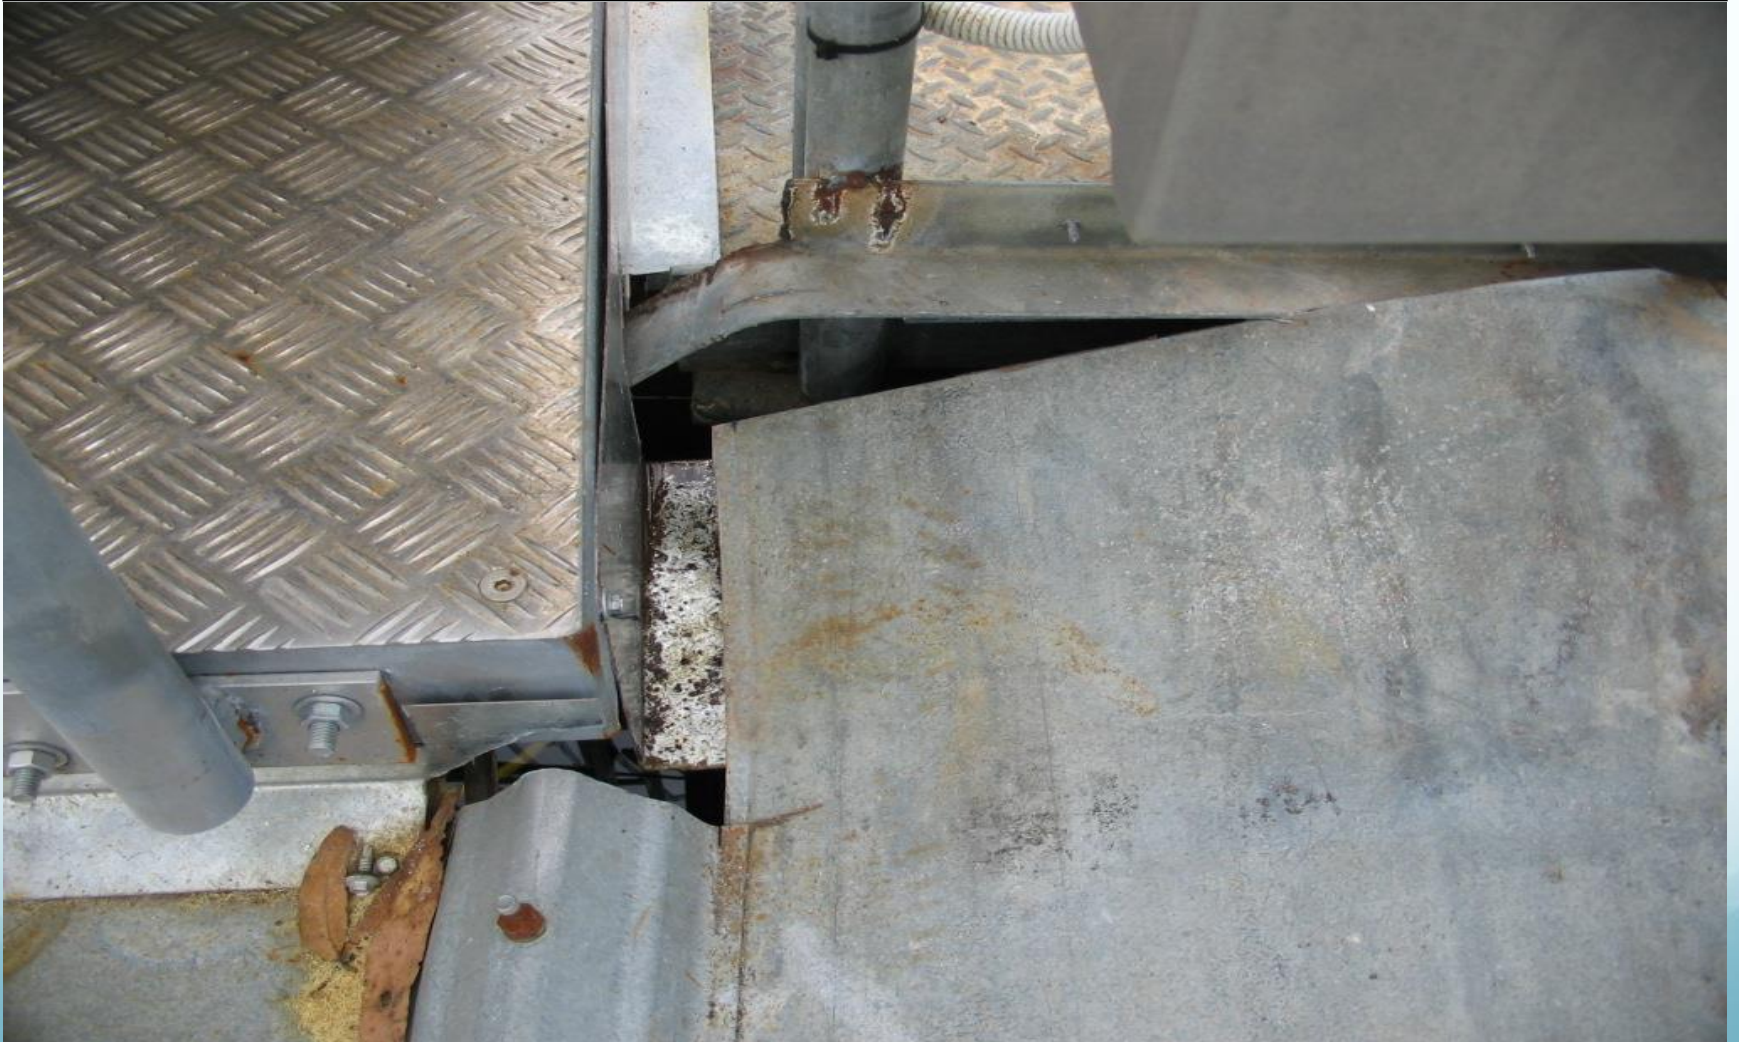
Another close up of the new platform area and how the roof now drains directly into the tank. Good design would have overcome these issues and made the project worthwhile.

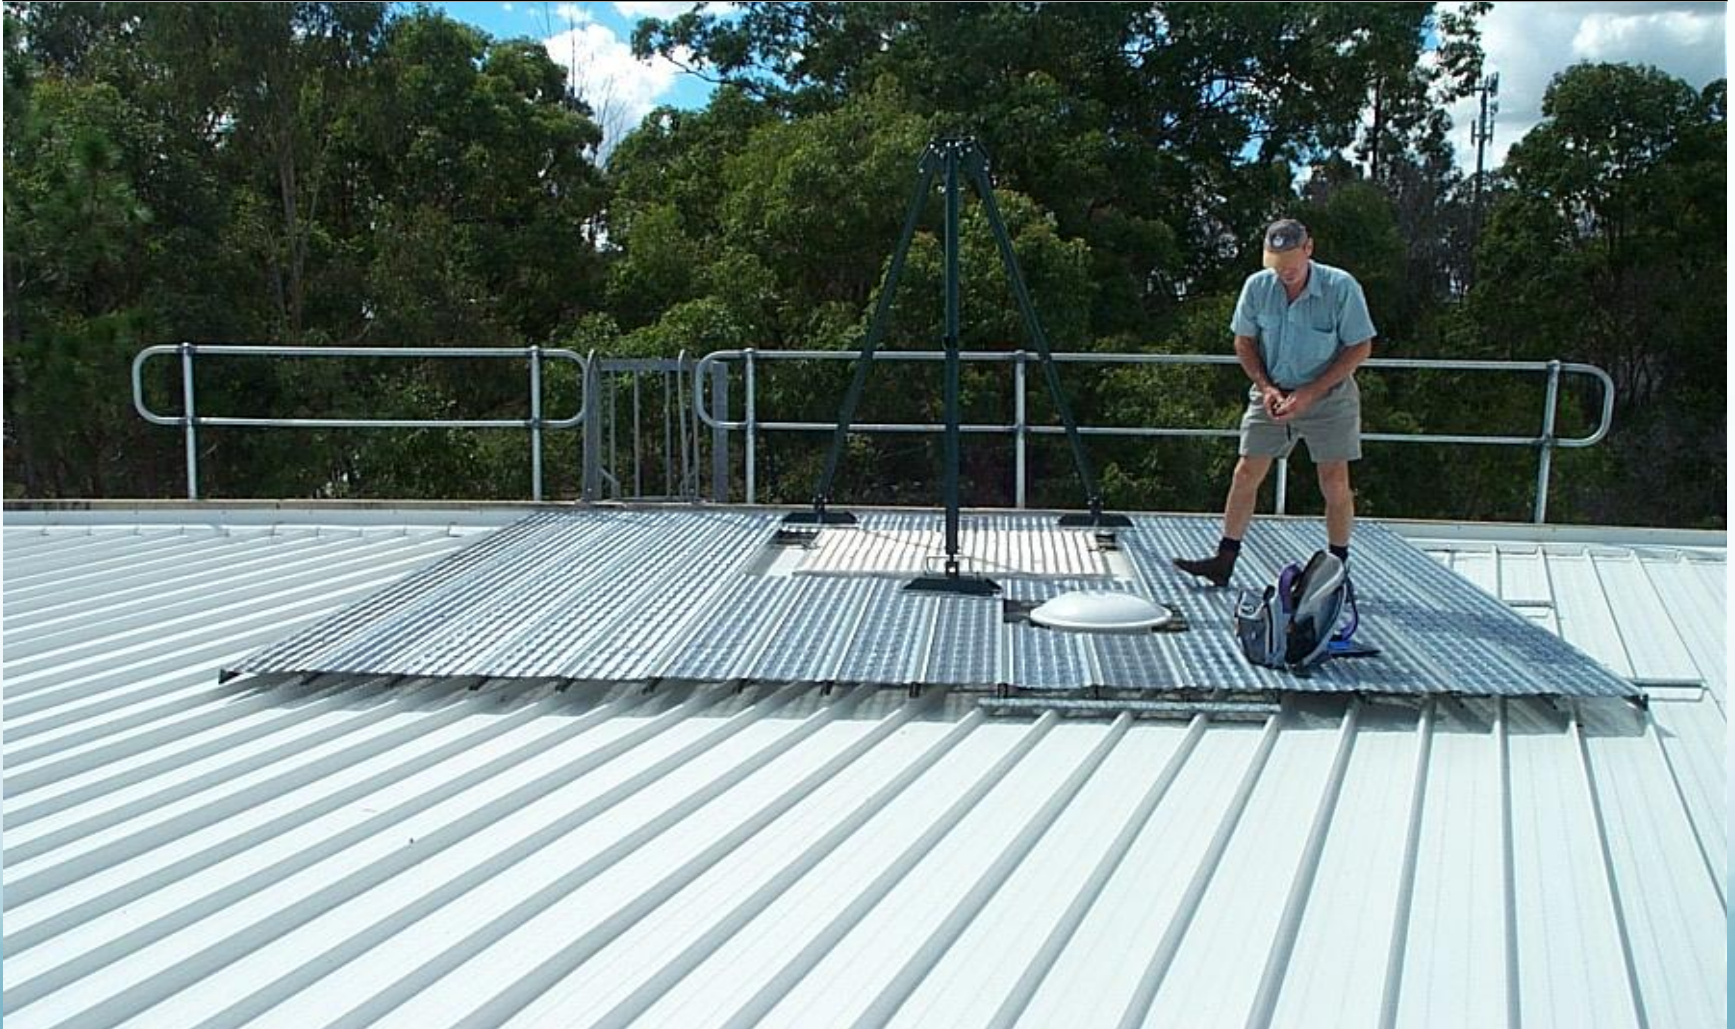
A new roof and platform, however a roof vent was placed right in the middle of the working area – this DOES count as a trip hazard!

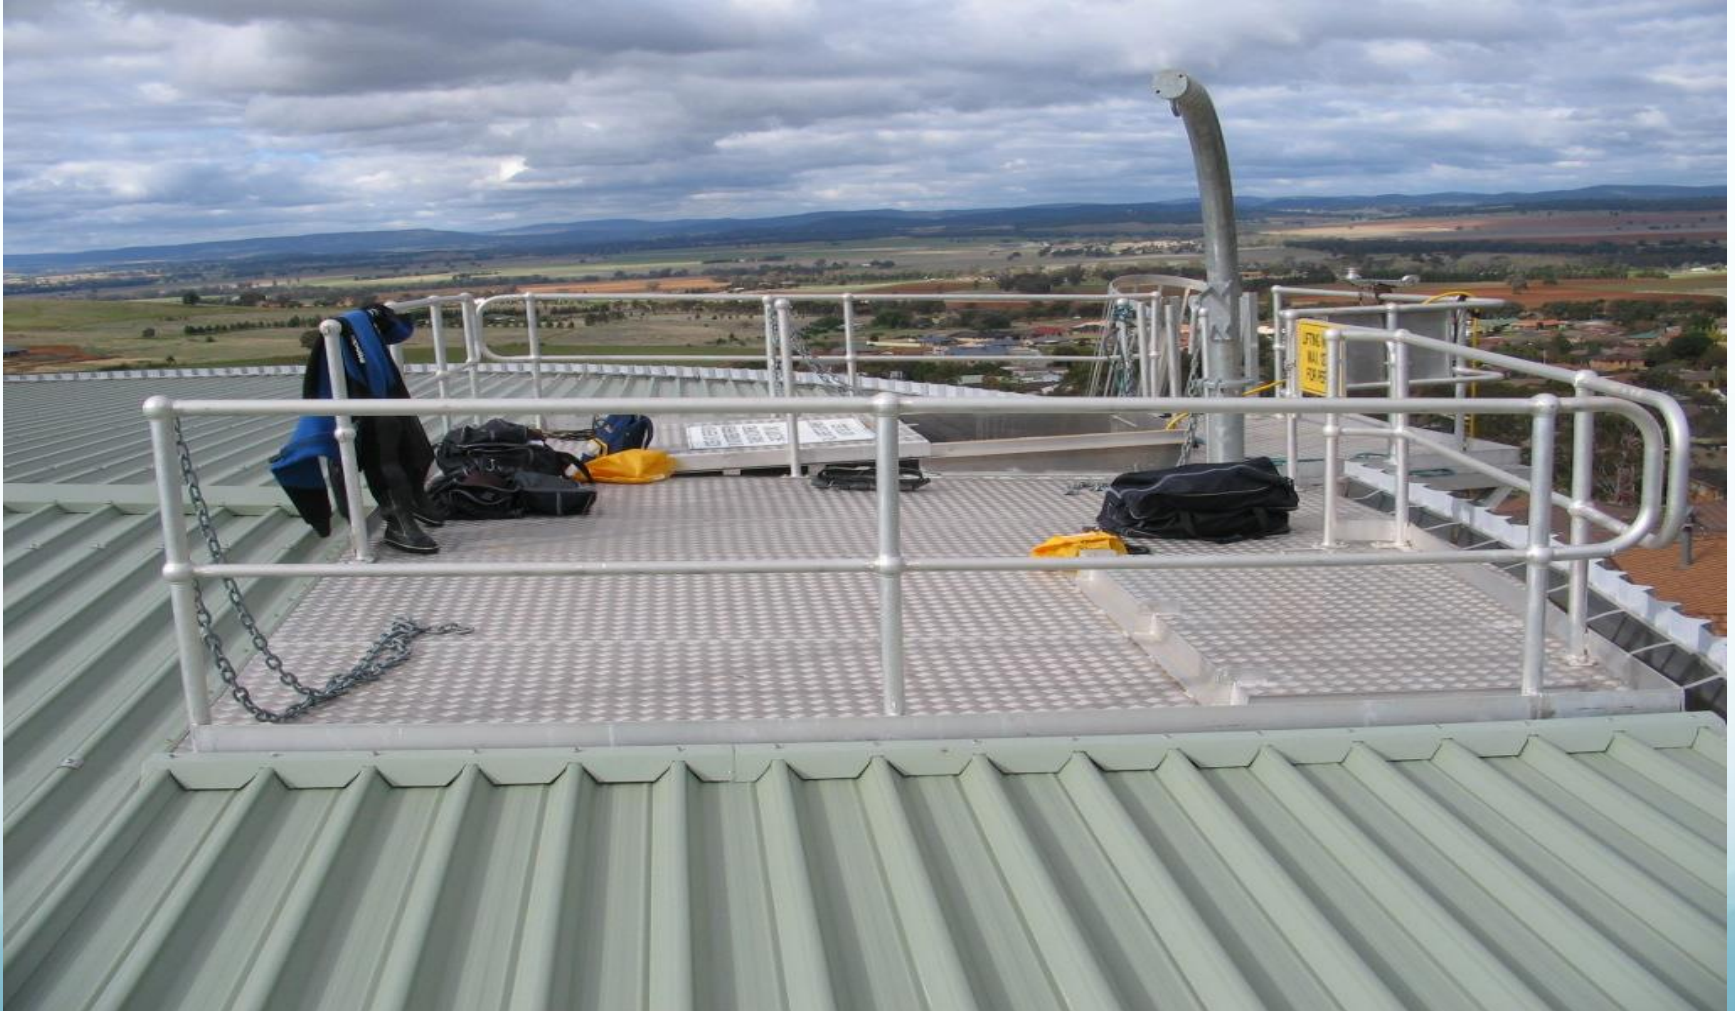
This new platform layout is a big improvement – it has a good slope for effective drainage and a rescue system is in place.

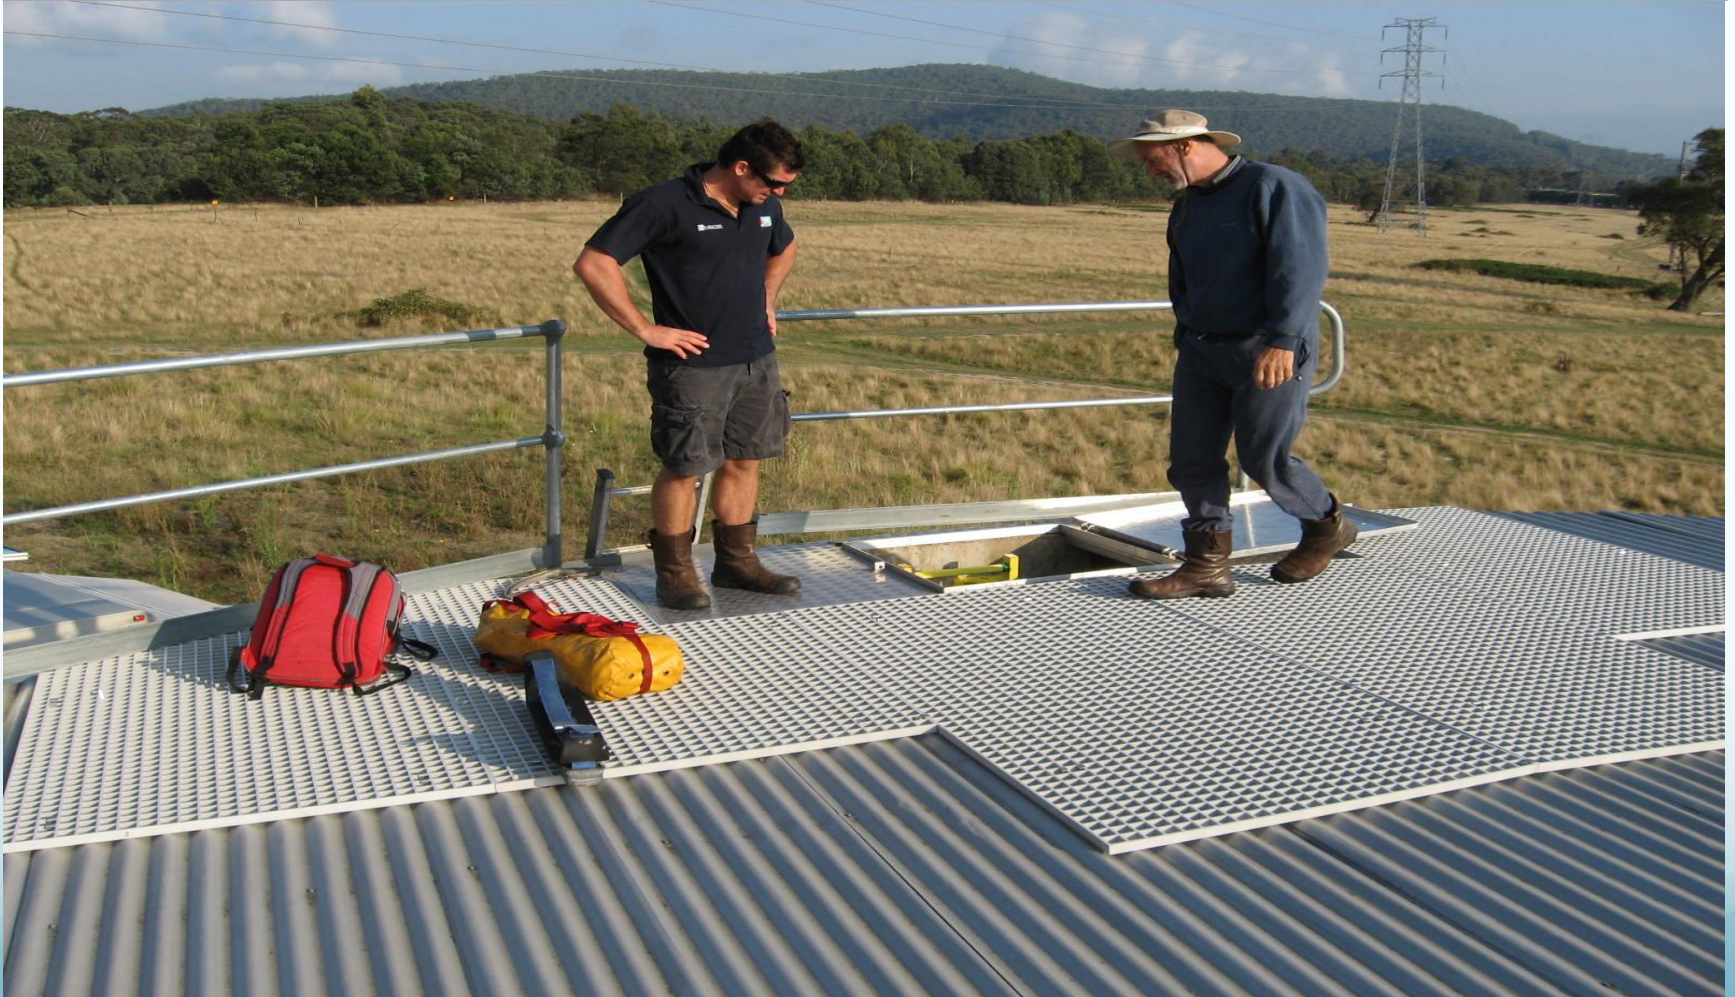
A simple 'open plan' upgrade on a small tank – adequate guard rails around the sealed hatch area and FRP mesh protecting the adjacent roof sheets.

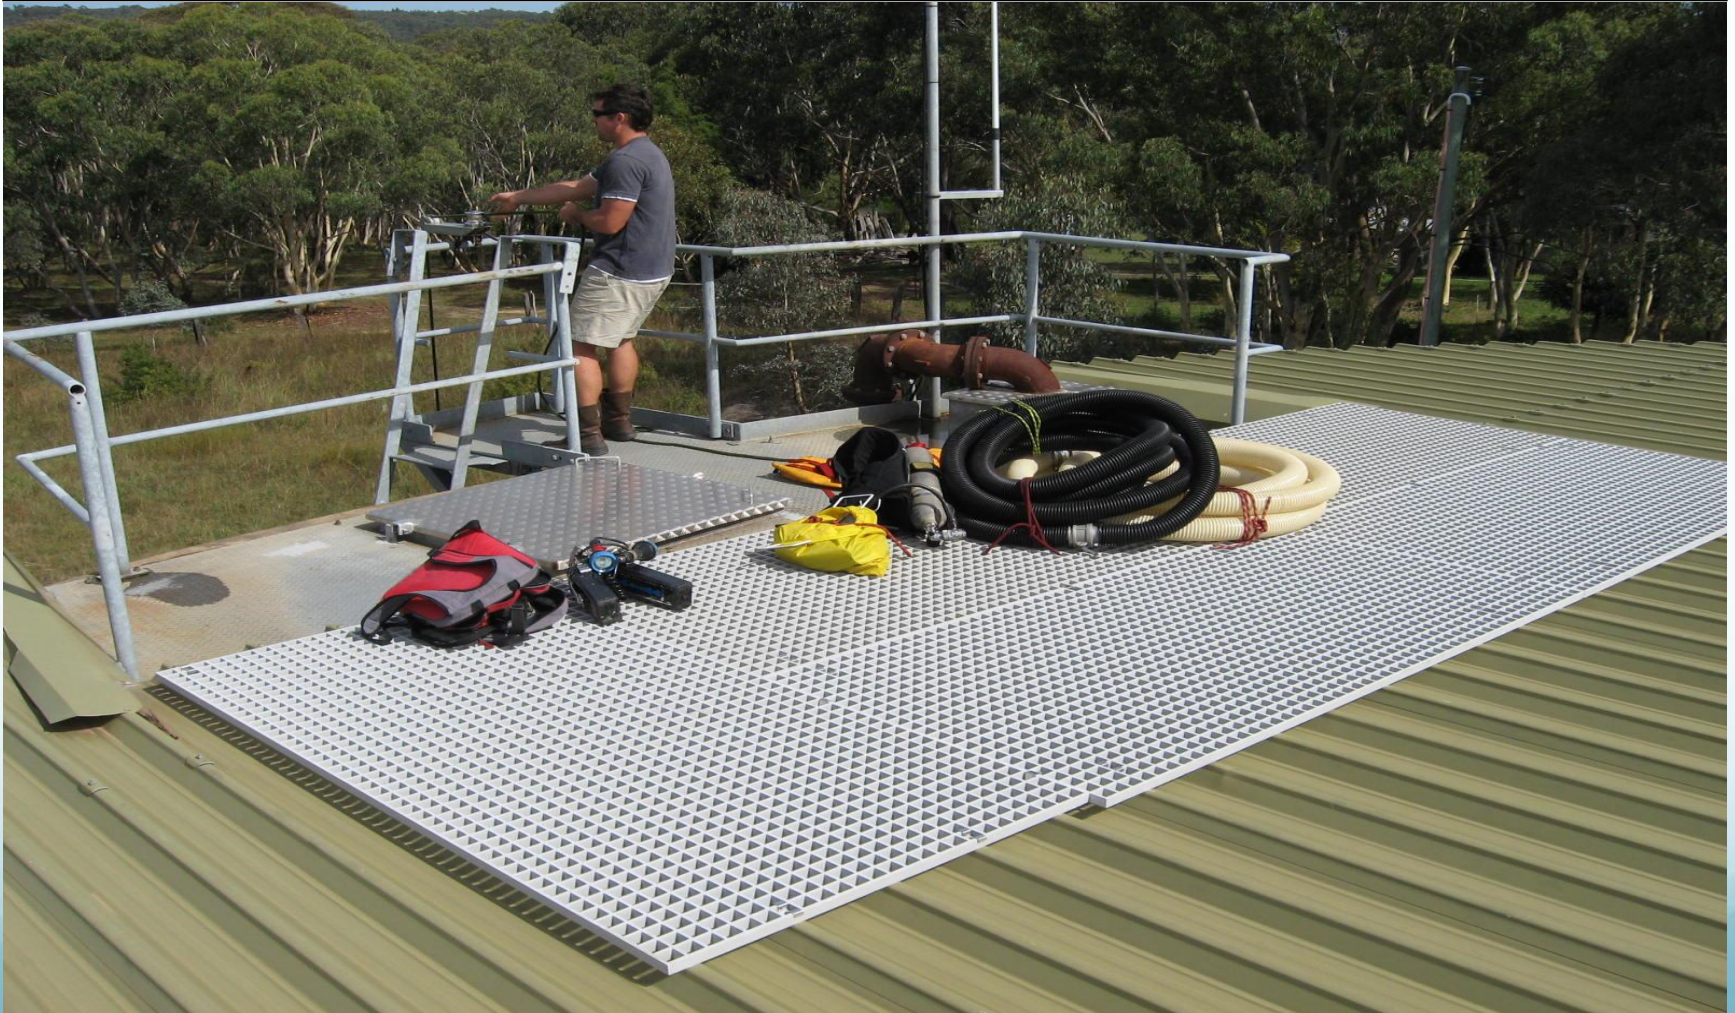
Another simple renovation – extra guard rails, a new overlapping hatch cover and the adjacent roof sheets protected to increase the available working area.

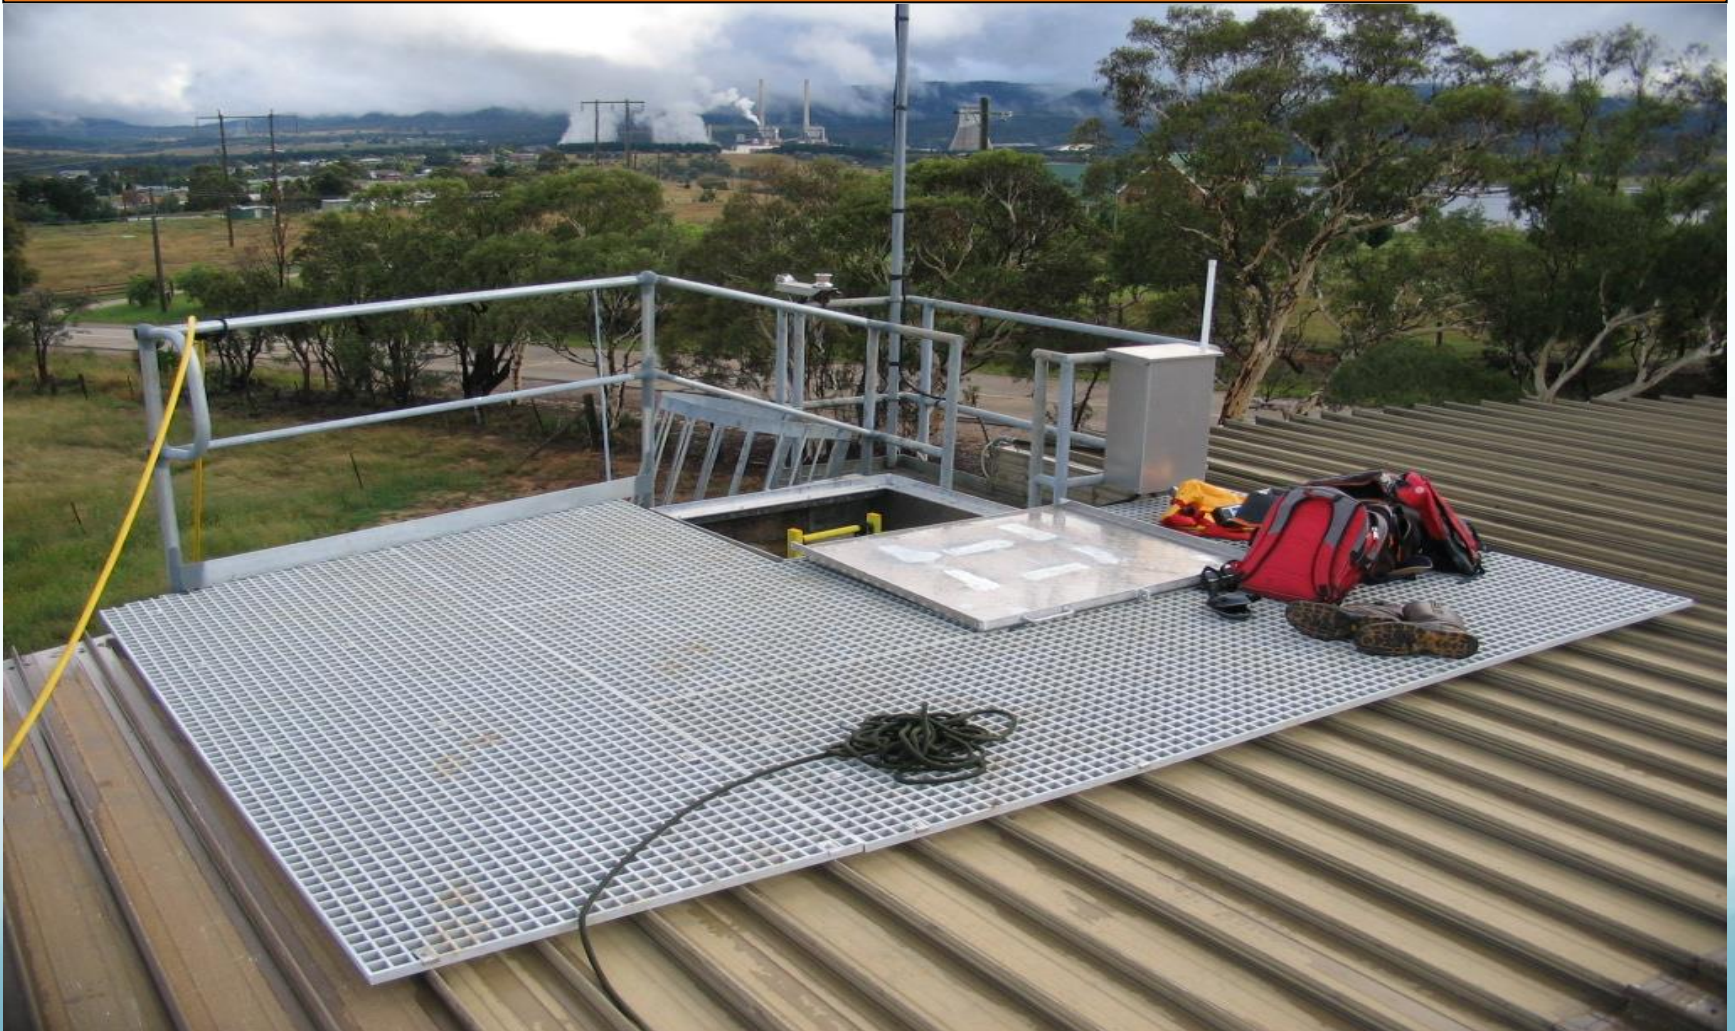
A new enlarged and fully sealed entry hatch, additional guard rails and an 'open plan' working area – note the telemetry control box located in a sensible position.

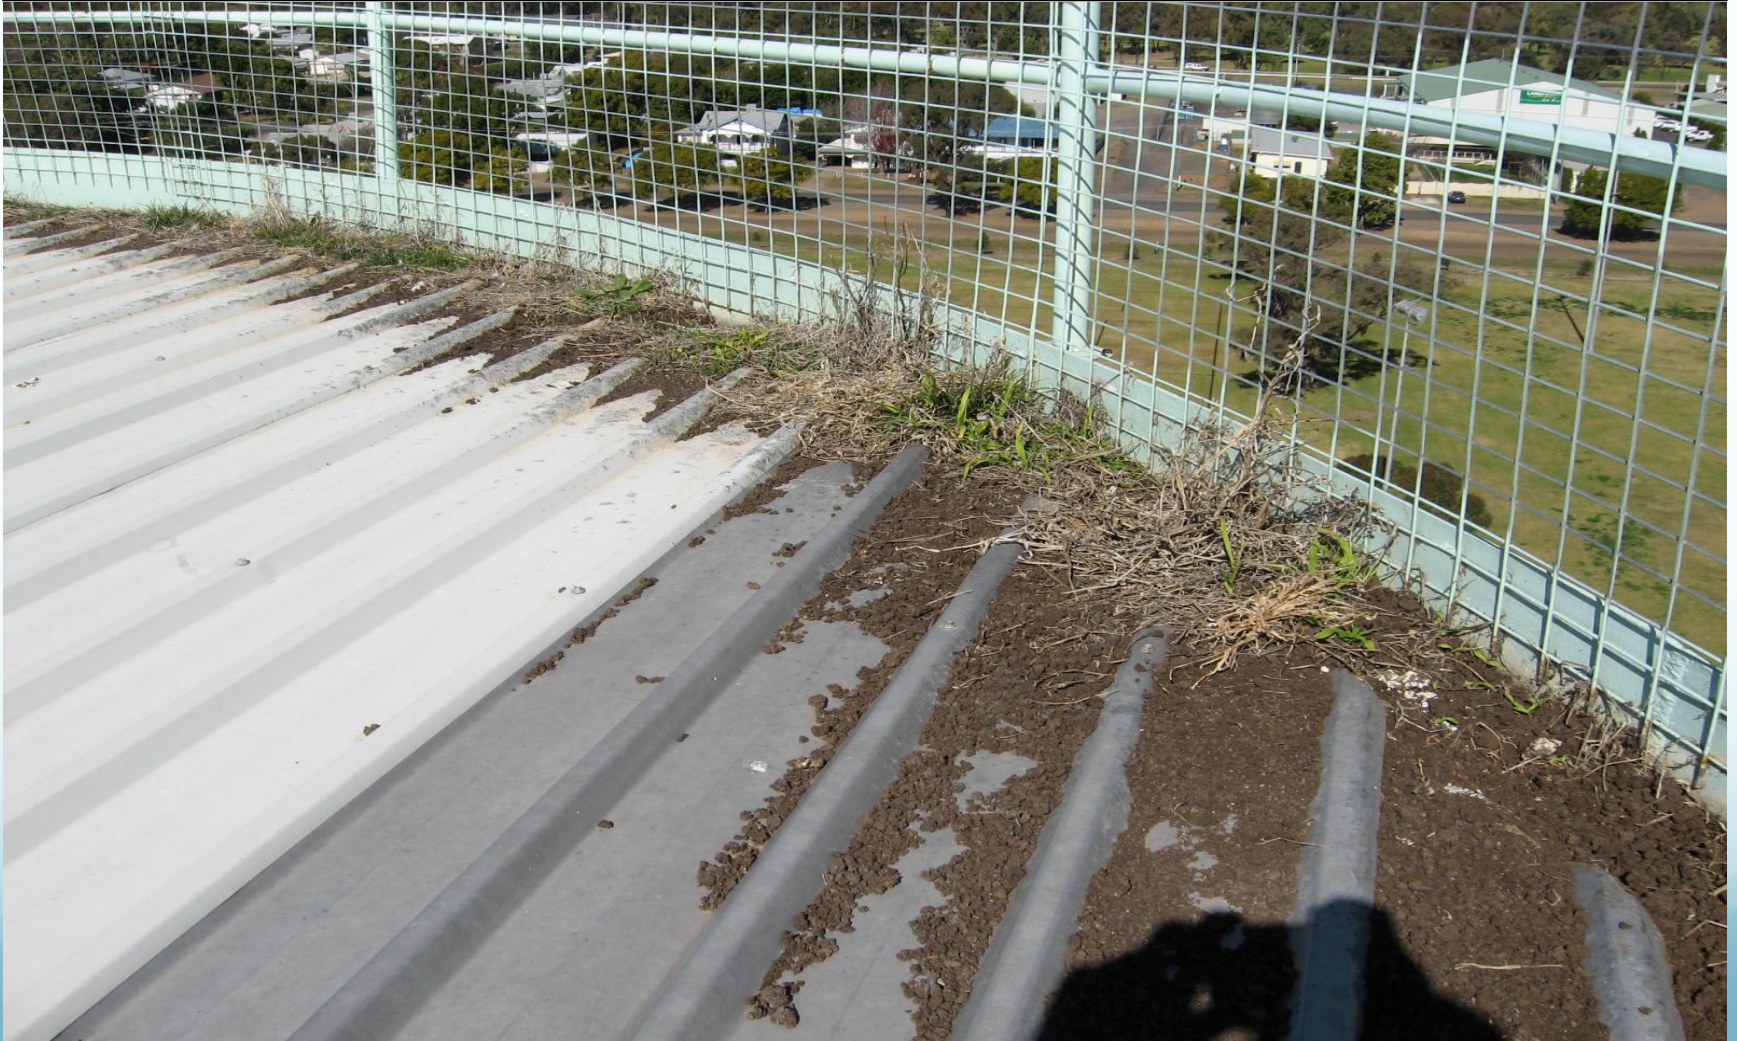
The roof area has not been maintained and the internal gutters are totally blocked with bird faeces and debris – this contamination drains back into the tank during rain events.

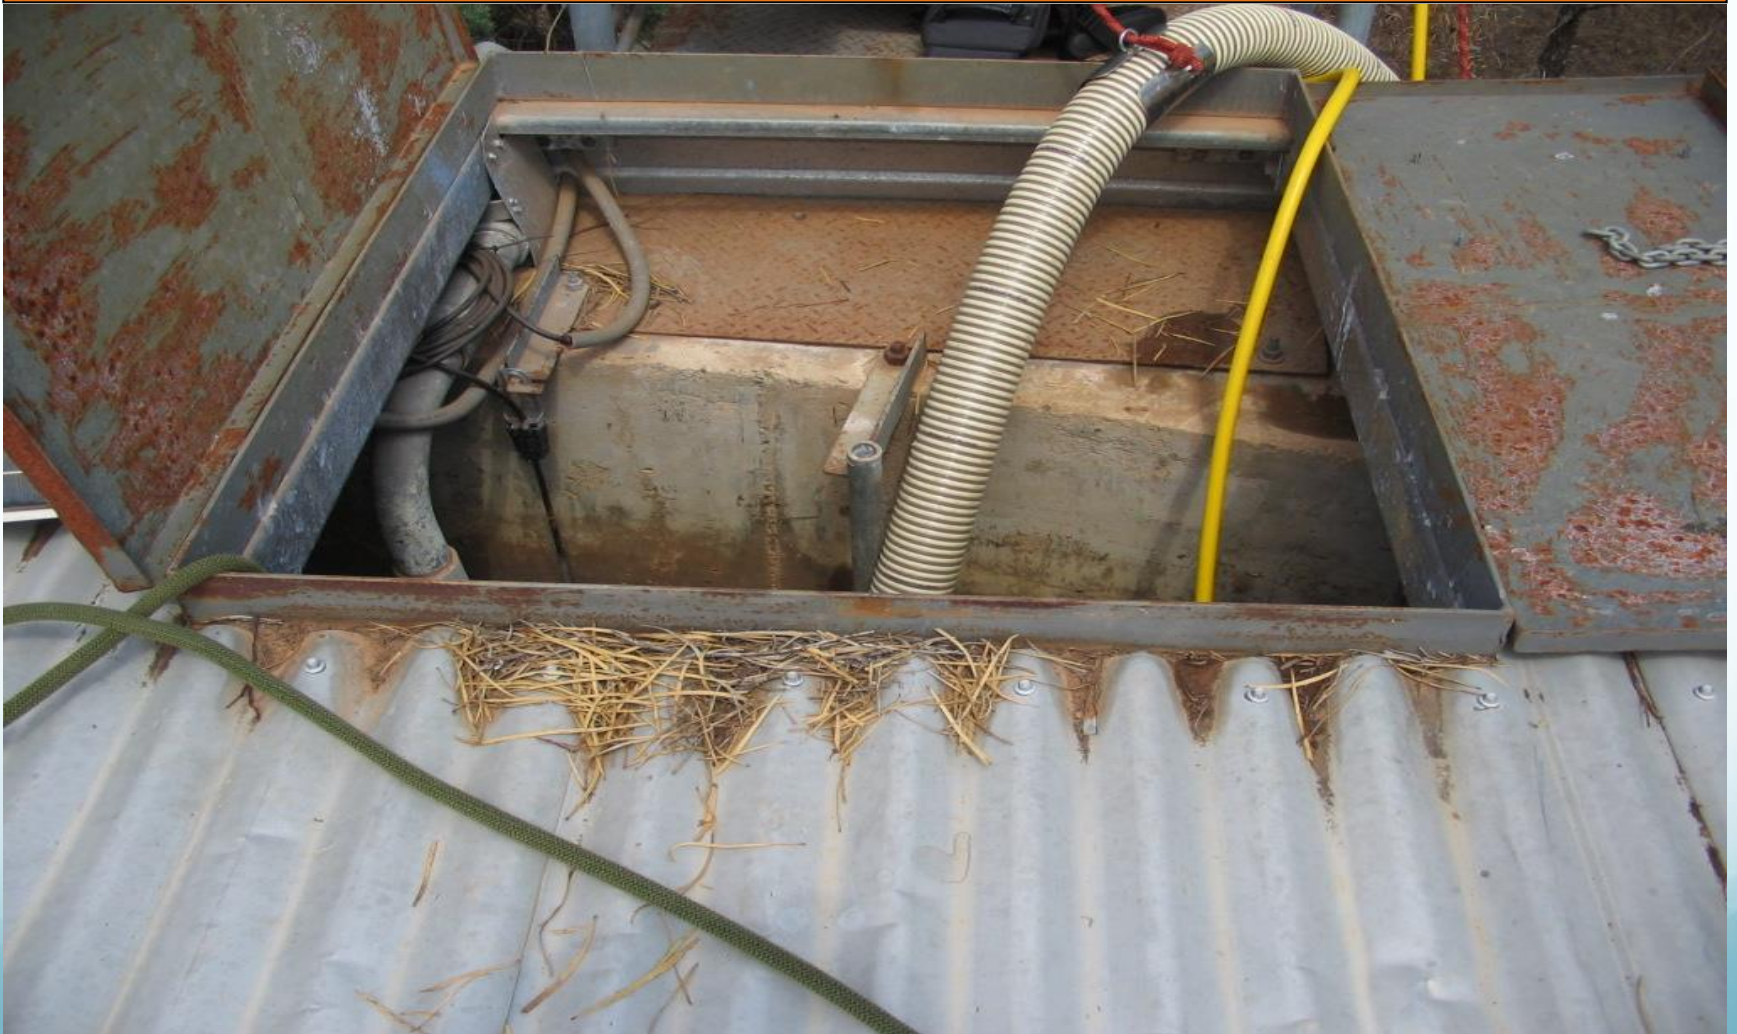
The roof sheets are fastened directly onto the hatch frame and have no means of draining water and debris away from this area - the ponded water leaks into the tank.

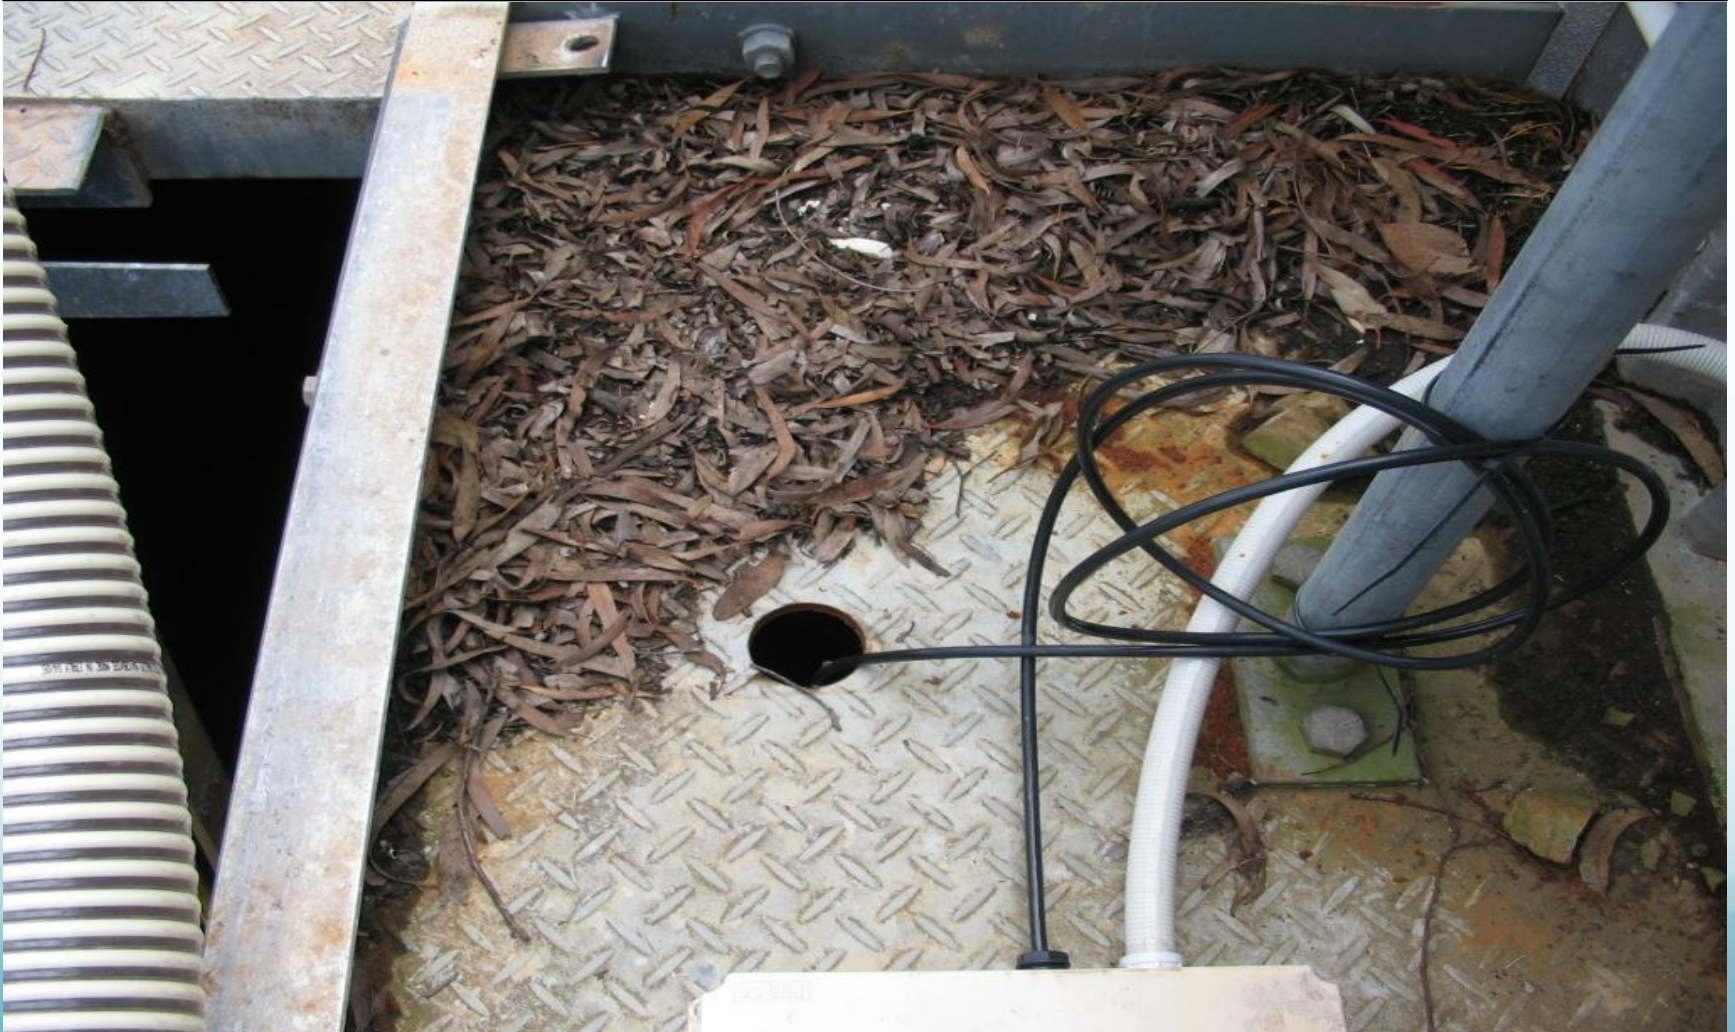
A significant hole has been cut into the platform area to service a sensor unit – all this accumulated material is finding its way into the tank.

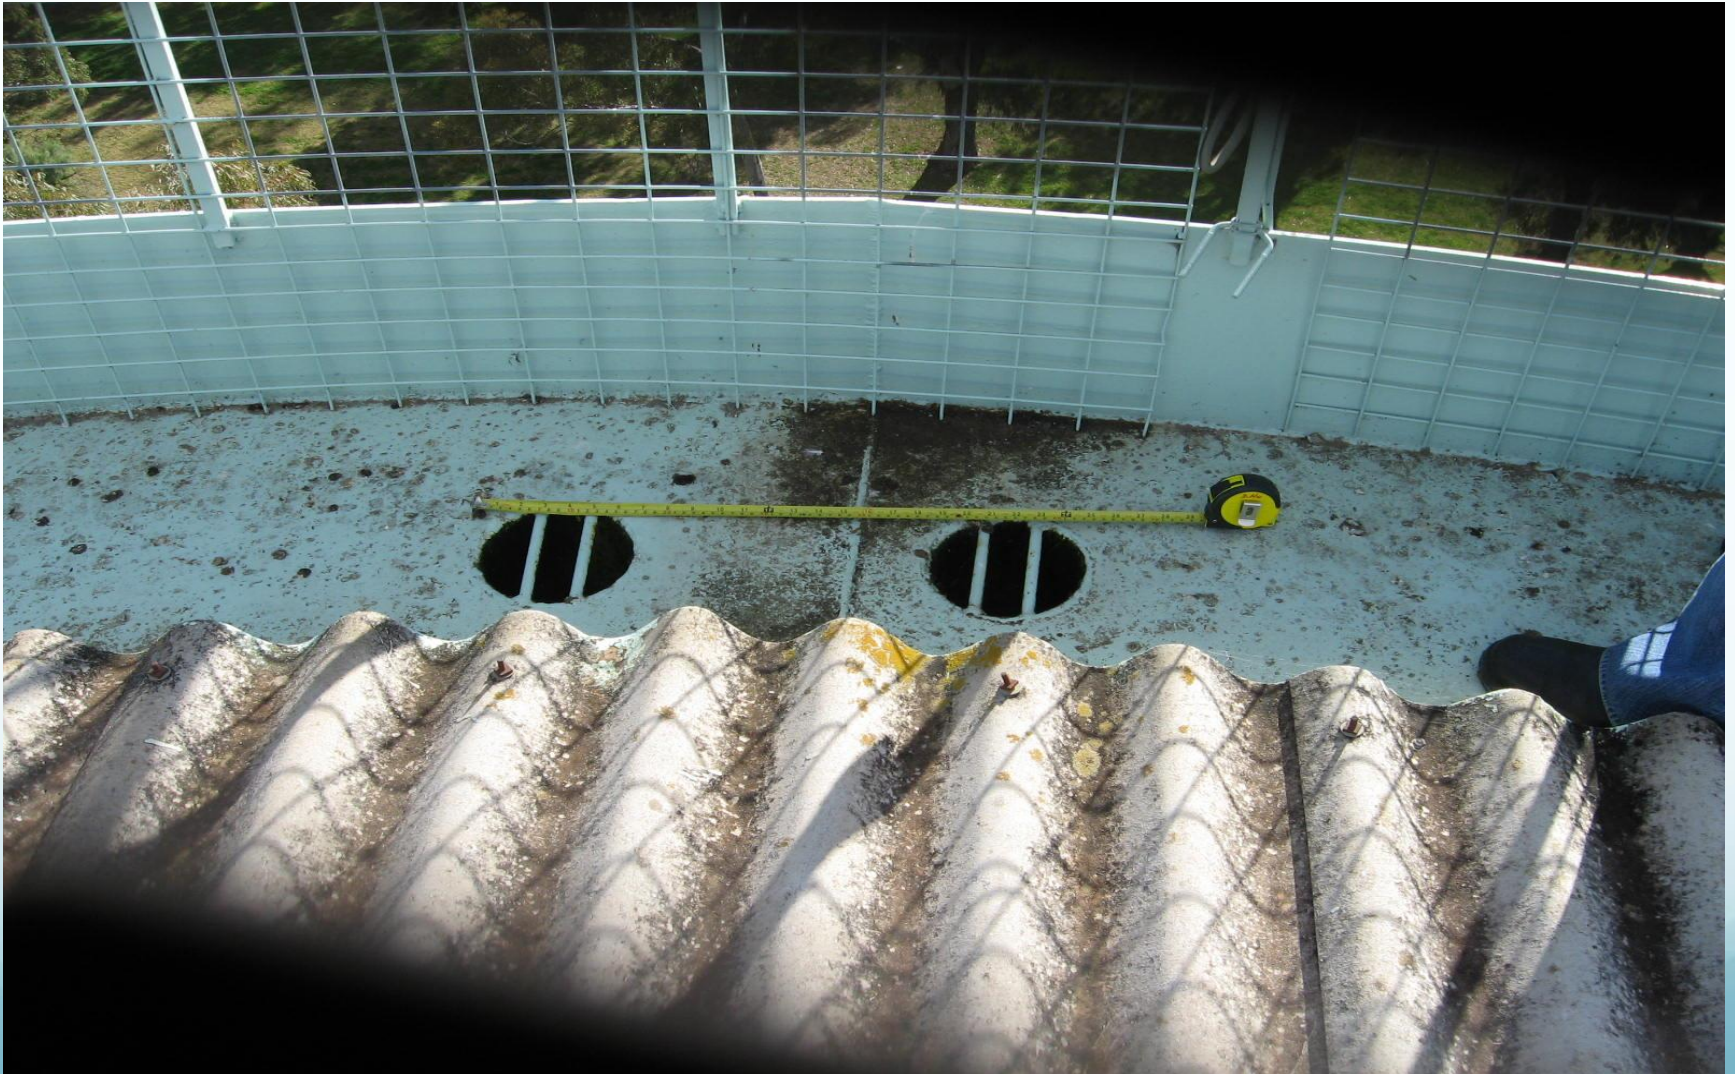
These roof drains appear to be OK – until you look underneath the platform area!
