RESERVOIR RENOVATIONS – BEST CHANCE OR LOST CHANCE

This paper will highlight the key areas where old designs were deficient and it will also offer solutions to improve the safety of both operations personnel and the stored water.

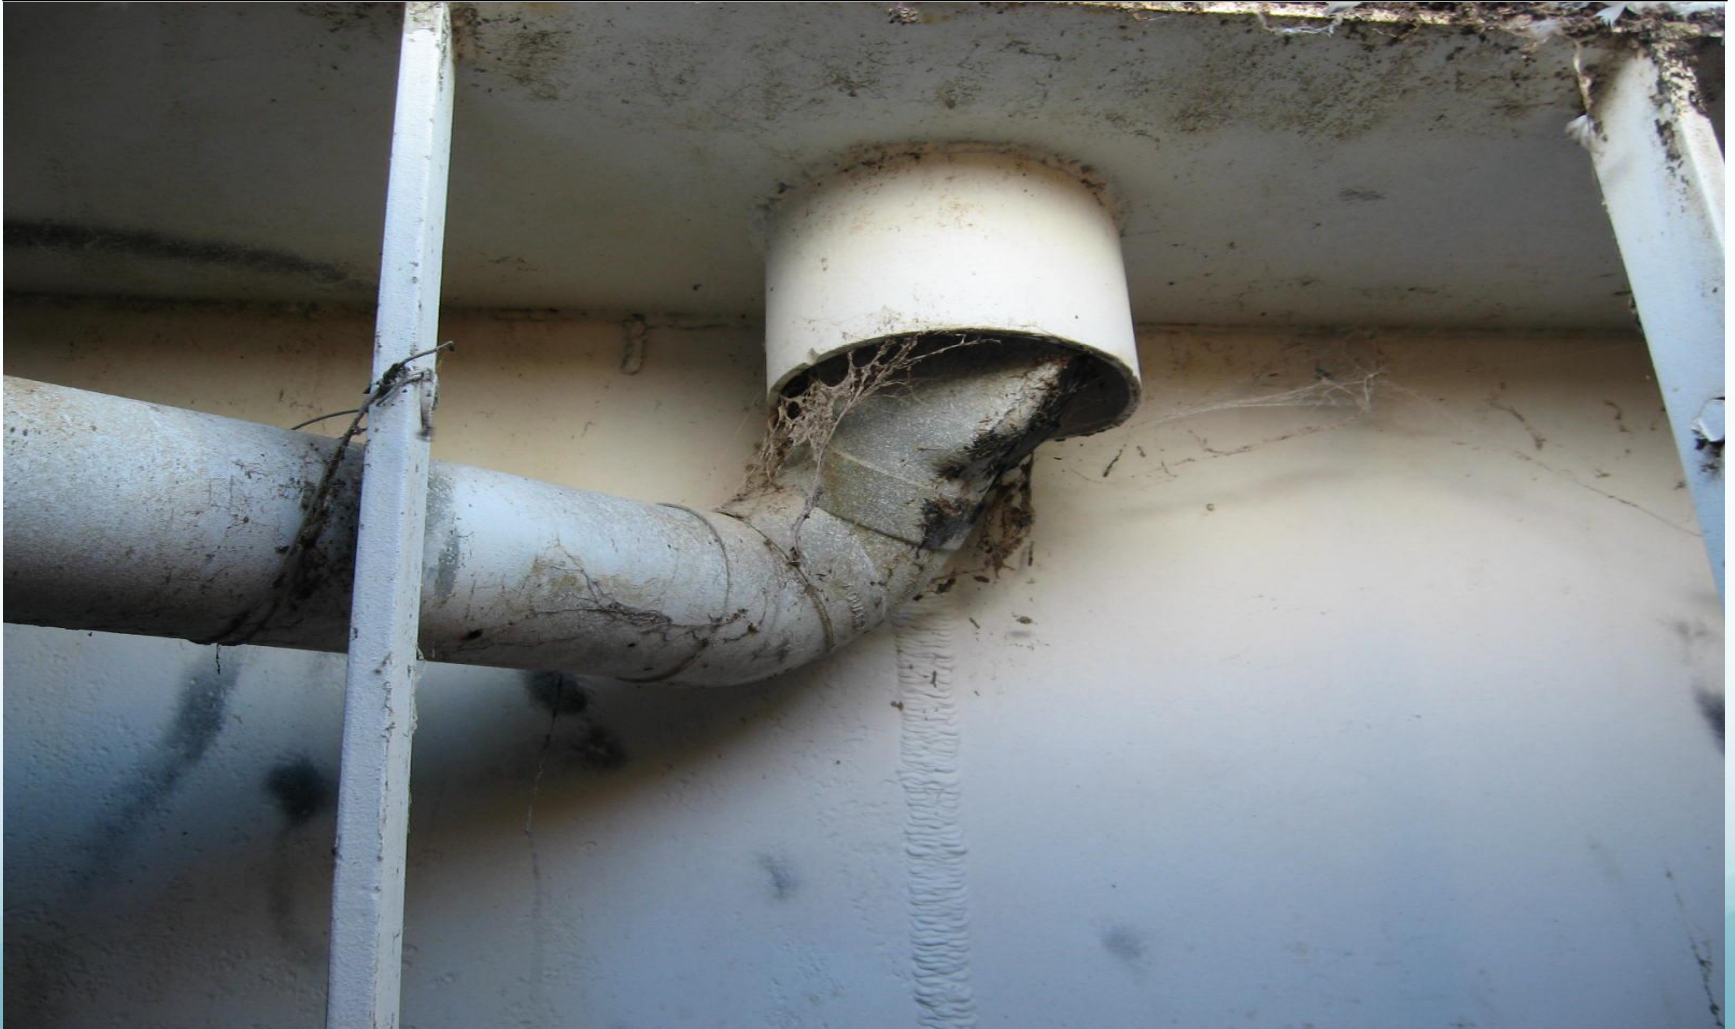
A piece of 90mm storm water pipe is simply pushed inside a 150mm drain point – and expected to prevent excess water and contamination from entering the tank!

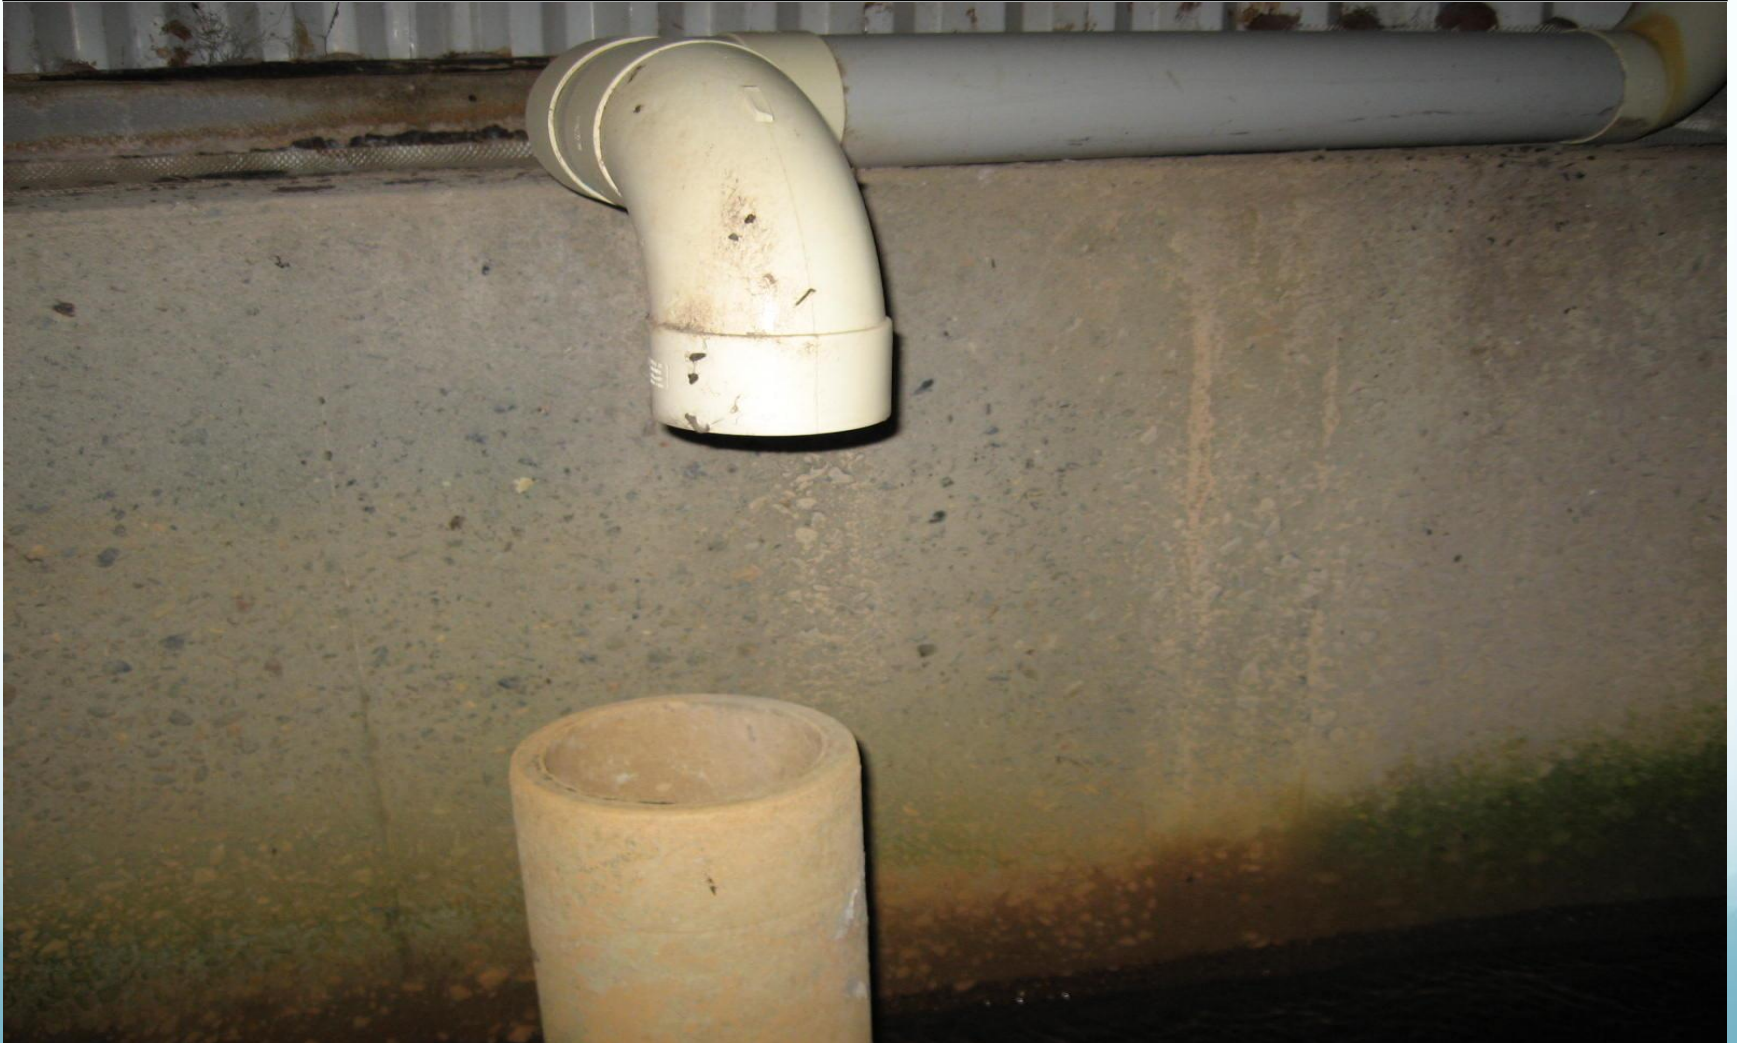
Another example of a roof drain which is not connected into anything – this was very simple to fix once it was identified.

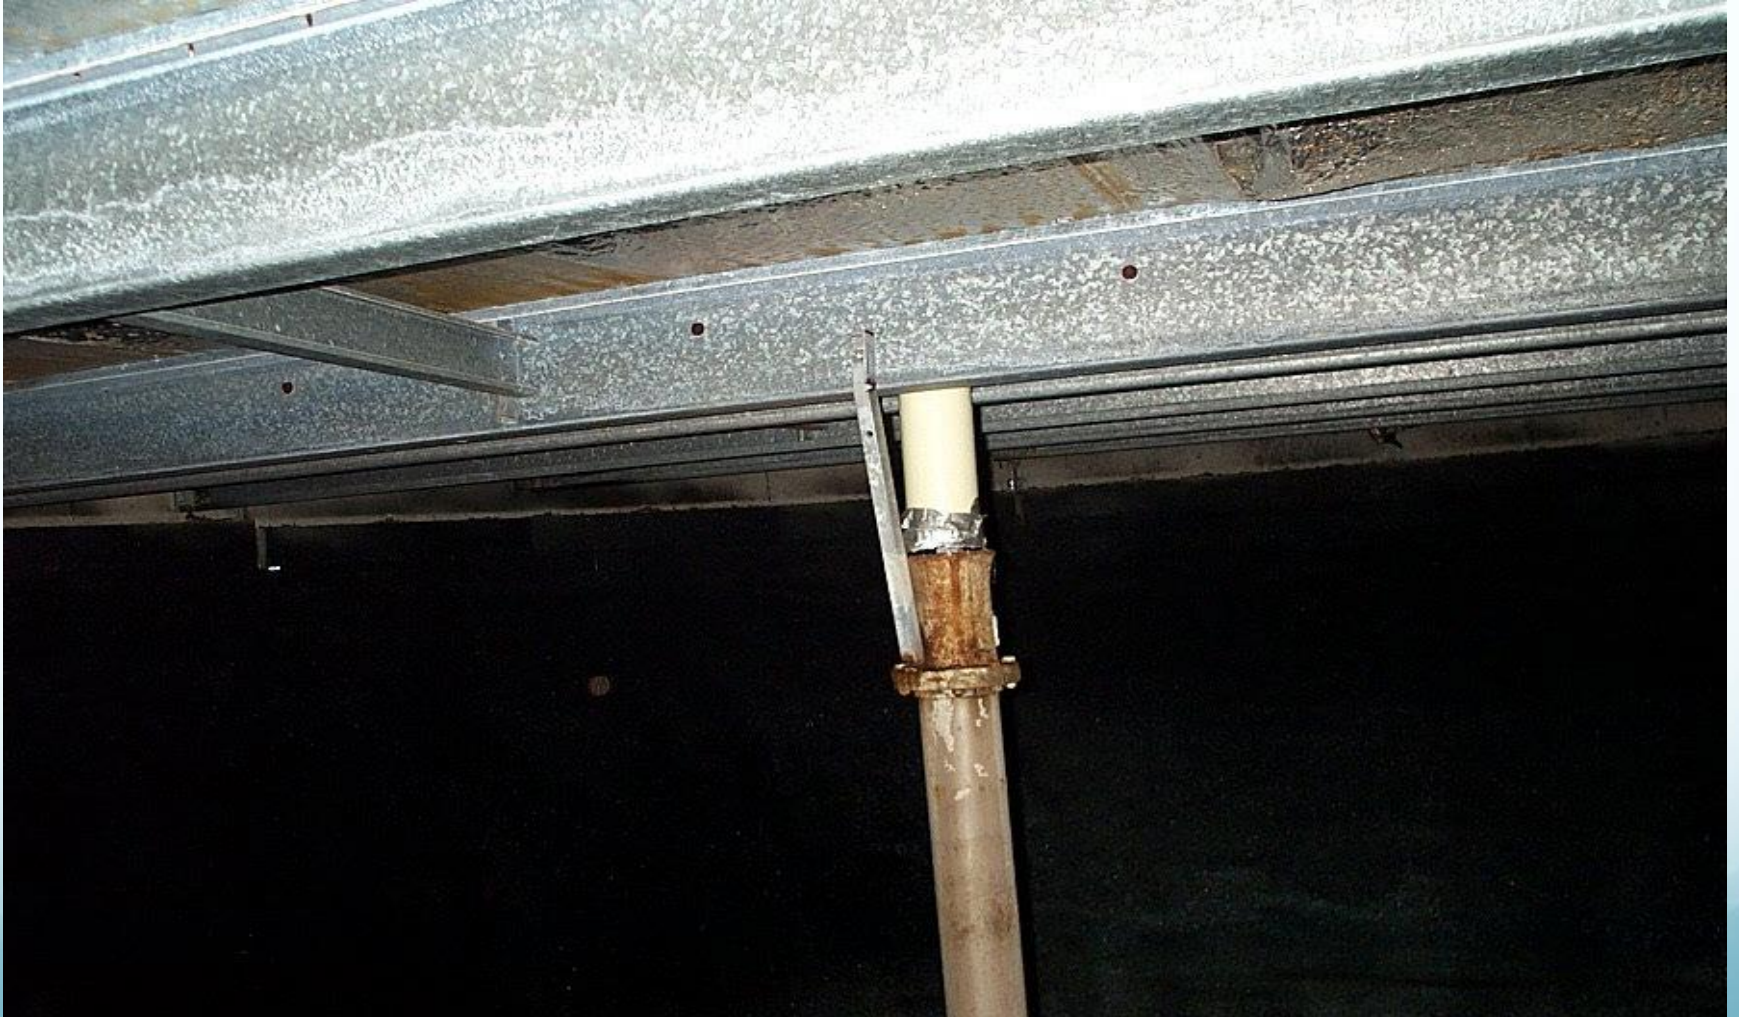
This drain point is only slightly better – at least some duct tape has been used to try and create a seal between the pipes!

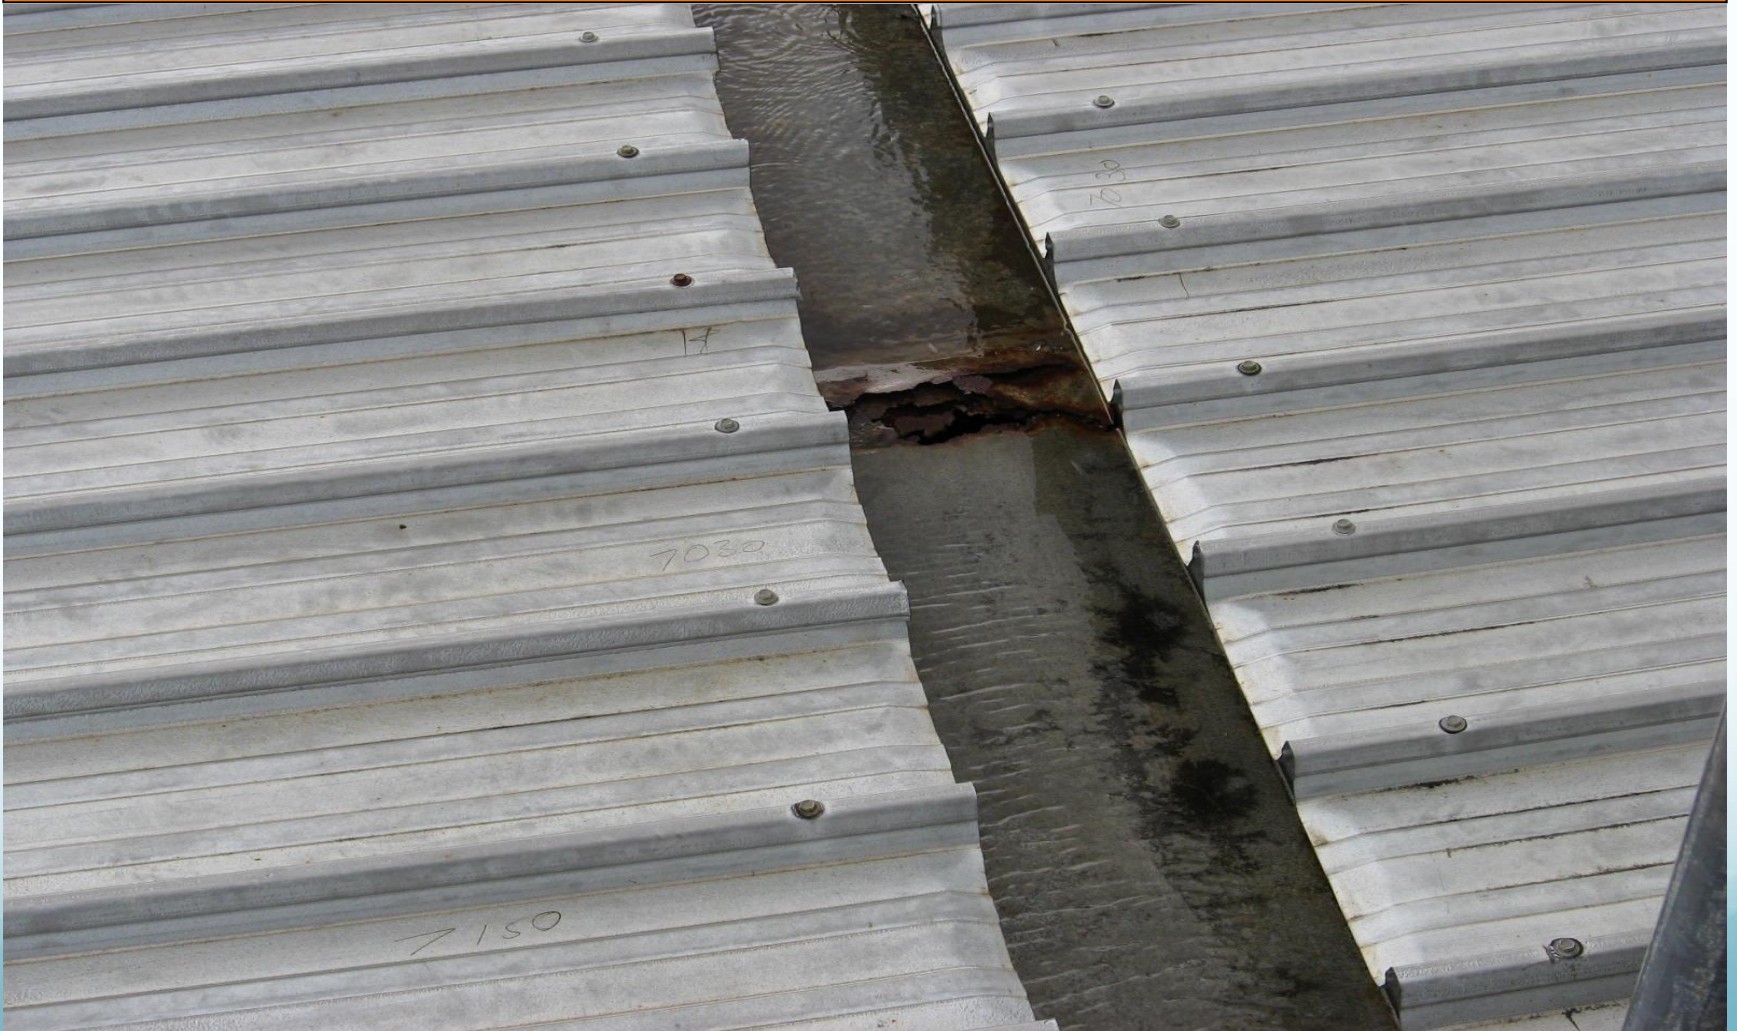
This box gutter has corroded away and is now draining all of the roof directly into the tank

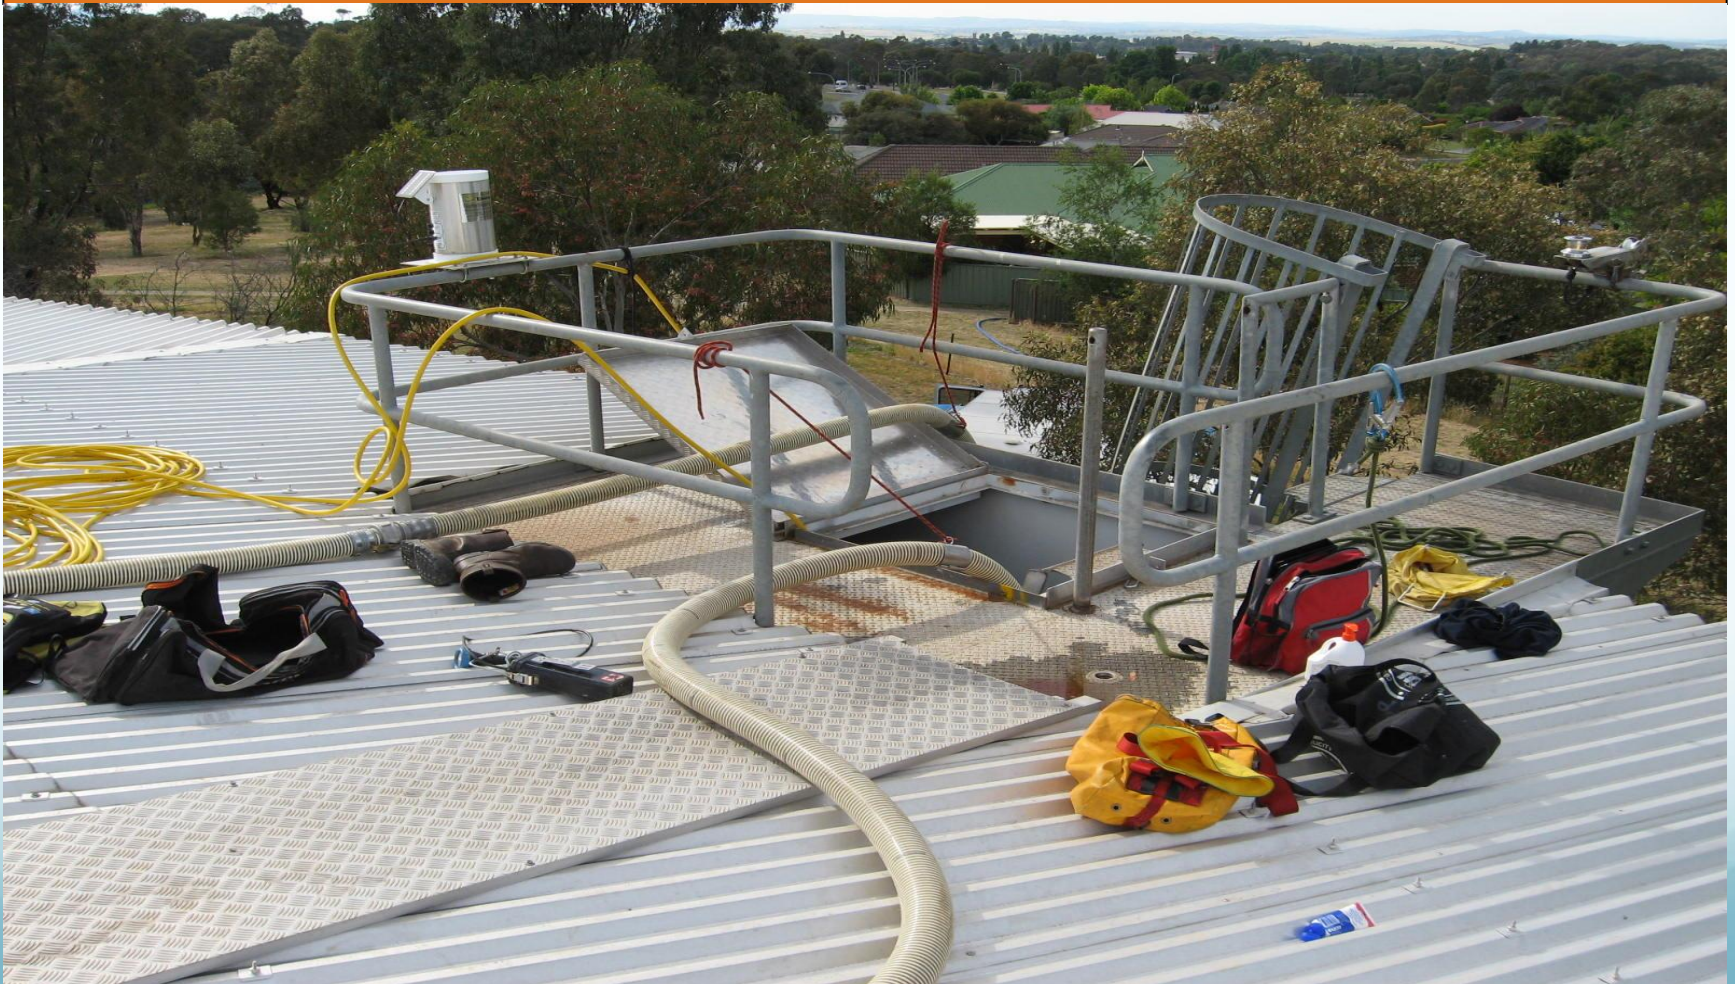
This platform has a reverse fall and water was ponding around the entry hatch area – a simple drain point was cut in at the lowest point and then plumbed out through the adjacent side wall area

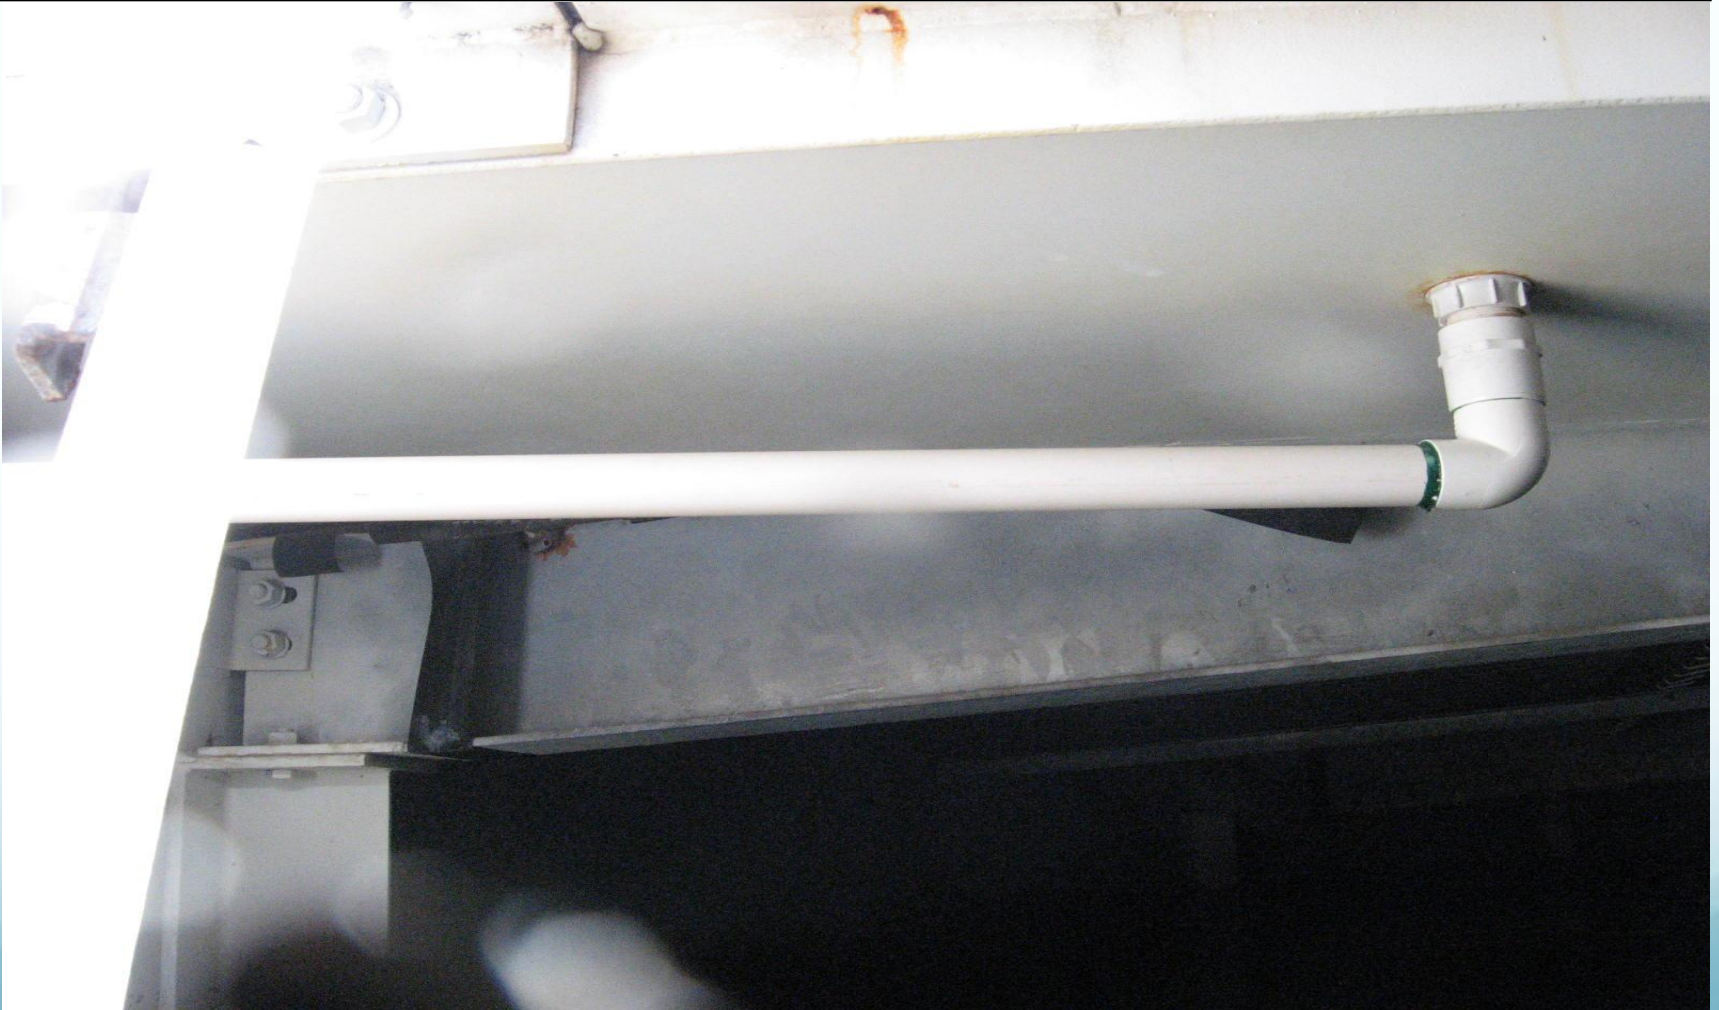
The under side area of the platform – this simple plumbing job was carried out using 'off the shelf fittings' while standing on the internal ladder

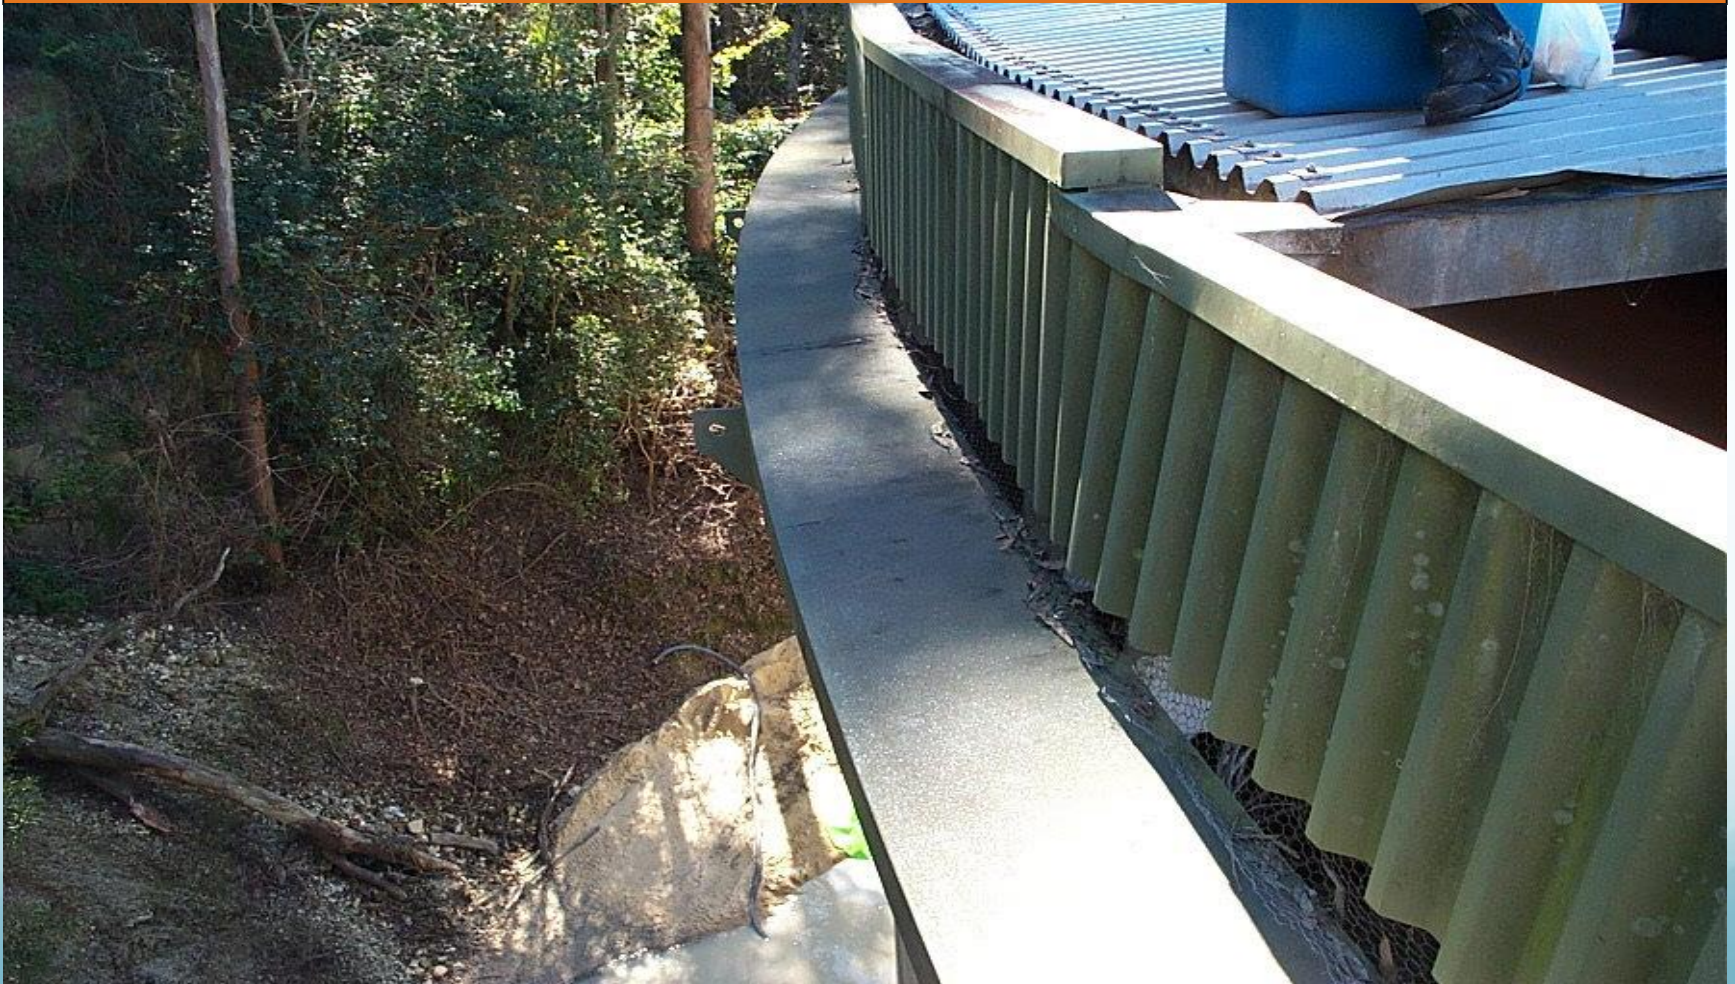
This tank is surrounded by high trees and leaf debris is gathering on the upper wall support ledge and blowing or washing into the tank. The base section needs to be sealed off and fine mesh vents be cut into the side panels at regular intervals.

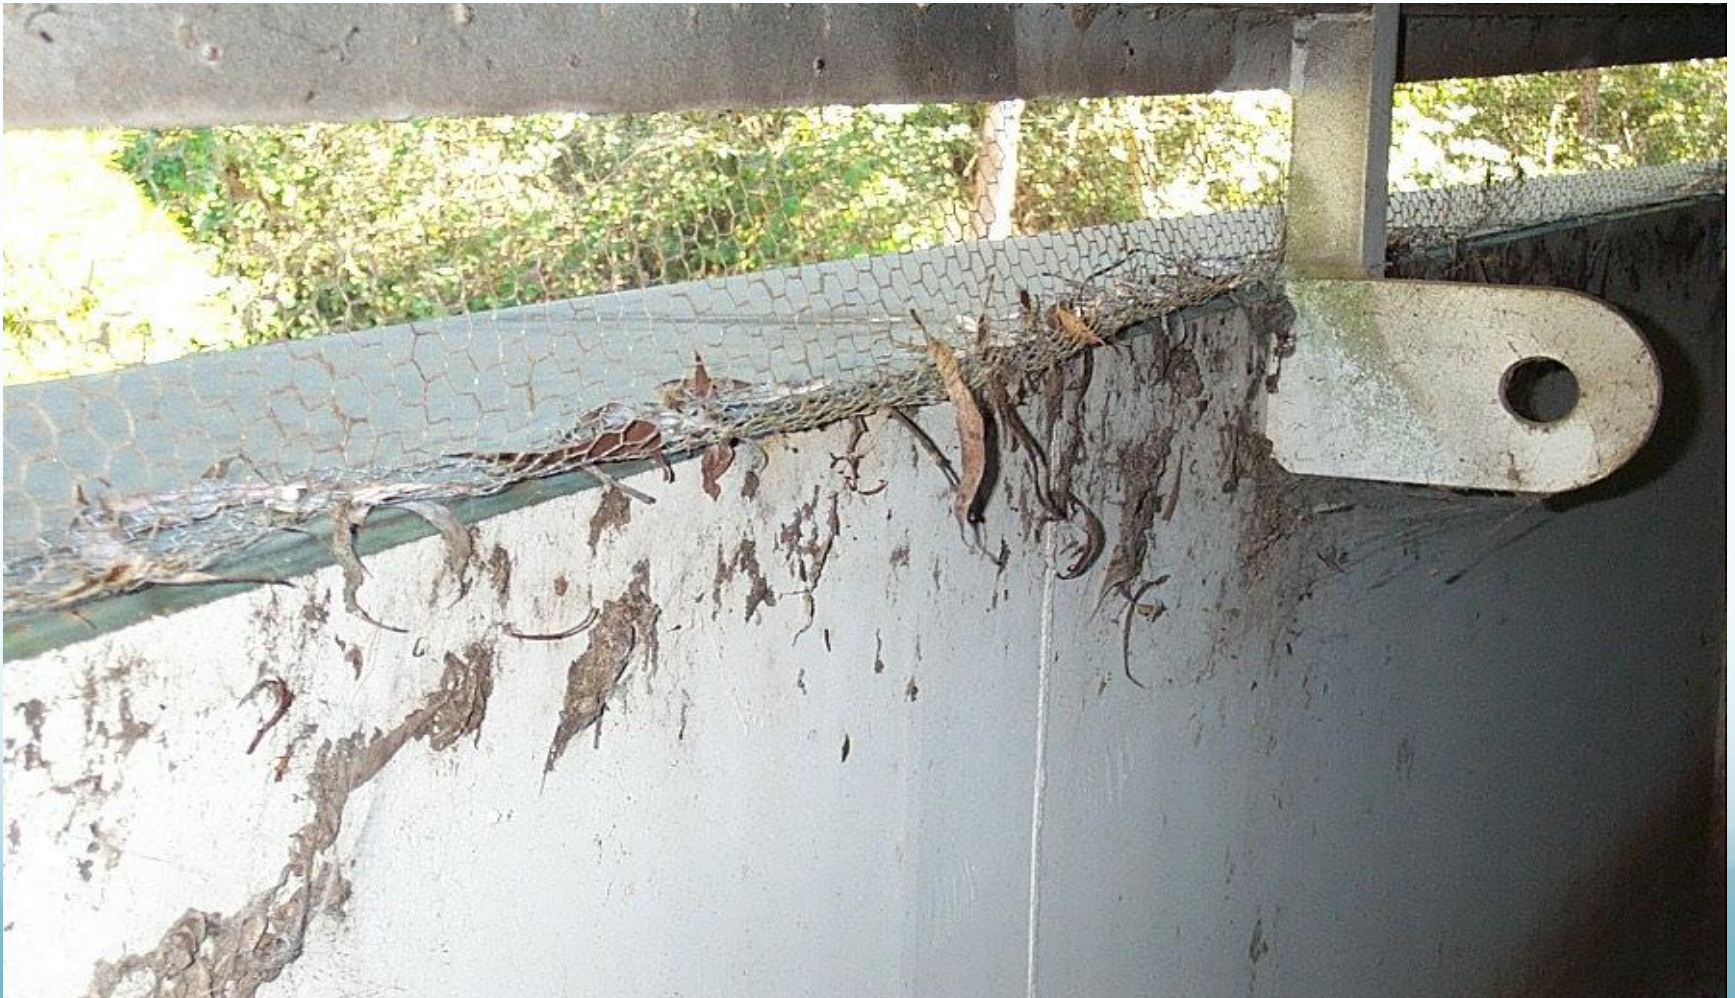
This ventilation is poorly designed – the mesh is too coarse and not sealed along the lower edge, where contamination and debris is collecting and entering the tank.

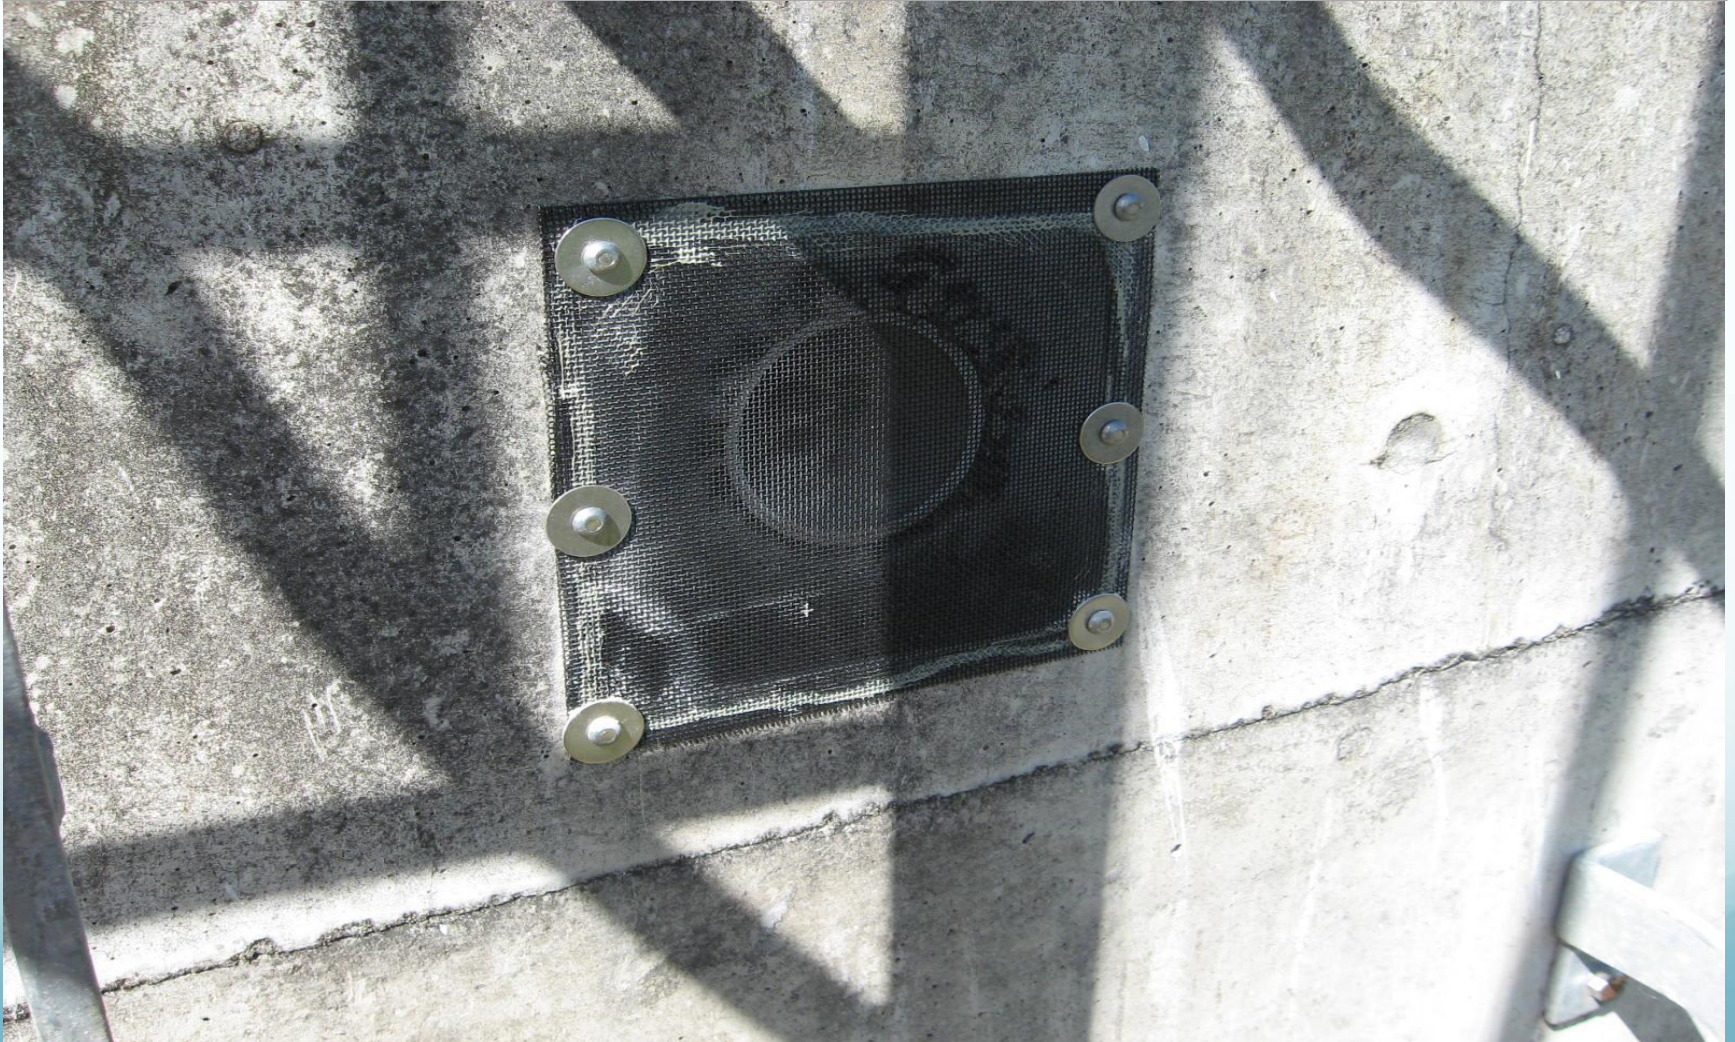
Use ventilation mesh that will not corrode or allow small contamination particles to enter the tank

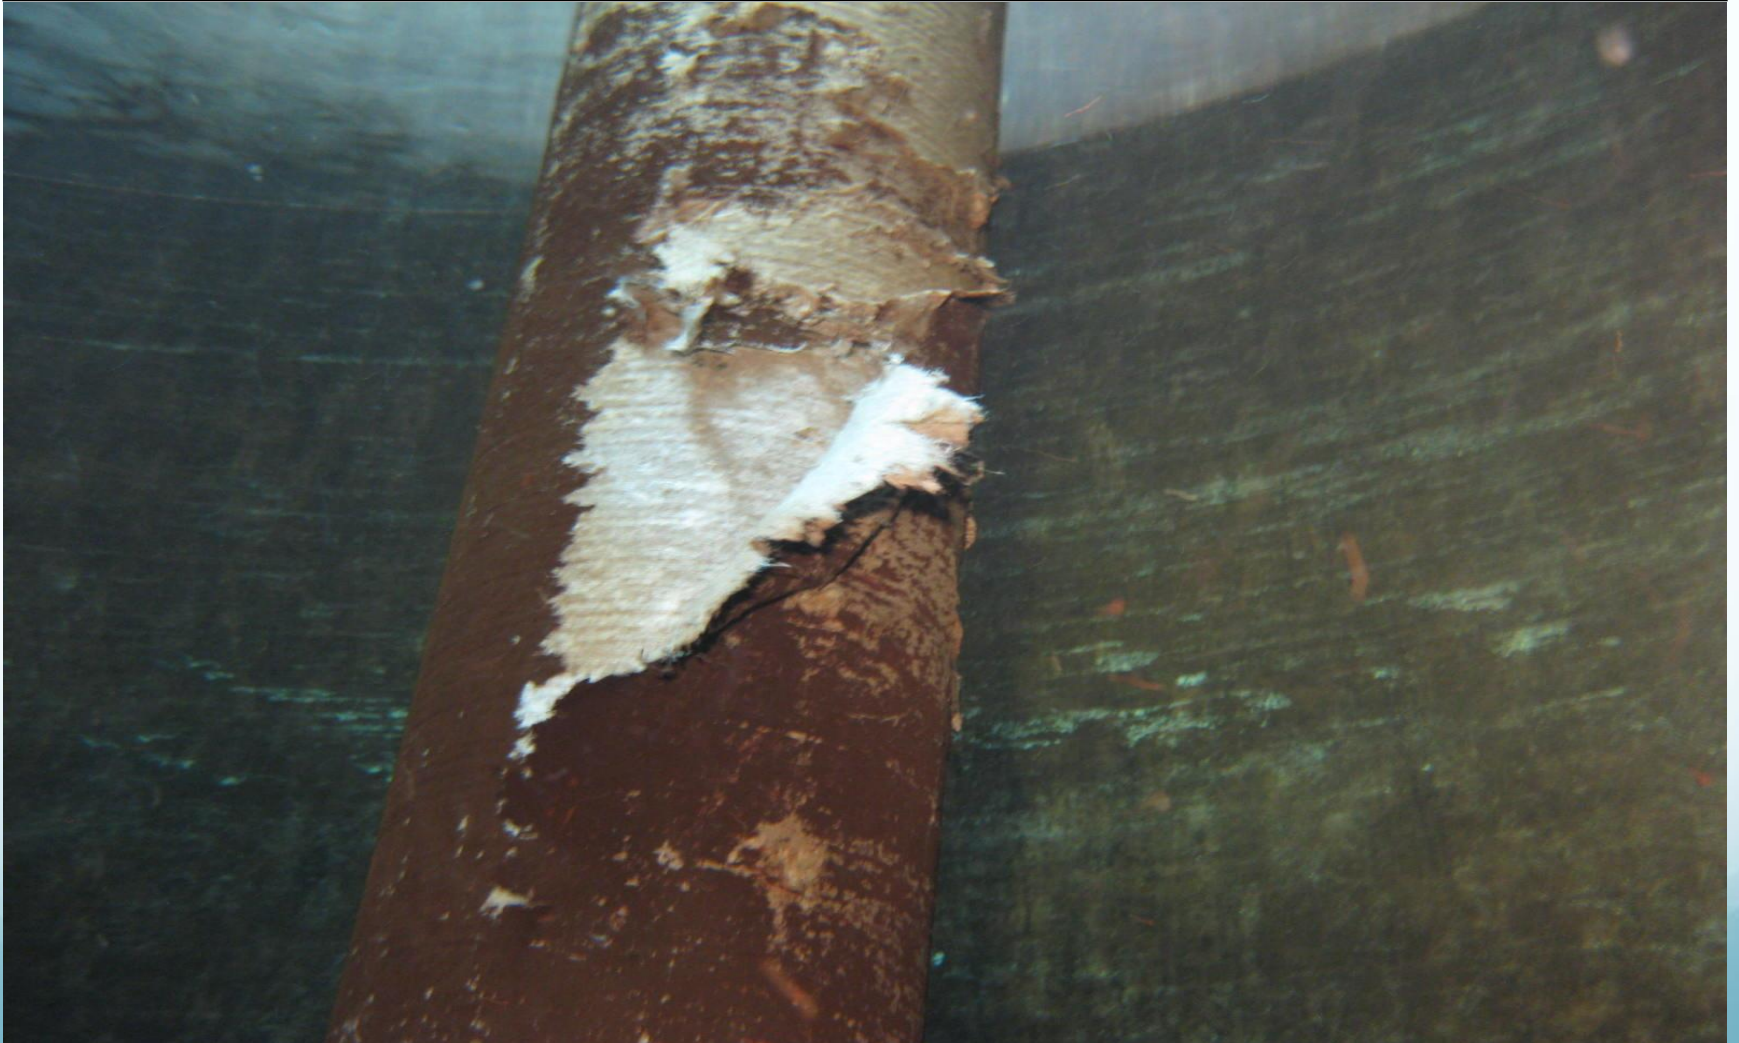
This AC overflow riser pipe has begun to delaminate and the particles are mixing in with the stored water.

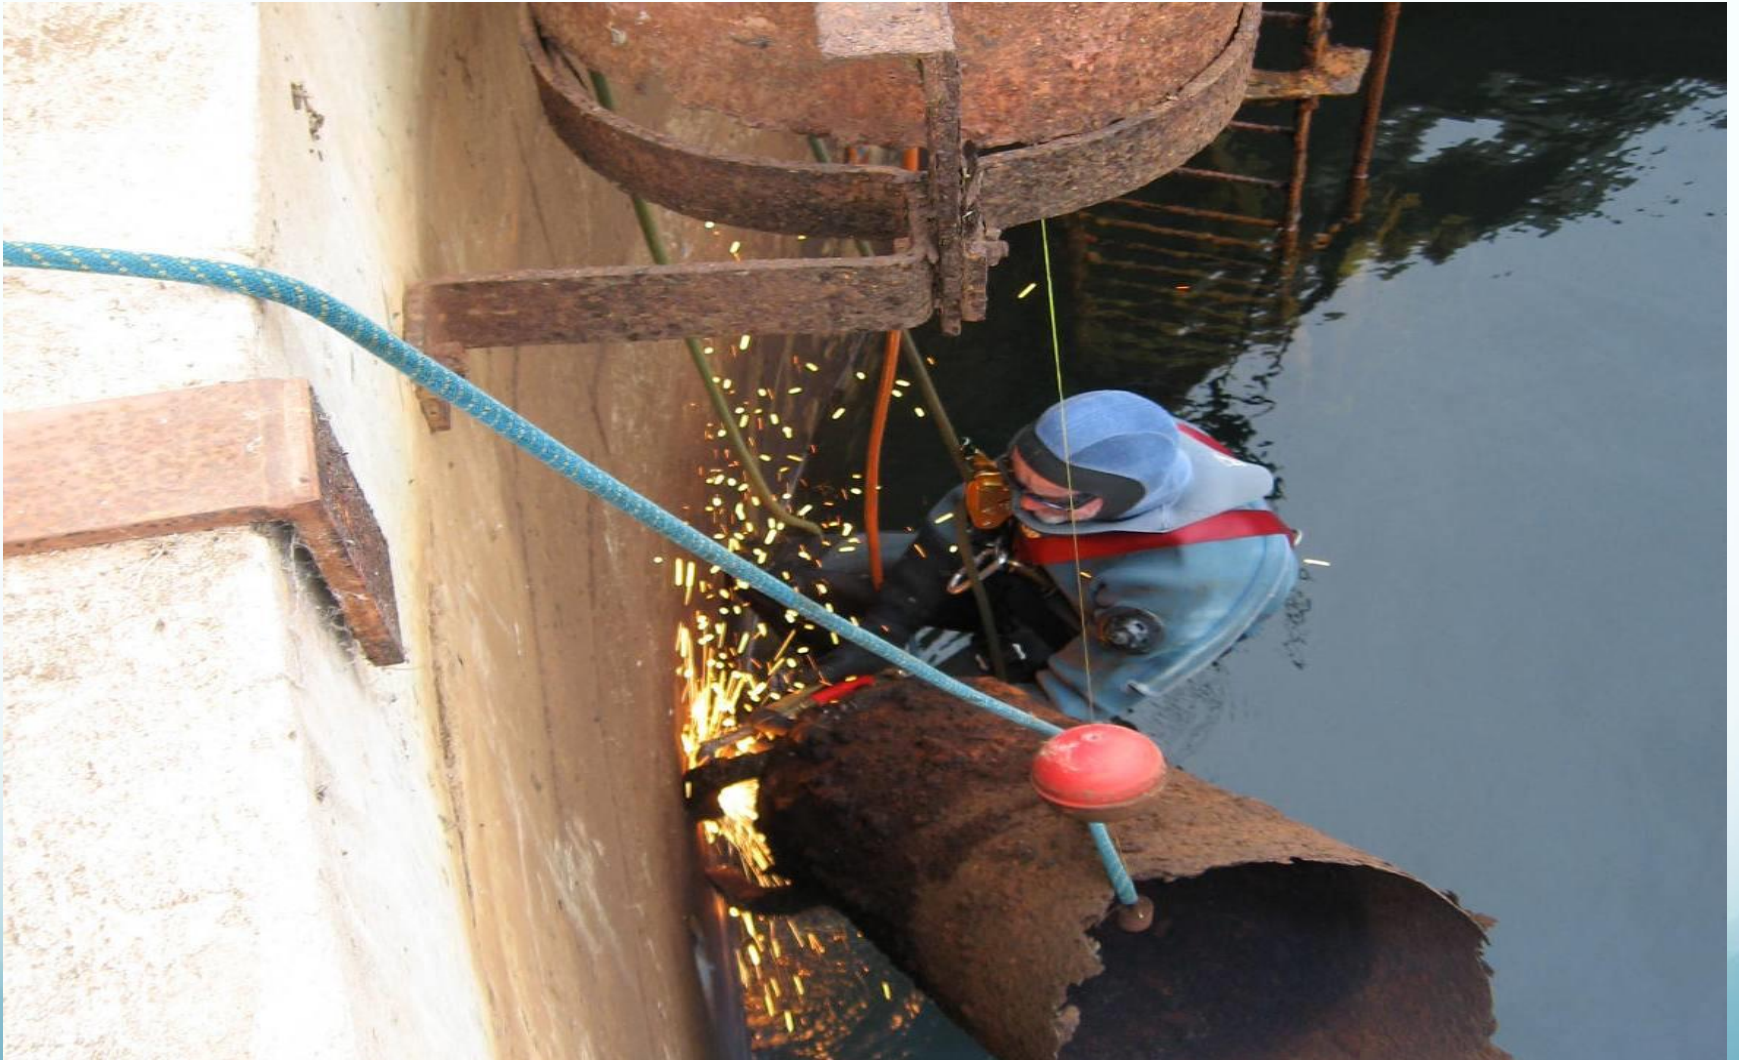
Remove any old and obsolete pipe work when tanks are being renovated.

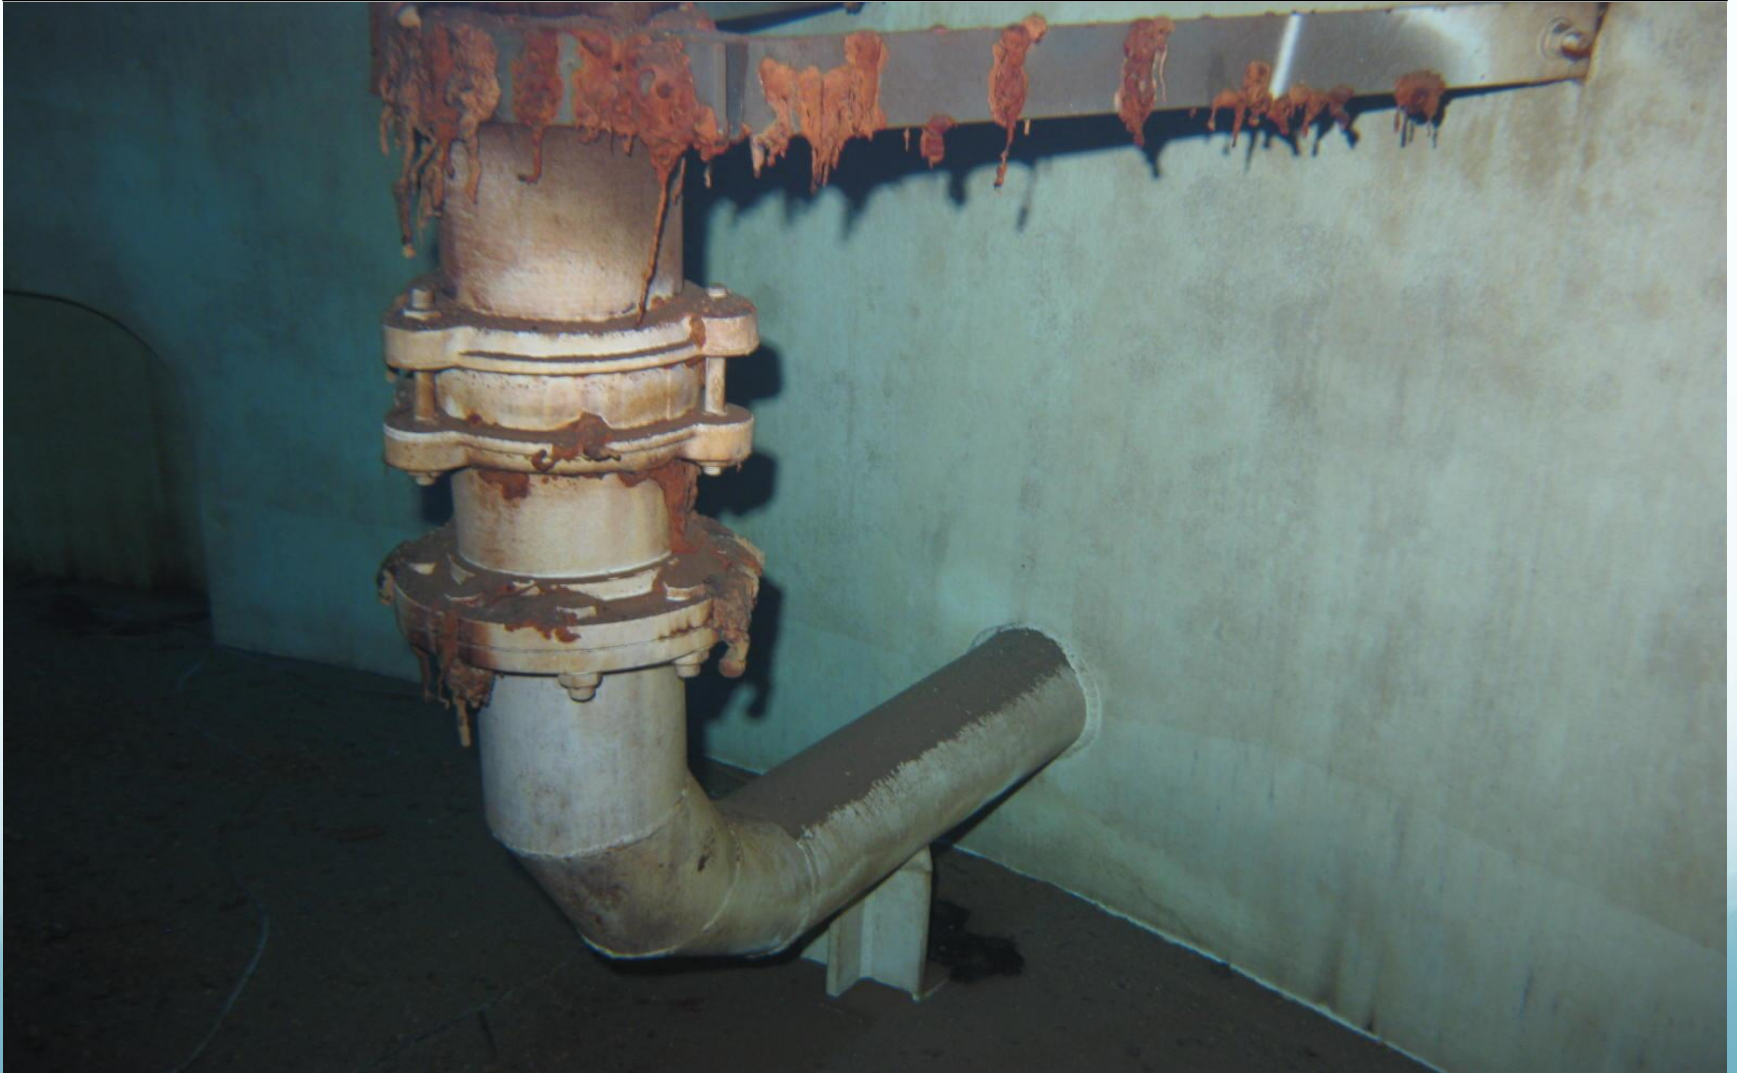
The support brackets on this overflow riser pipe are galvanized and beginning to corrode, while the epoxy coated areas are still OK.
