RESERVOIR RENOVATIONS – BEST CHANCE OR LOST CHANCE

This paper will highlight the key areas where old designs were deficient and it will also offer solutions to improve the safety of both operations personnel and the stored water.

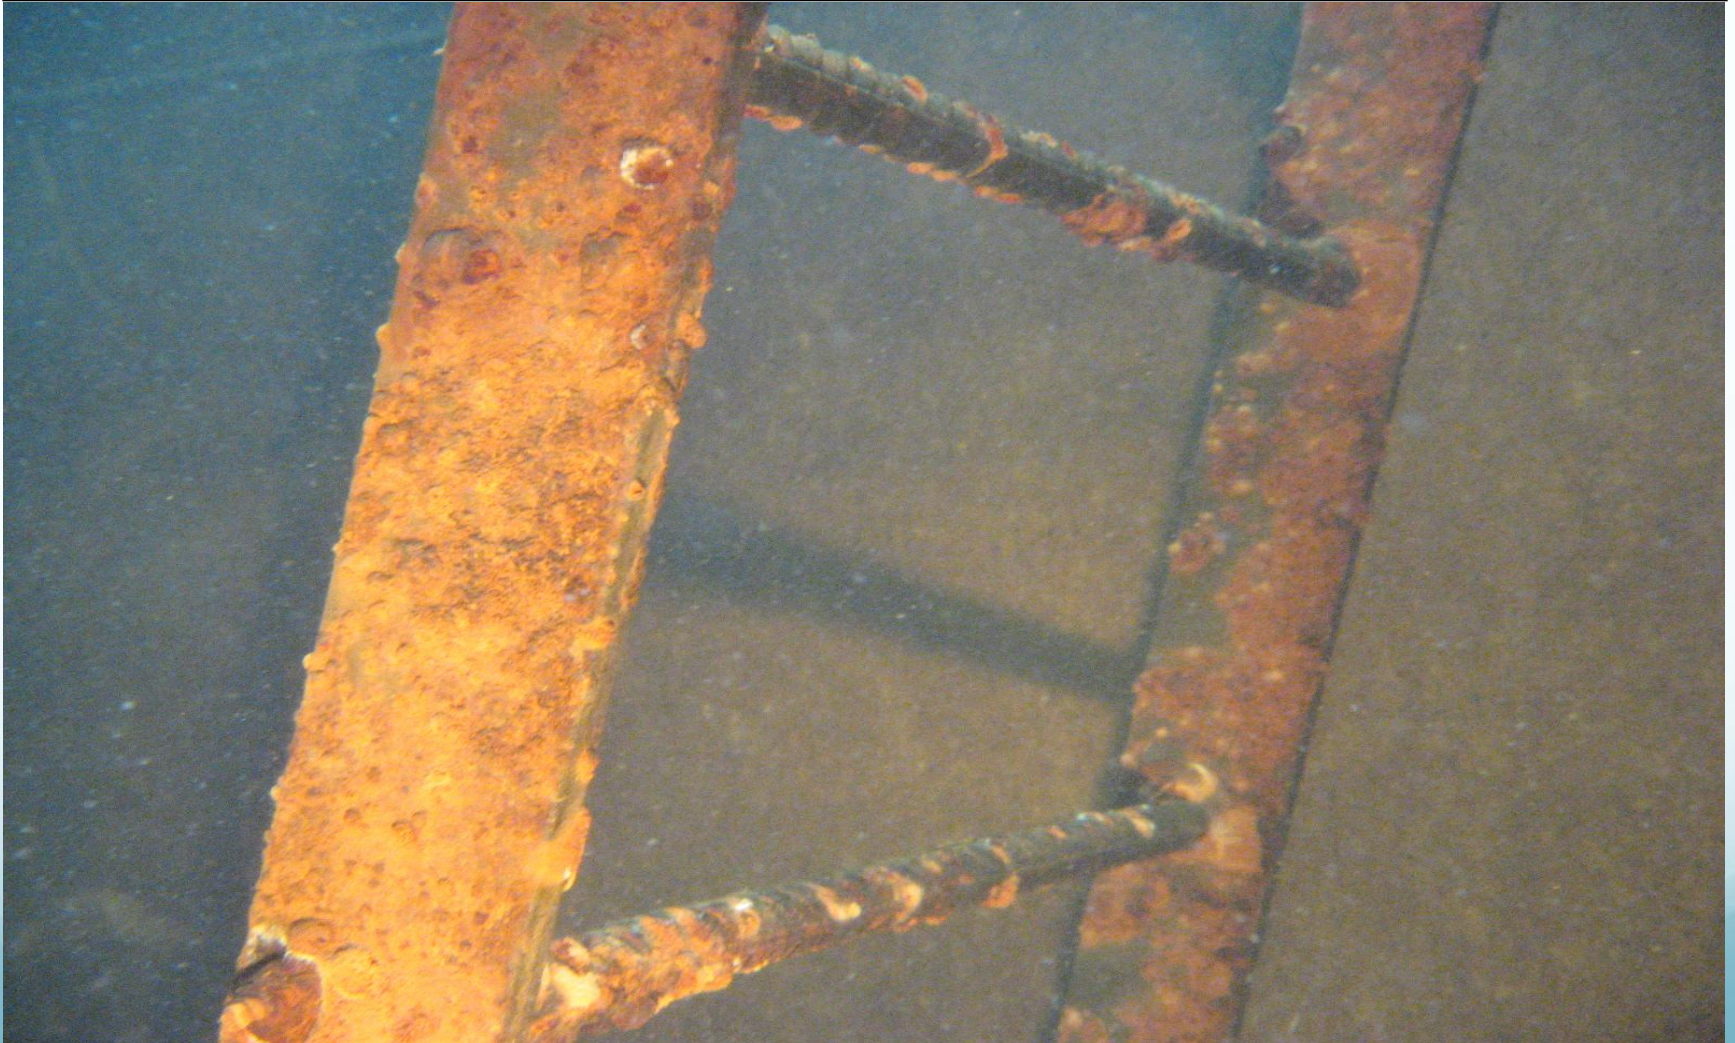
Ladders and fittings were also often galvanized whilst the epoxy coated wall and floor areas are still in good condition.

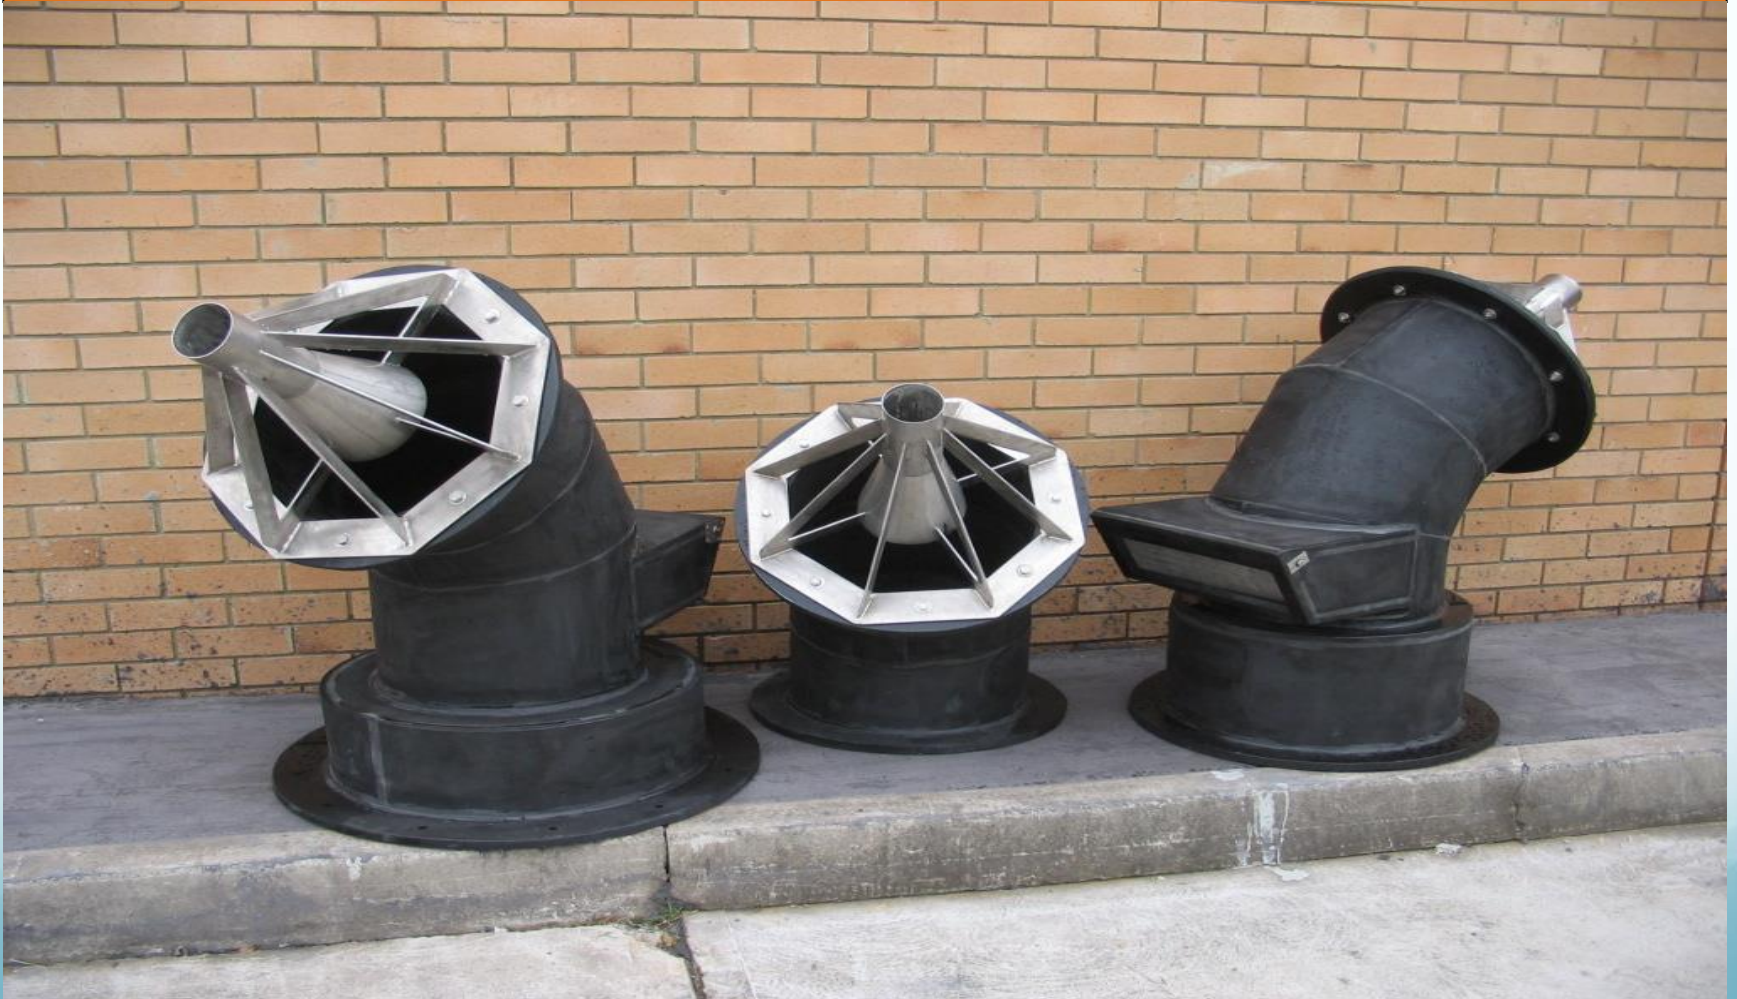
Directional inlet nozzles made from non corroding HDPE – these units will enhance the inlet pipe work and improve the stored water quality. The SS Ram tubes provide a safety barrier for divers and also reduce any back pressure issues to the inlet pumps.

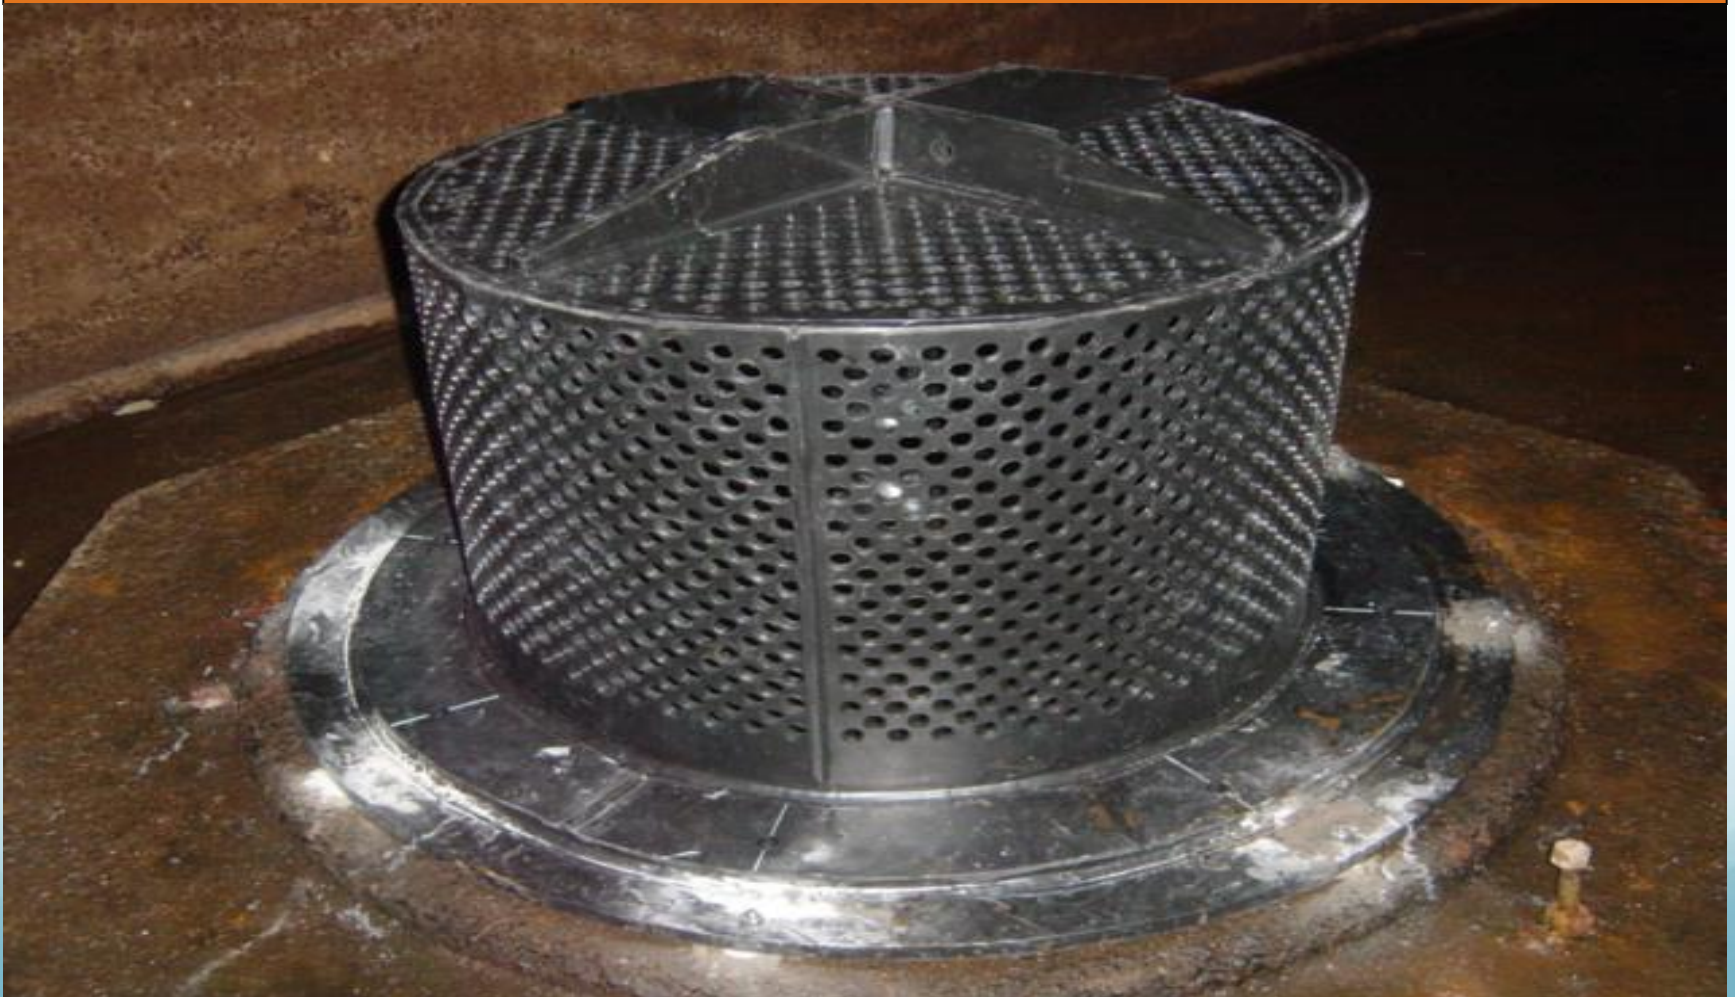
Outlet safety screens made from HDPE prevent sediment accumulation from entering the pipe work – they should fit the penetration closely to avoid internal sediment entrapment which is difficult to remove during normal cleaning operations.
