# Inspecting Service Reservoirs for Water Quality NOW

Jillian Busch and Dave Barry  
Aqualift Project Delivery Pty Ltd  
July 2015

# Inspection Program

82 Tanks inspected across western NSW

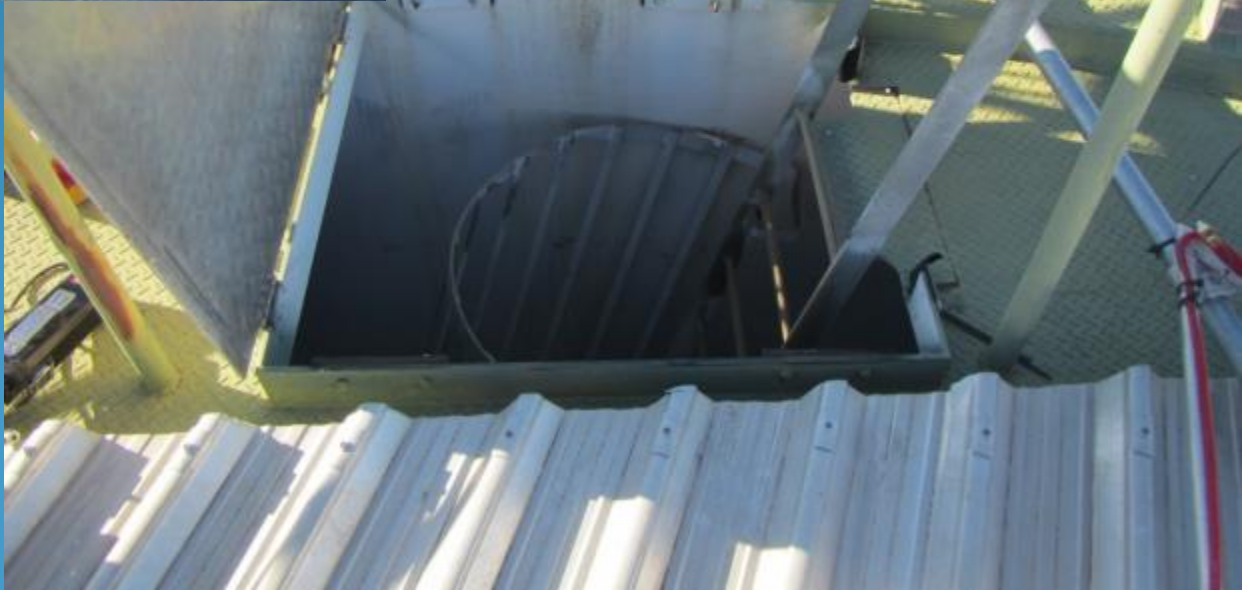
- Ladder stiles protruding
- No sealed front edge

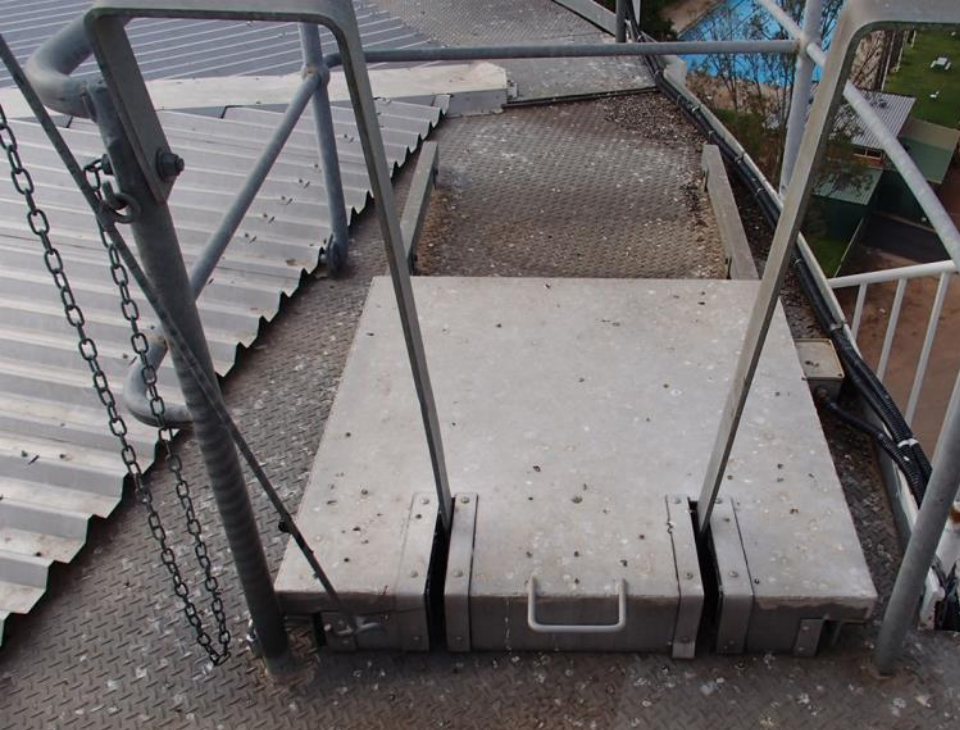
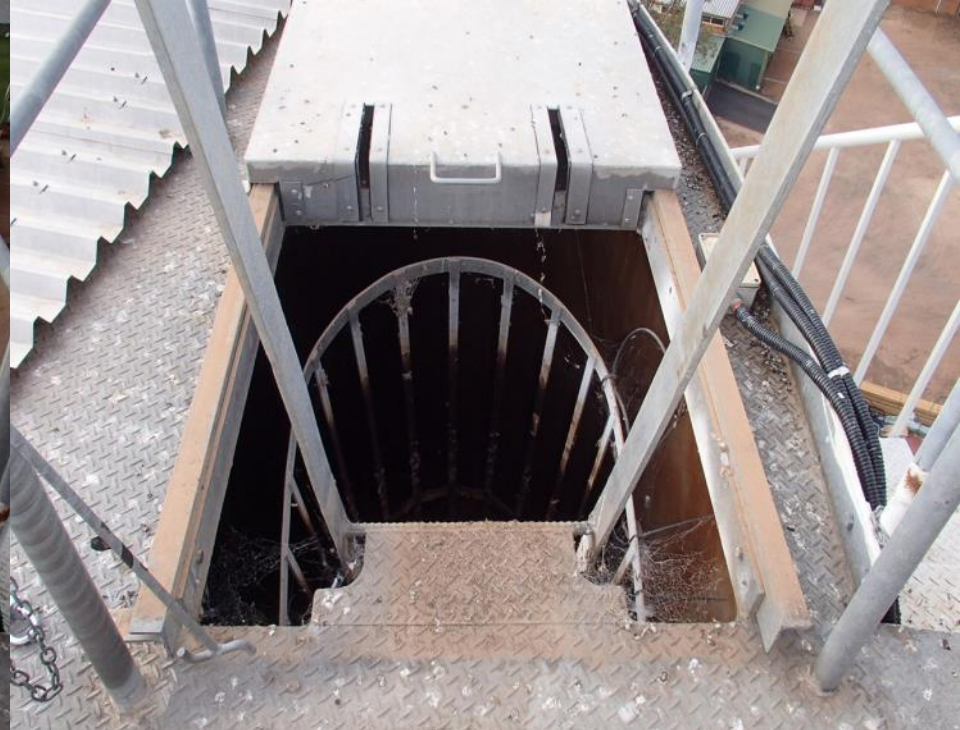
Sliding hatch cover with the same issues...

- protruding stiles
- no front edge
- faecal material entering the tank

Type 1 entry hatch frame and hinged cover required

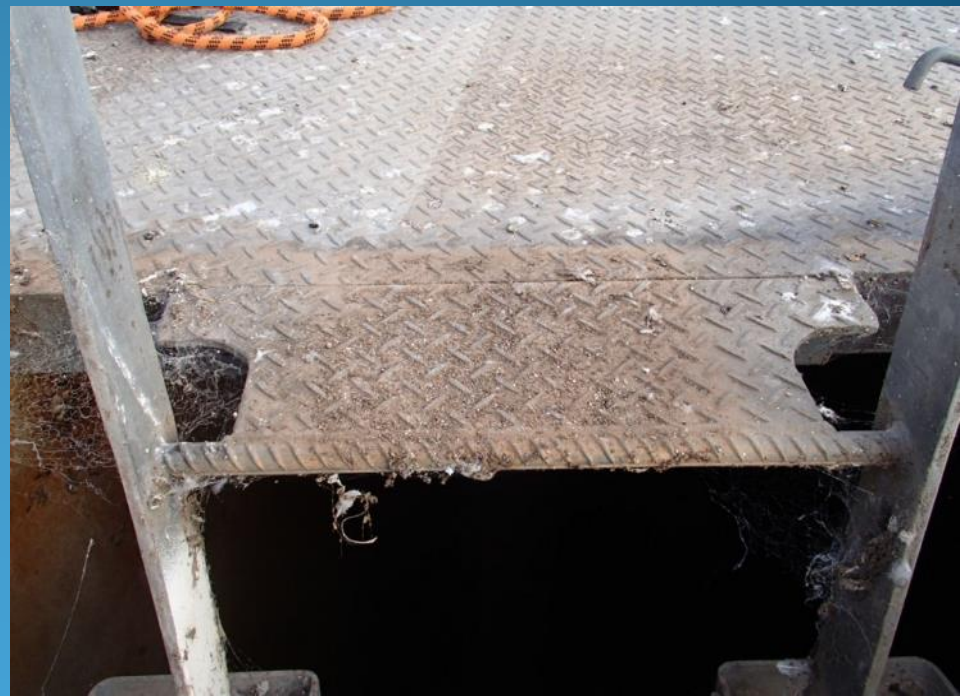
No hatch cover in place  
since the tank was  
painted...years ago!

Dead birds found inside

No effective sealing or  
security

A Type 1 Platform  
renovation suggested

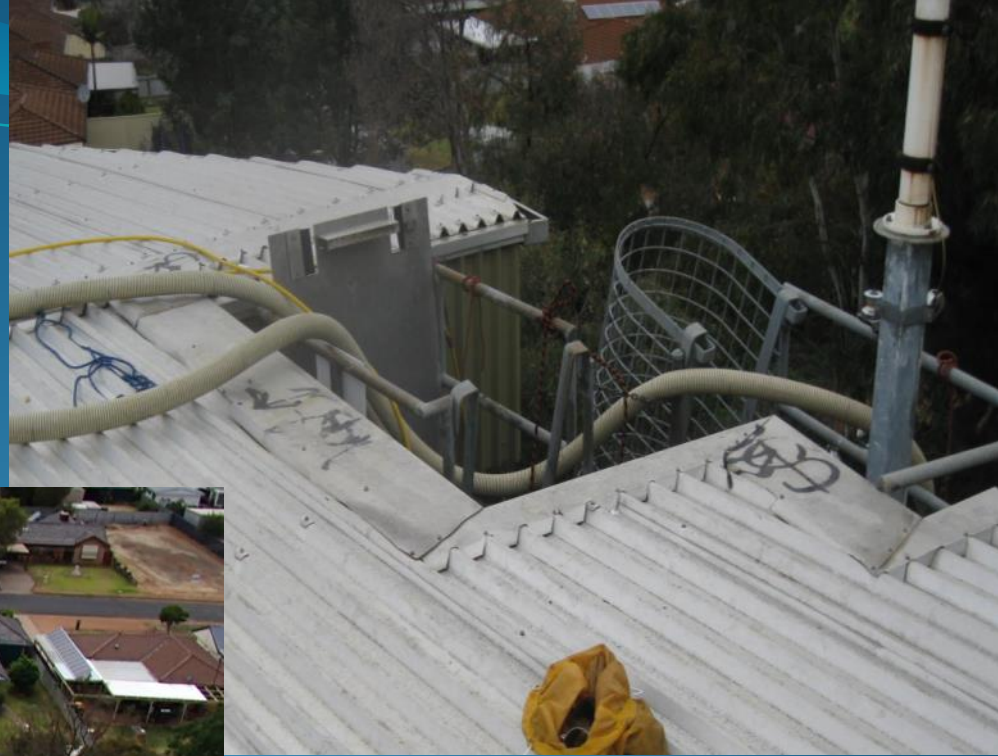
- Too small to work on or around
- No safety rails on roof edges

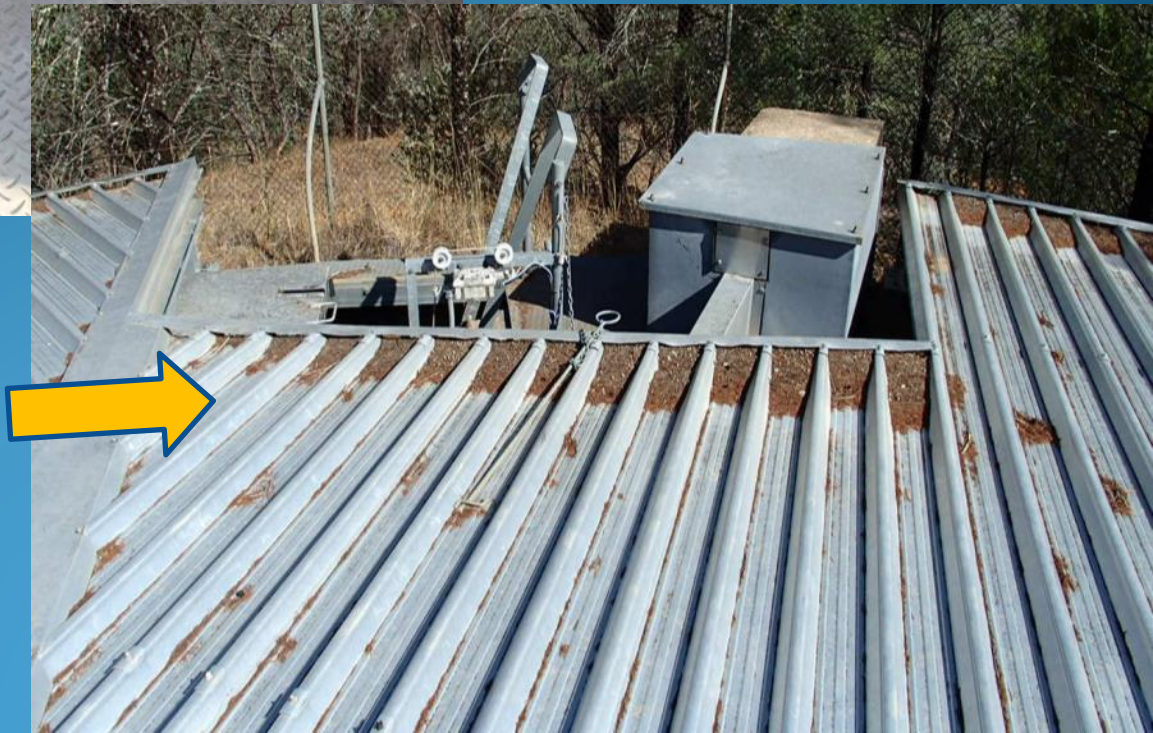
Negative fall  
allowing debris  
ponding  
- regular cleaning  
is required

Side flashings on  
roof sheet edges  
allow debris ponding

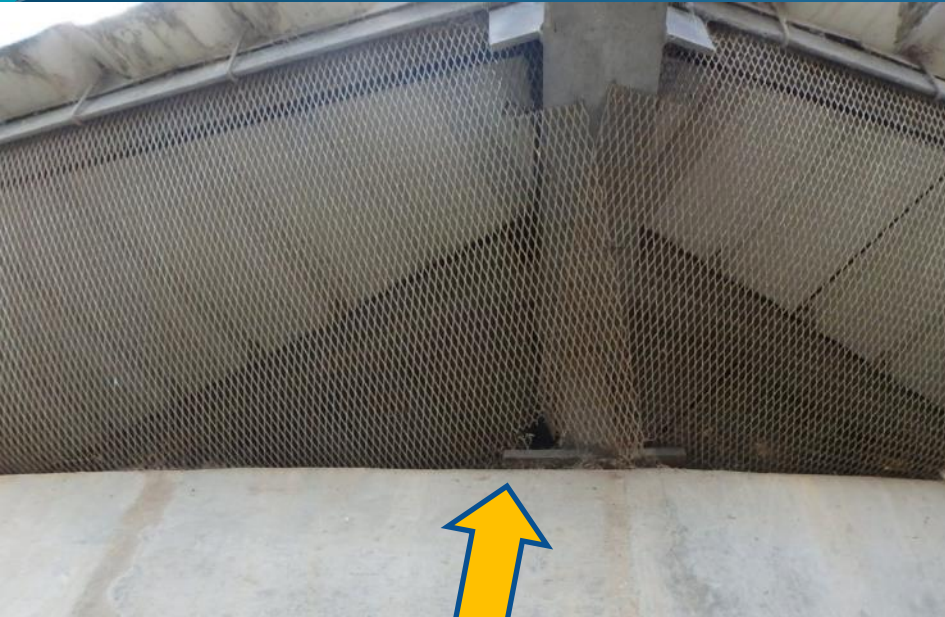
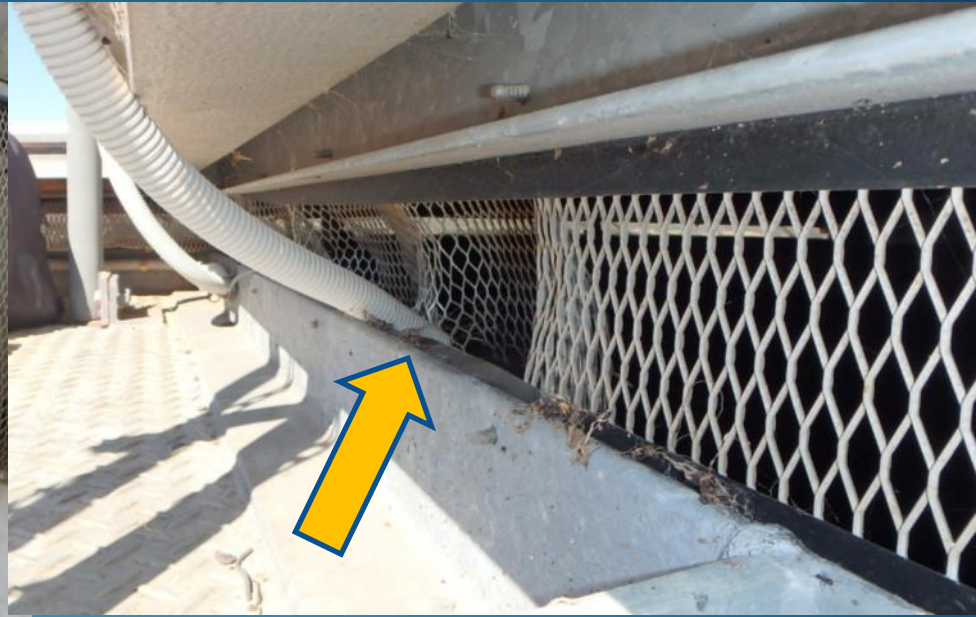
Birds and vermin can enter past these open areas

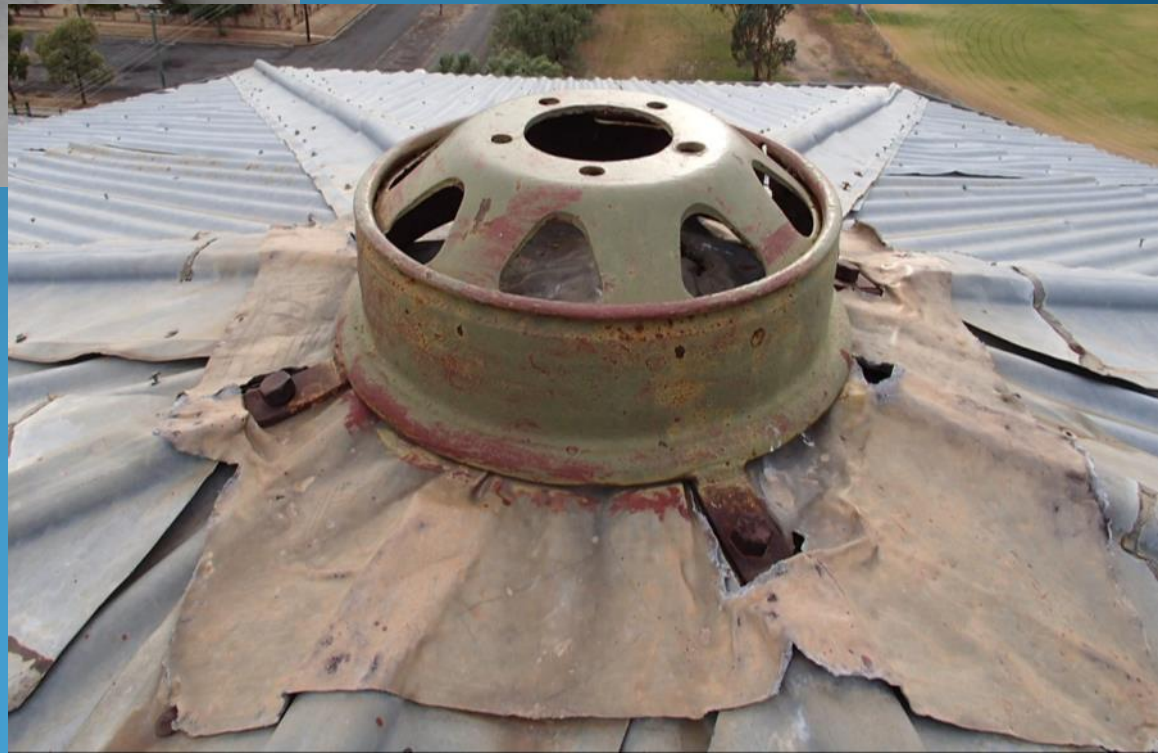
A 'Wheely' good  
idea to hold the roof  
down!!

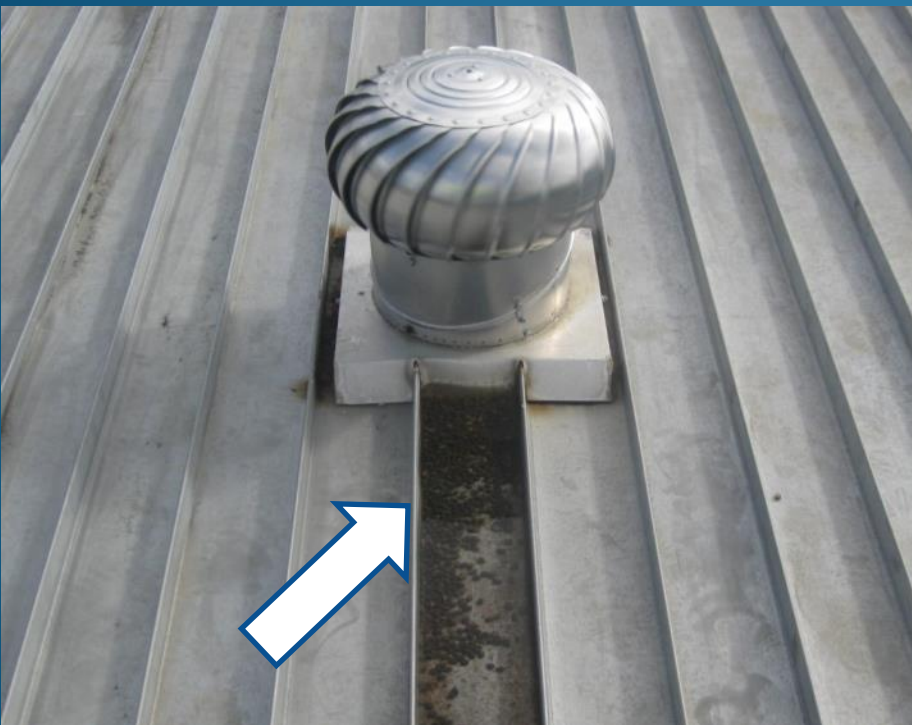
No upstream drainage -debris is ponding & entering tank

- Balance ventilation with roof framing life
- Face vents away from prevailing weather
- Seal roof vent bases to allow for upstream drainage

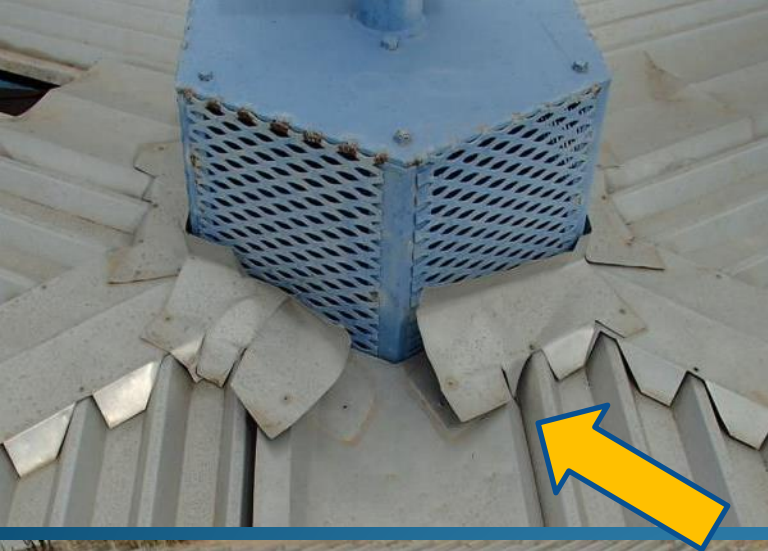
Flashings are unsecured  
and will become wind damaged  
in the future

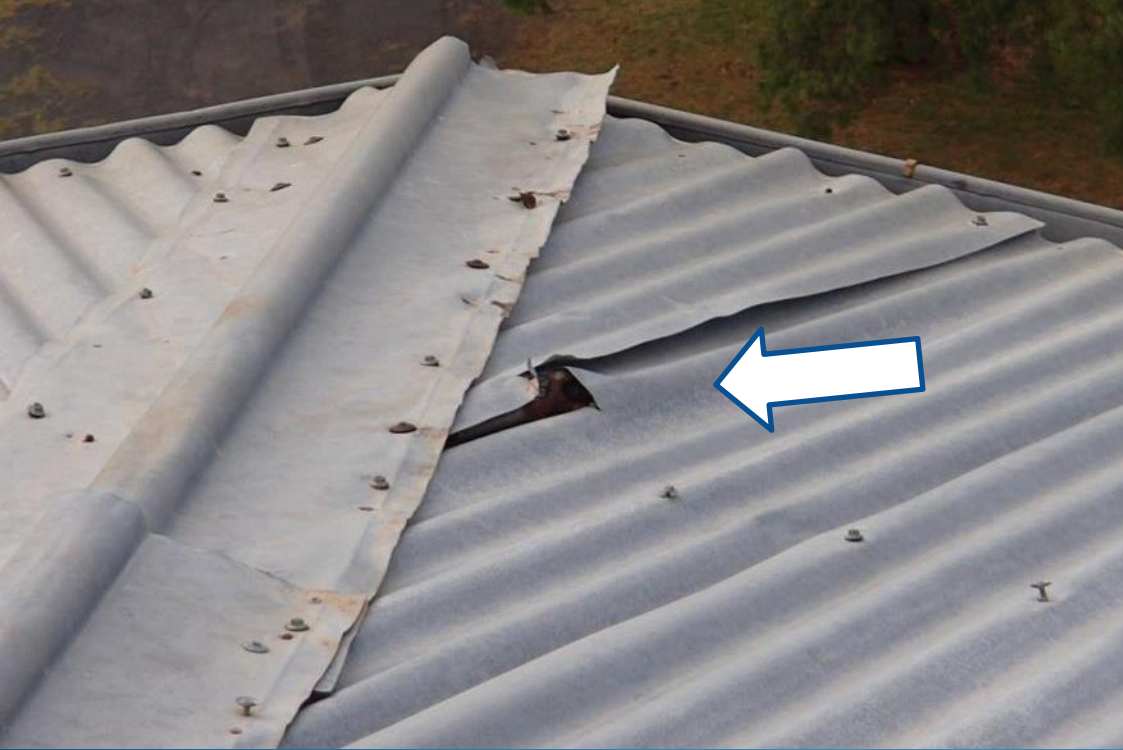
Roof sheets and flashings not secure...

- prone to wind damage

Roof sheet edges are not secured

- vermin can enter tank
- wind damage may occur

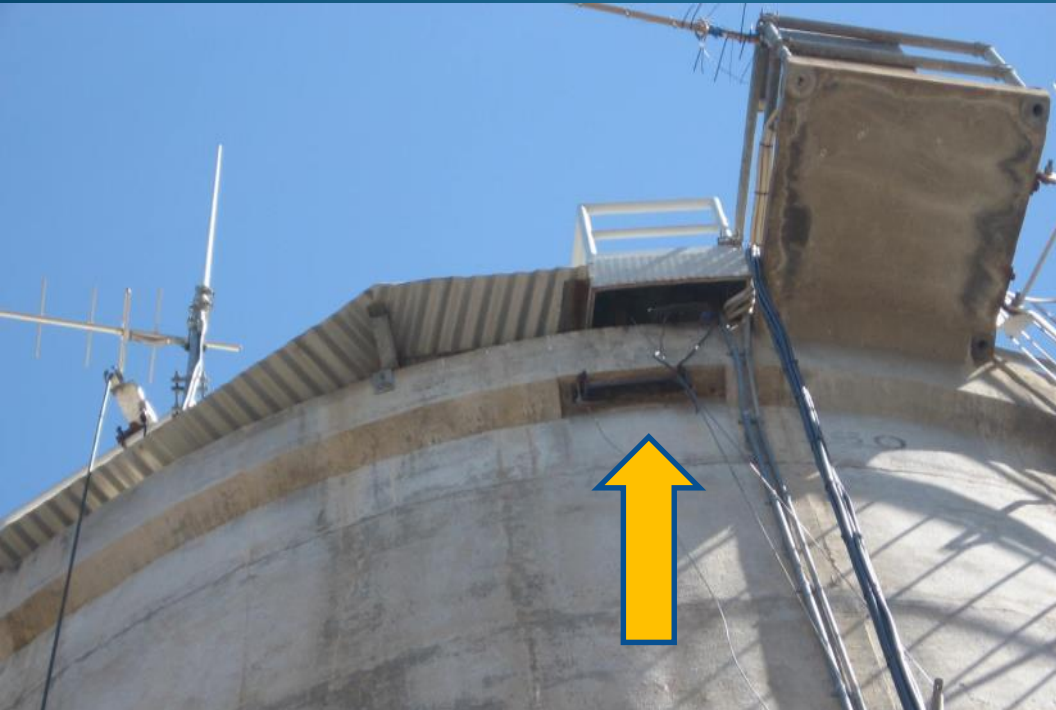
Pulley cover boxes are often open on the underside

Vent mesh is often damaged where cables pass through

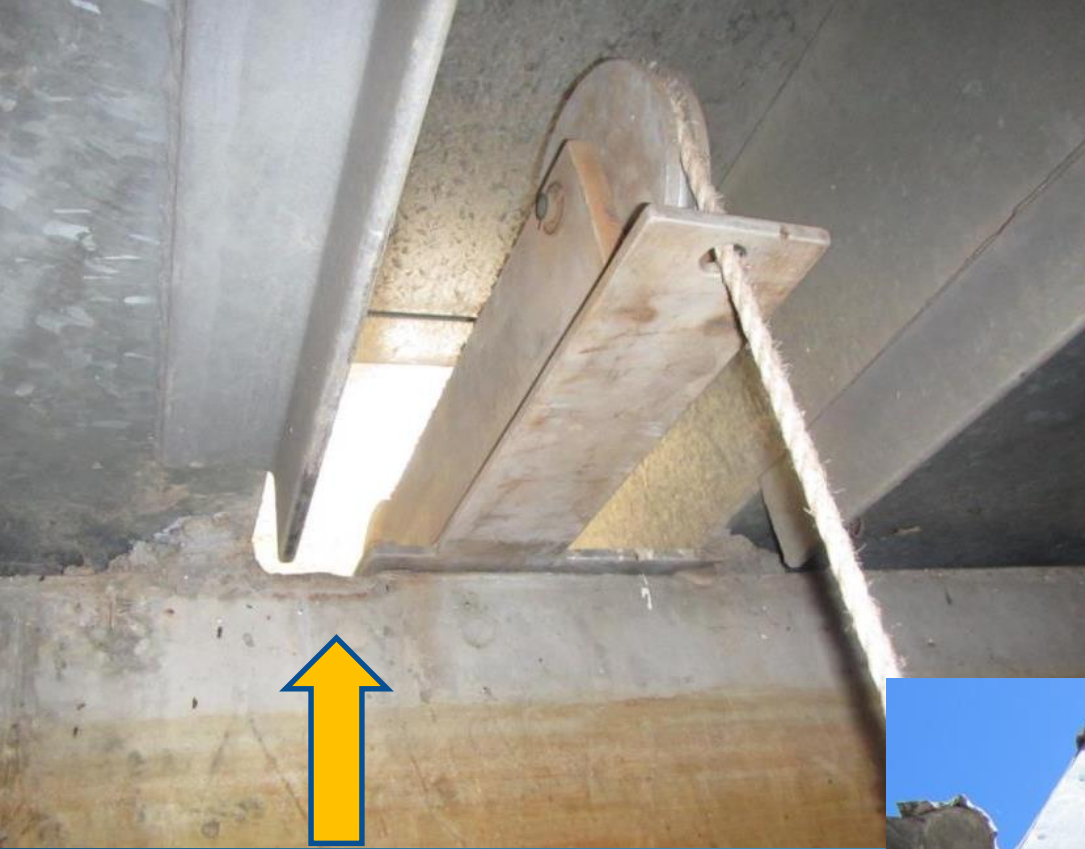
Level pulley systems  
often create bird and  
vermin entry areas

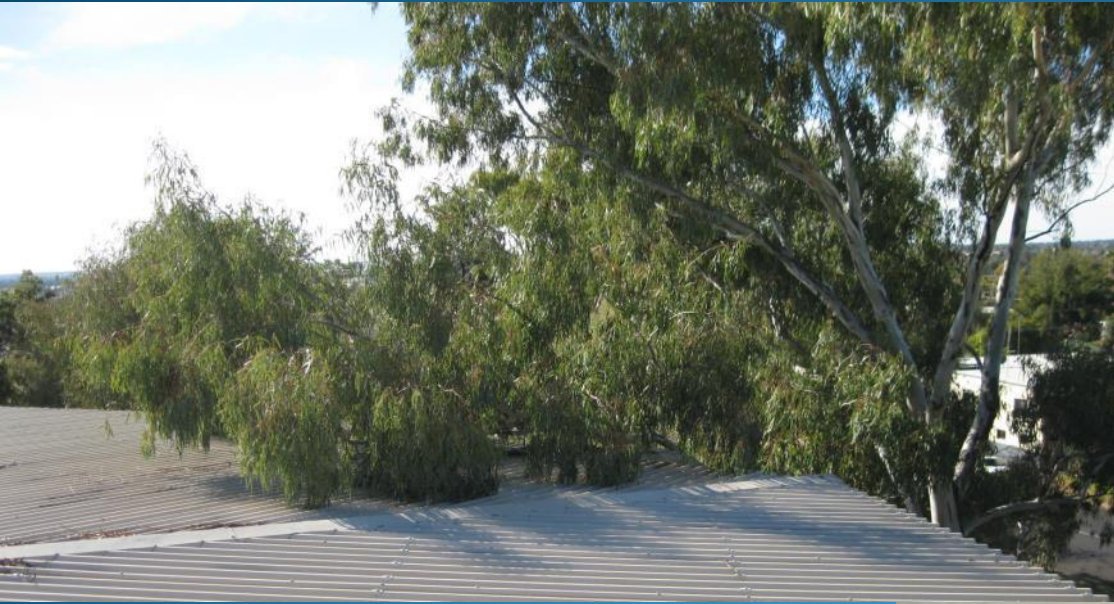
Overhanging trees allow vermin entry to roof area

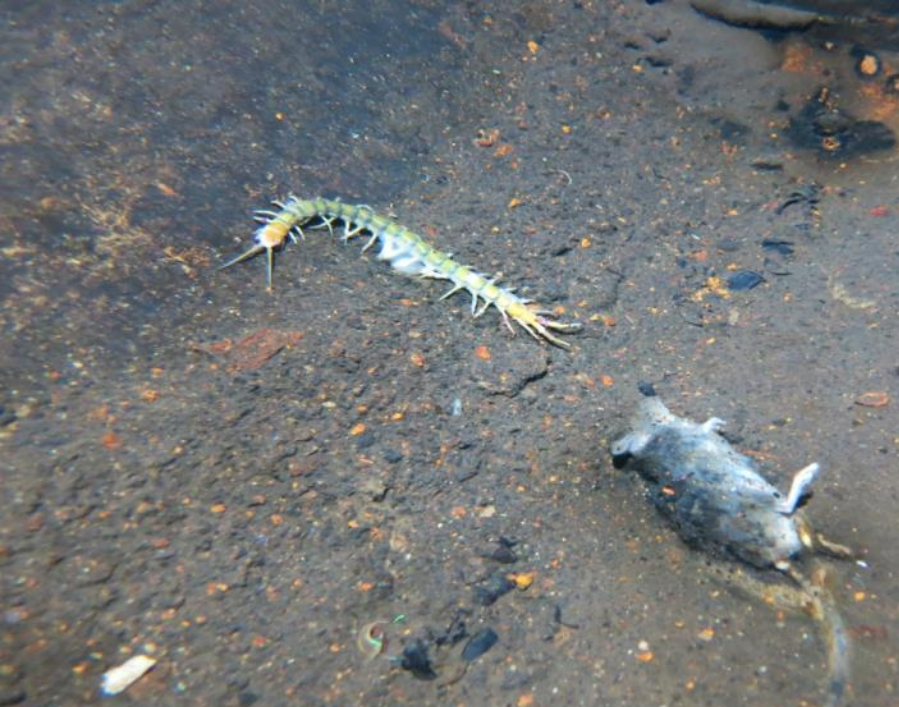
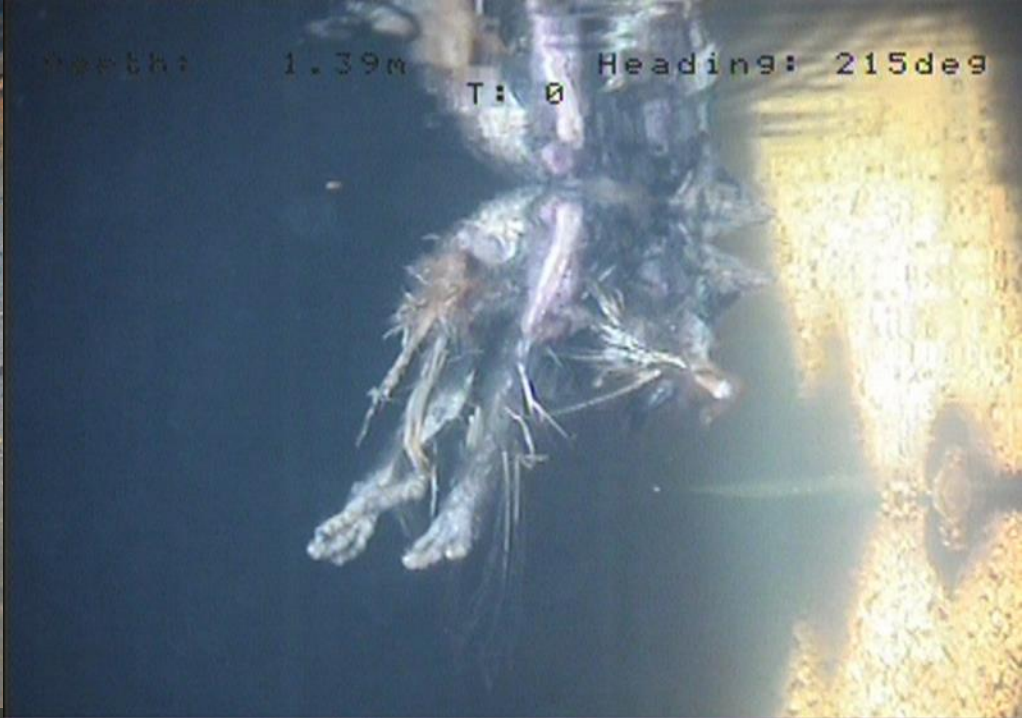
Debris - no explanation required??

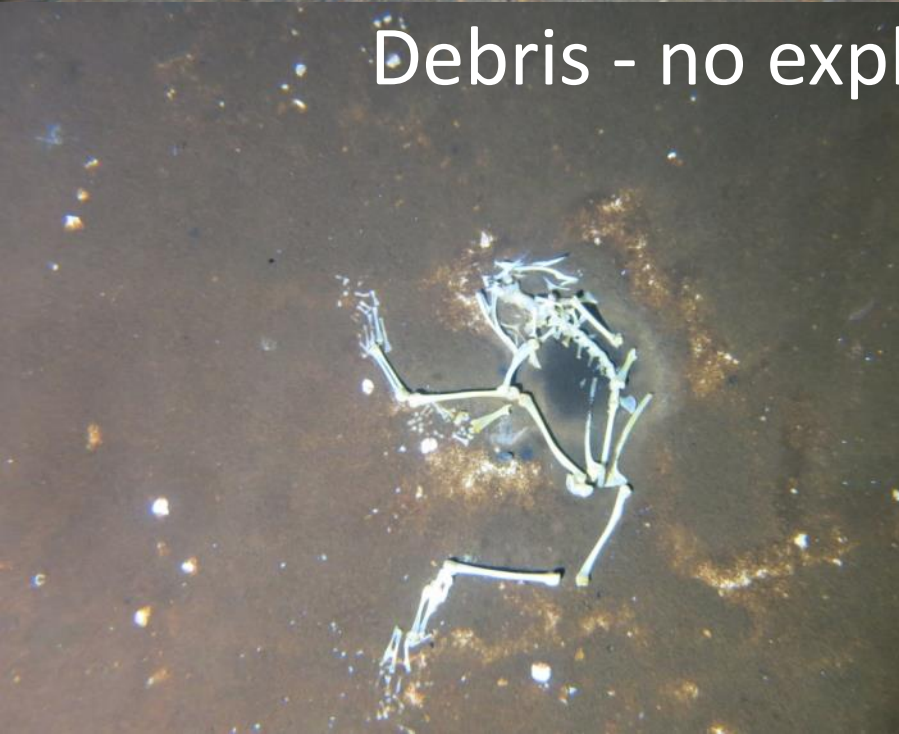
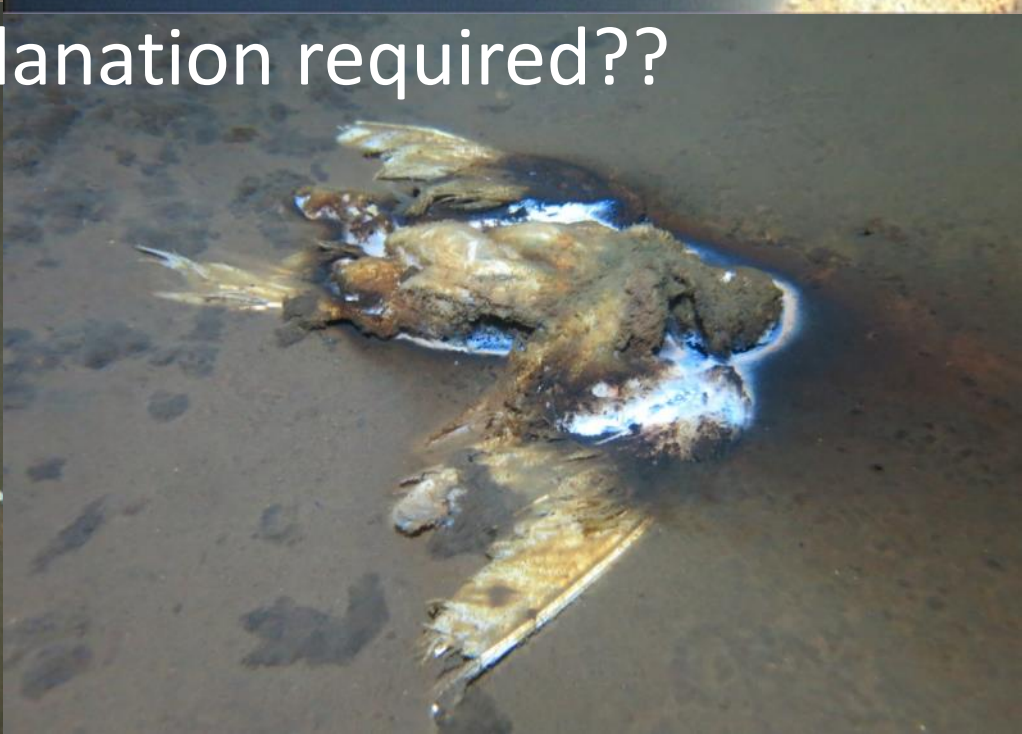
Obvious bird entry area –  
note the faecal evidence of  
birds roosting (and drowning)  
for a considerable time

Quickly fixed with mesh and  
an EWP!

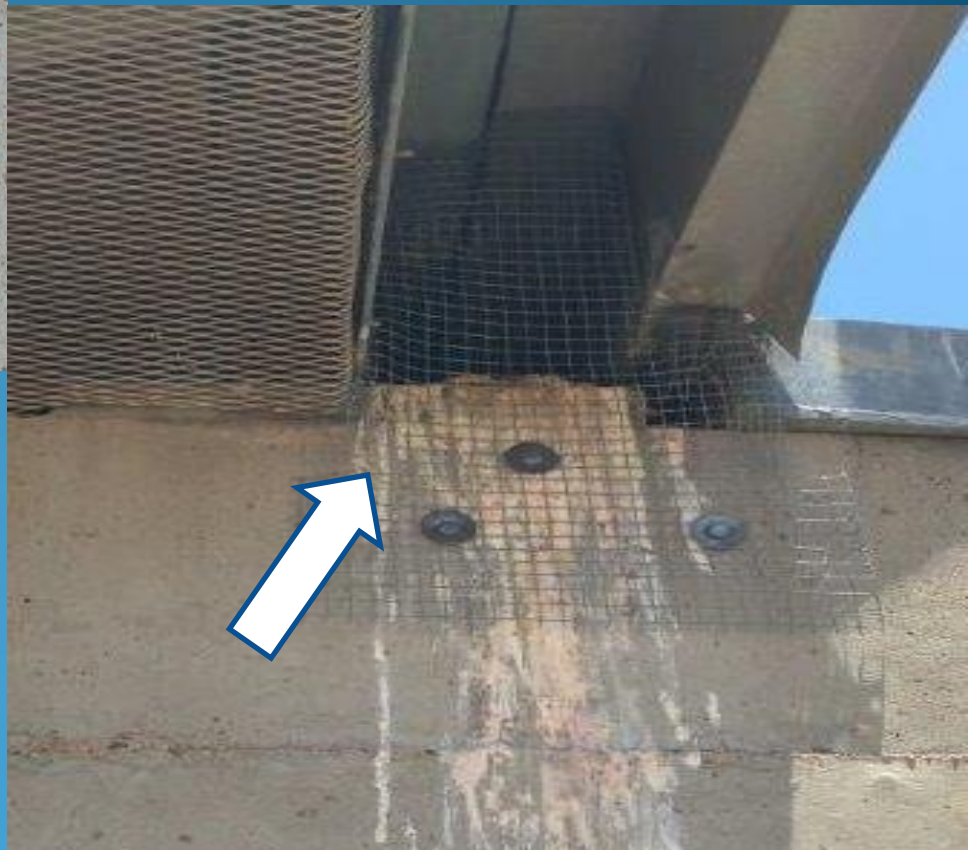
Faecal contamination  
from roosting birds

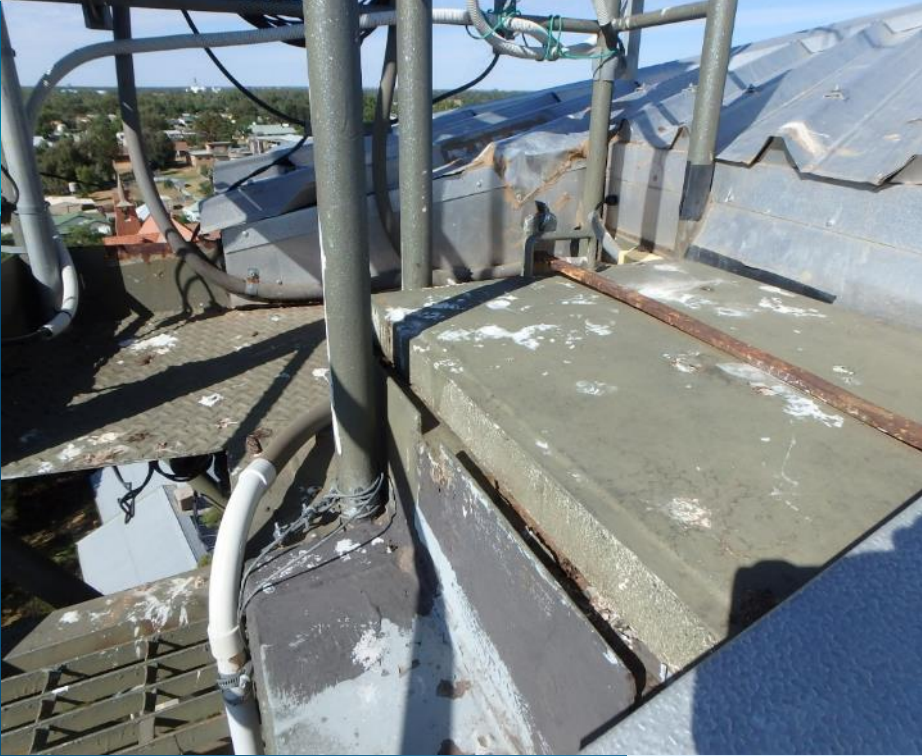
No effective platform  
– too many aerials

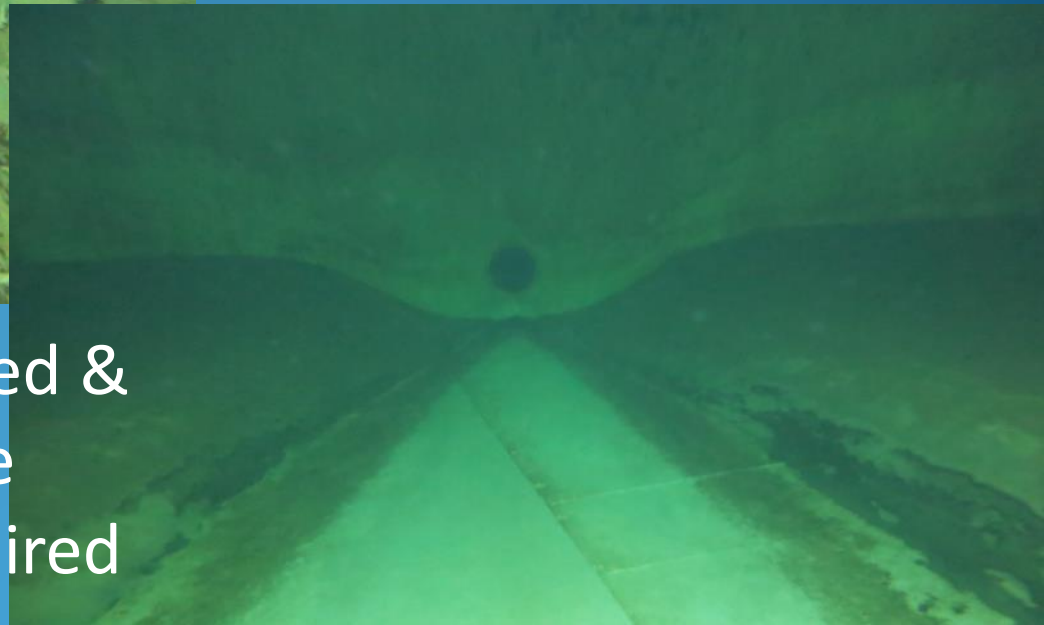
Sediments are being displaced & stirred up during filling cycle  
- a directional nozzle is required

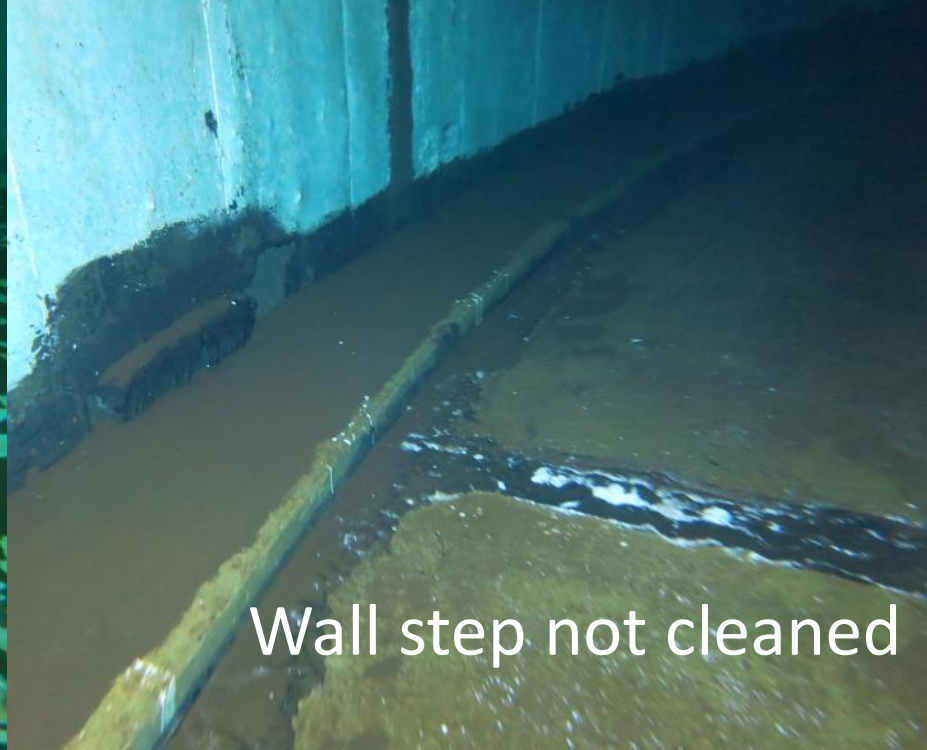
Cut line obvious –  
uncleaned area remaining

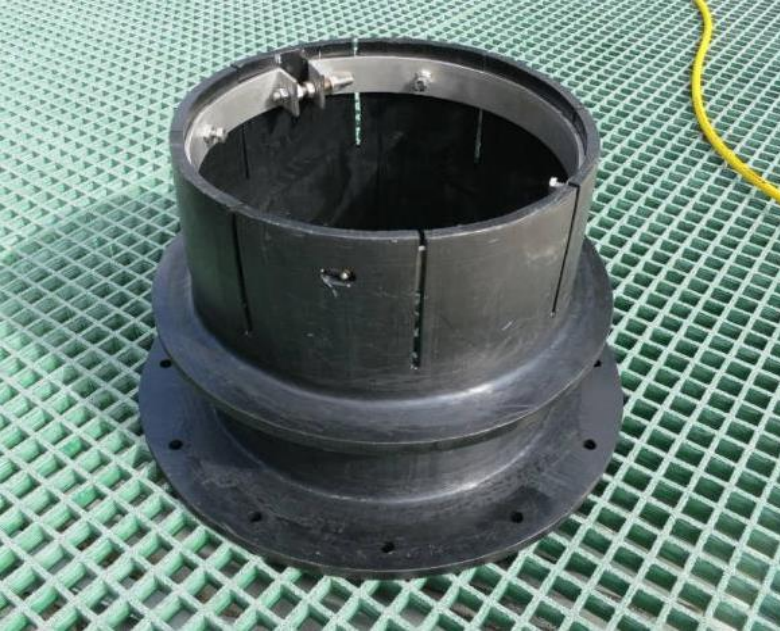
An HDPE adaptor spigot to fit inside existing wall mounted penetrations

It works similar to a 'Uniflange', except it clamps internally instead of externally

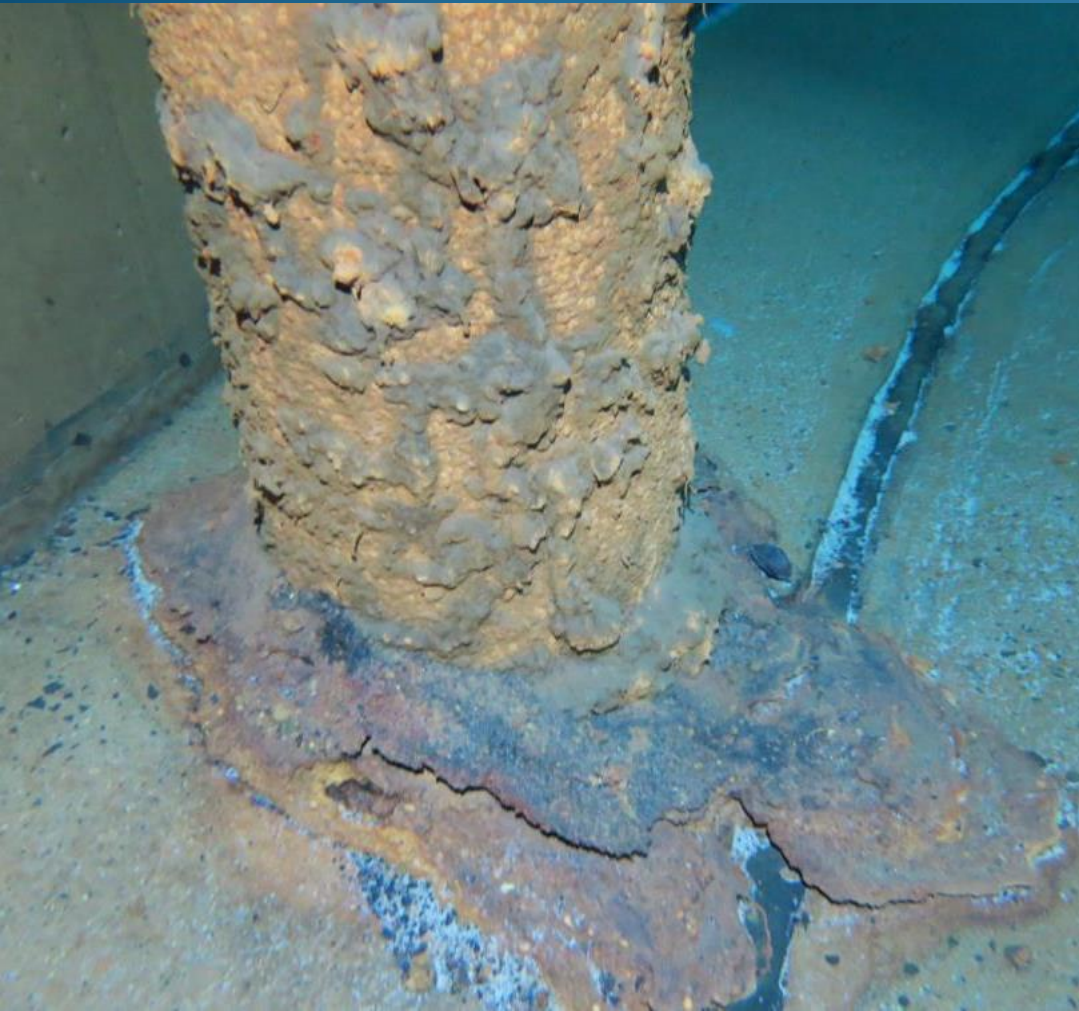
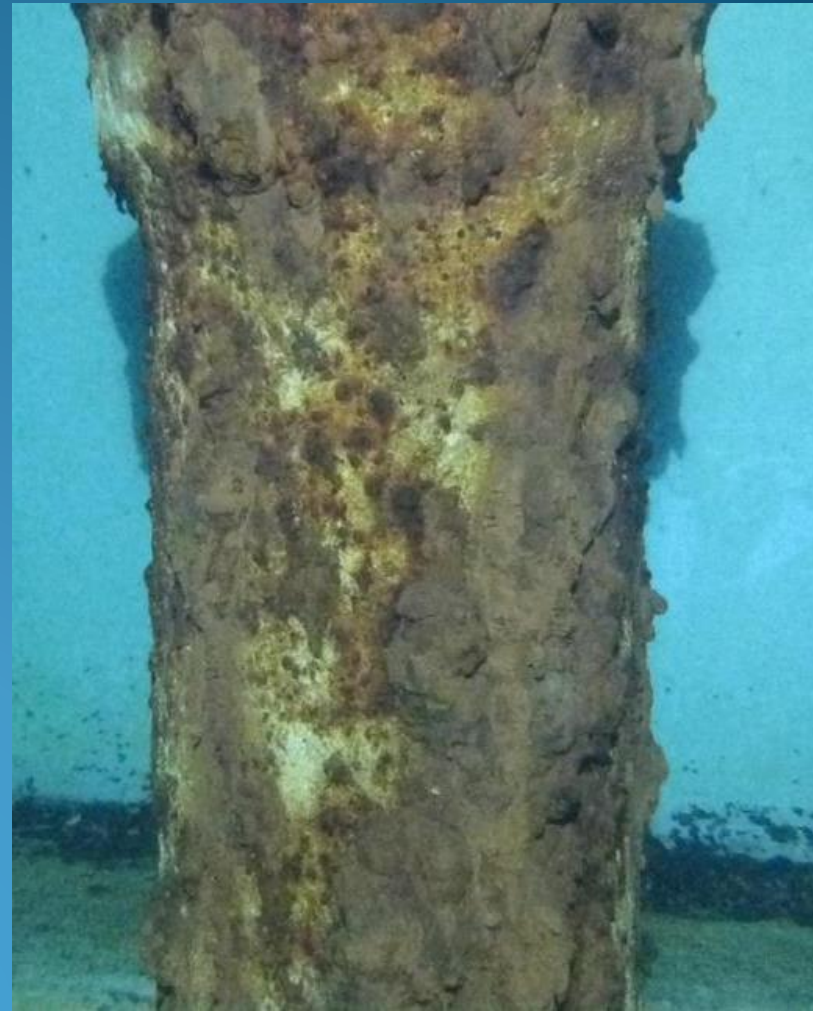
Most overflow systems in concrete tanks are not coated  
After 30 to 50 yrs structural failures & leakage can occur

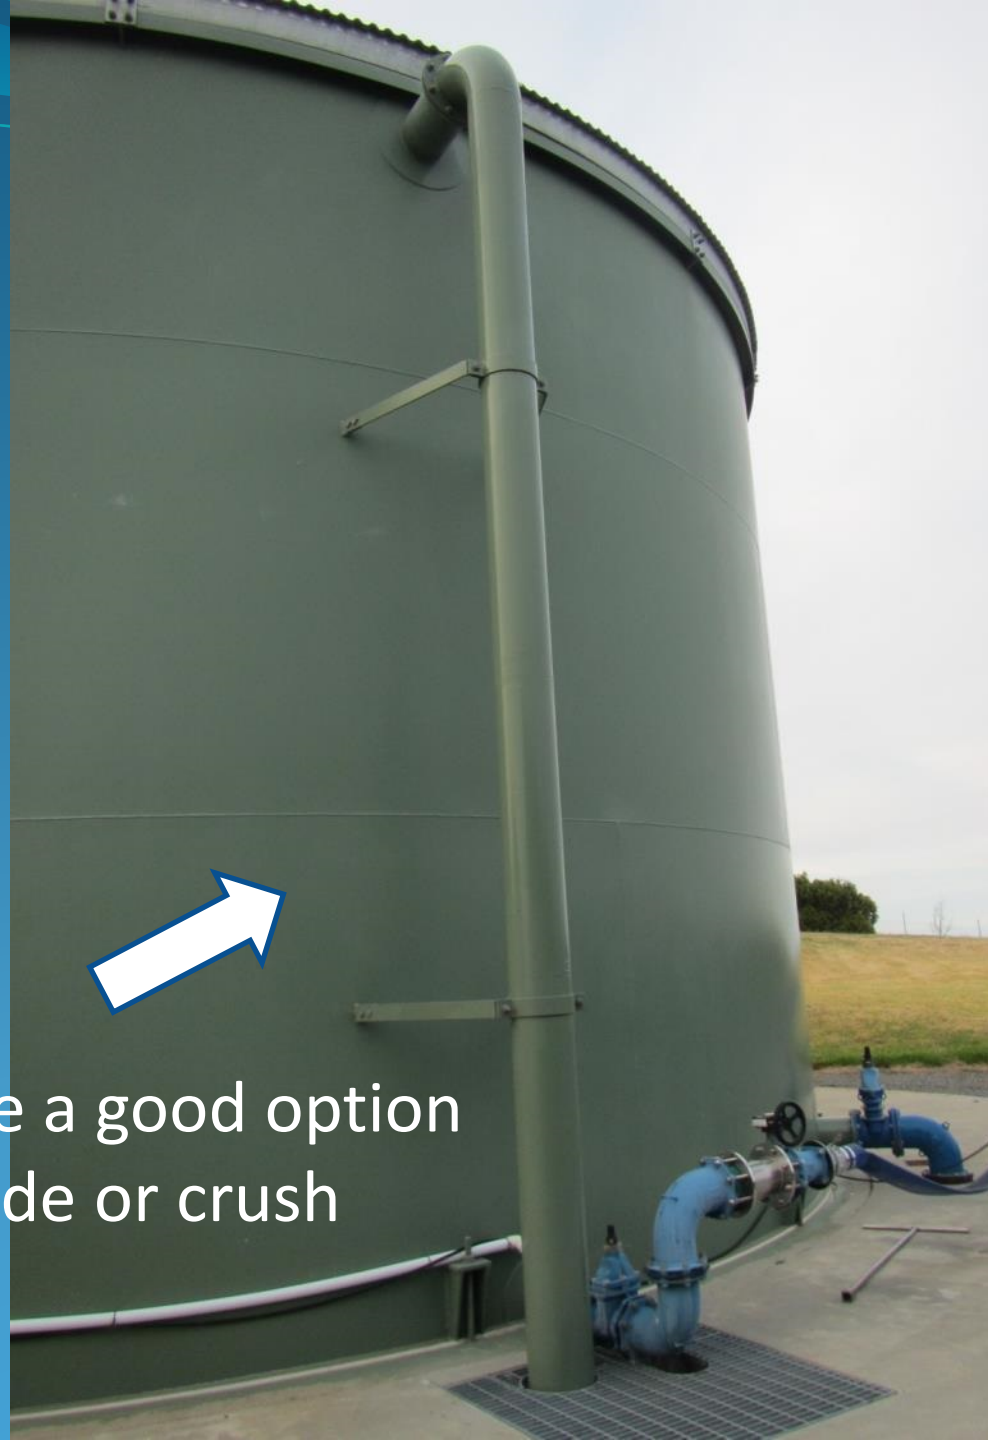
External overflow systems are a good option  
- nothing inside tank to corrode or crush
